ES473 Environmental Geology

Landslide and Flood Hazards of the Monmouth-Independence Area

GRI CITY OF SALEM
S. RIVER ROAD ROCK CUT MAINTENANCE

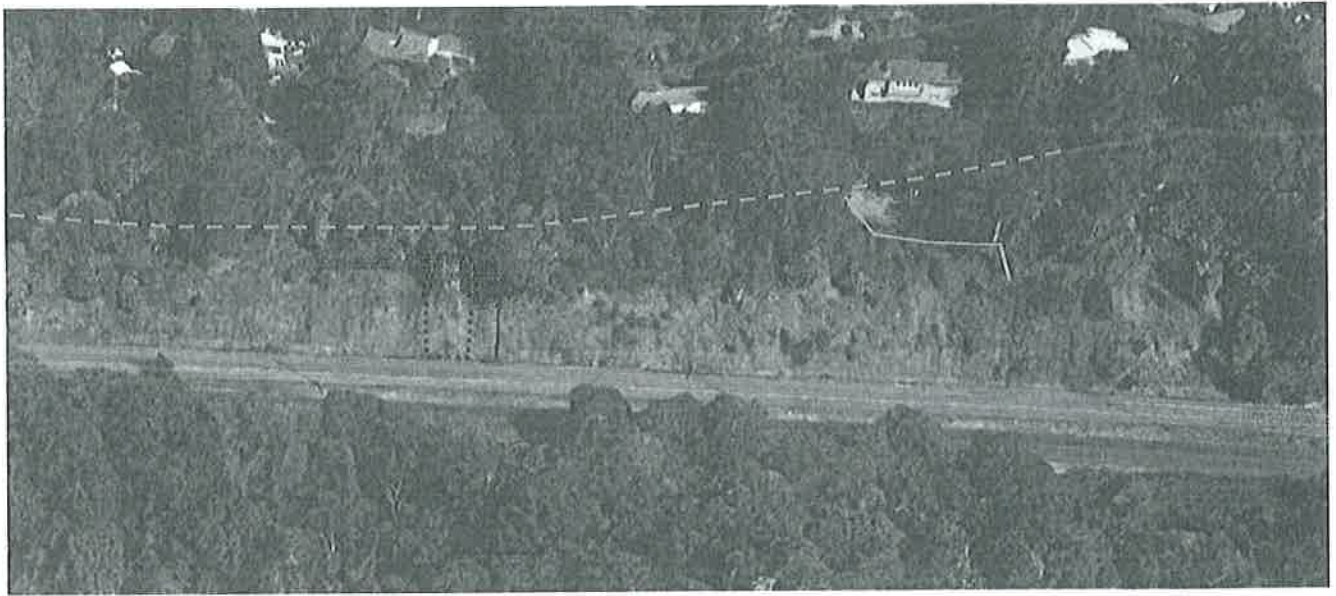
FIG. 2

View looking east; north is to the left. The area of December 2014 rockslide is outlined in red. Areas of rock excavation and slope grading are highlighted yellow. Approximate sewer alignment north of Alta View Drive S is shown in green. The south limit of tree clearing is shown in orange.

Draped mesh systems are generally suitable to contain occasional rockfall debris up to about 2 ft in diameter. Since the draped mesh system was installed on this rock cut in the 1990s, several large-diameter rockfall and large rockslides have damaged the draped mesh system and concrete barrier. The most recent event occurred on December 16, 2014, when a rockslide about 30 to 50 ft wide generated an estimated 400 cu yd of debris and temporarily closed the roadway (2014 rockslide). Several panels of the draped mesh and at least six of the anchors that secure the draped mesh system to the face of the slope were damaged by the rockslide. The location of the 2014 rockslide is shown on Figure 2.

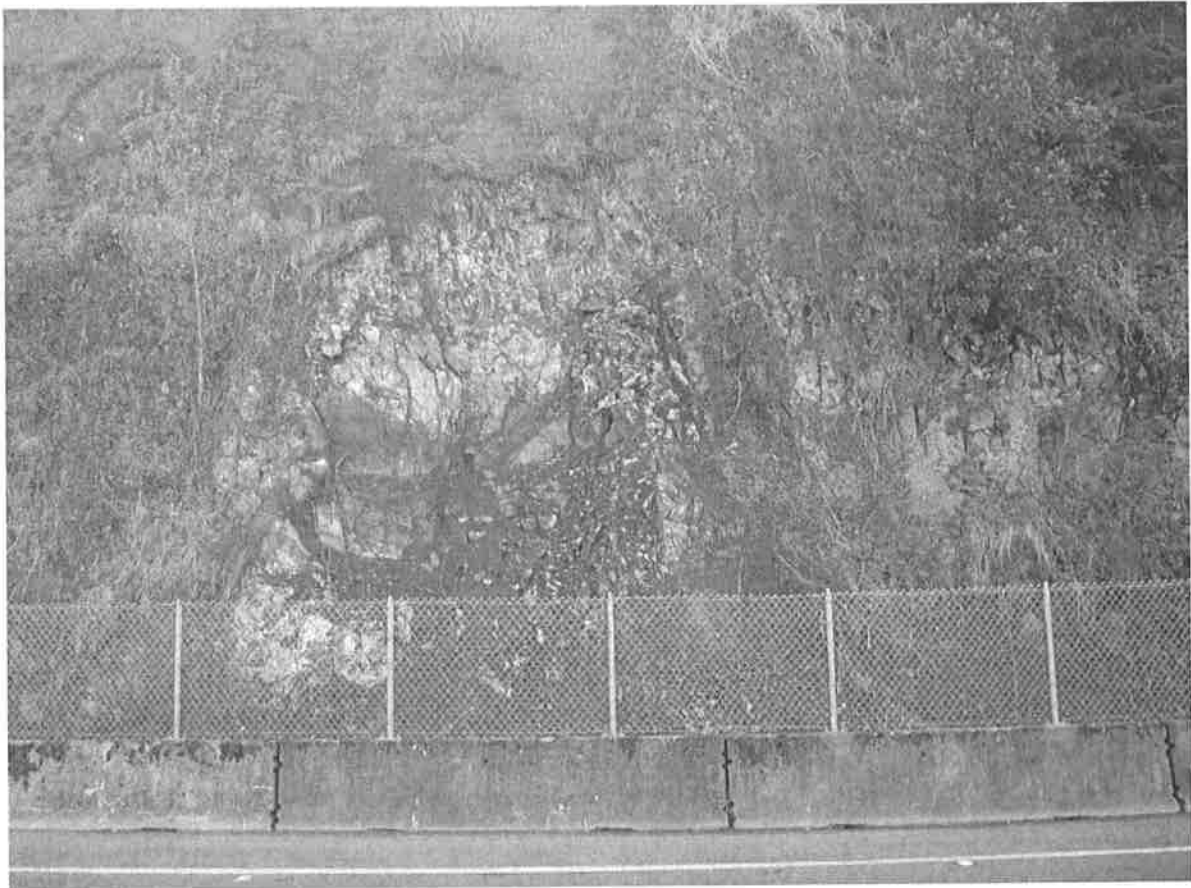
Scarp from slope failure in March 2011 on south rock cut. The failure is attributable to root wedging in fractures from a tree of similar size to the one shown in the upper right corner of this photograph. (Photograph taken April 8, 2011)

Root growth tends to increase the rate of large rockfall from cut slopes in highly fractured rock, such as this site. Large trees, especially deciduous trees, can have extensive and deep root networks, as evident by root mats visible on the fracture faces exposed by recent rockfall. We recommend removing any trees and

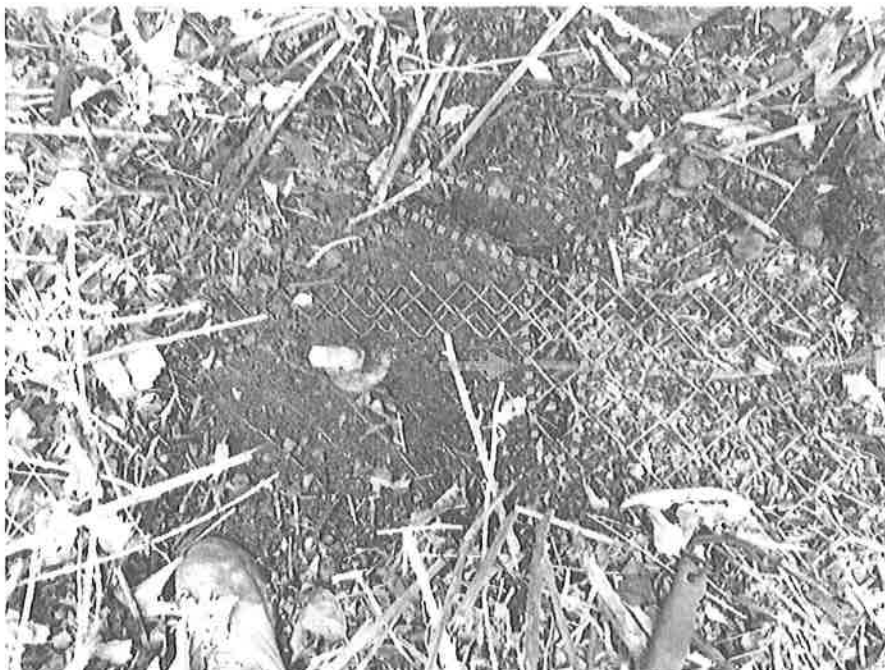
Top of photograph is the uphill direction. Note the open ground crack within the dashed outline of the area above and to the right of the anchor. The top rope for the draped mesh system is located beneath the mesh in this photograph, visible between the arrows to the right of the anchor.

Rock anchor and top of draped mesh in area south of the 2014 rockslide.

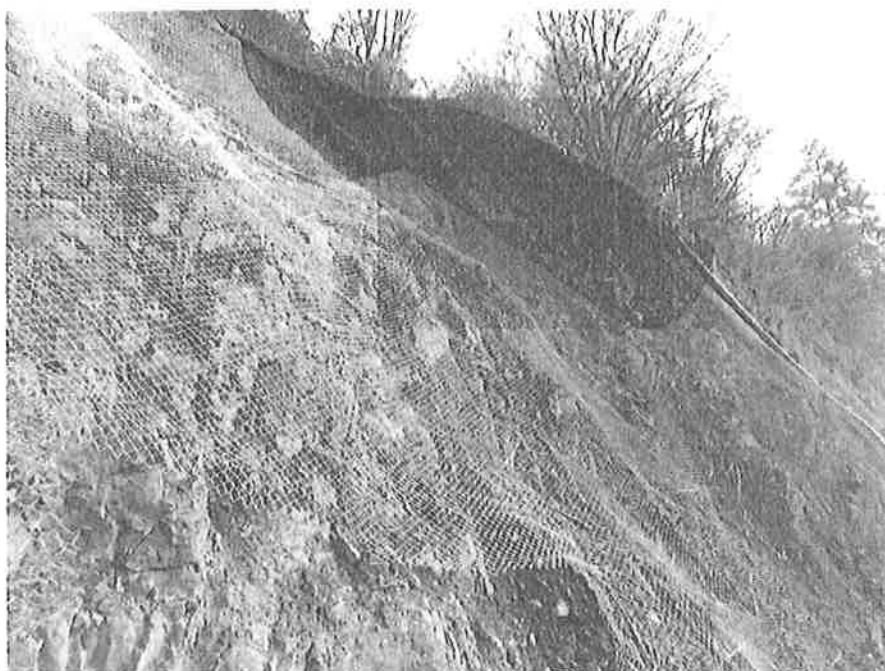
South half of 2014 rockslide, looking southeast.

The side scarp at the south edge of the 2014 rockslide and area directly to the south appear to have a high risk for additional rockslide or large-volume rockfall. We recommend excavation to significantly trim back the side scarp and overhanging slope caused by raveling of the cut slope. As viewed from the roadway, the side scarp should be trimmed by removing a wedge of rock starting at the base of the side scarp, about 10 to 12 ft below the crest of the cut slope that remained in place to the right of the side scarp, and extending upward to the right about 1/2H:1V. The height of the side scarp decreases farther up the slope and is estimated to be about 5 ft tall where it transitions into the headscarp at the top of the 2014 rockslide. We anticipate the excavation can be completed using a trackhoe excavator equipped with an extended-reach arm. The area of excavation should be scaled using hand tools before new mesh is placed. We estimate about 60 cu yds of rock will be removed by this excavation, and replacement of the draped mesh system in this area will require 1,800 sq ft of mesh and three new anchors.

Area to remove by rock excavation is highlighted in orange (estimated 50 to 60 cu yd). South end of area to trim back headscarp and overhanging slope is highlighted in green (estimated 1 to 1.5 cu yd per linear ft of rock cut.)

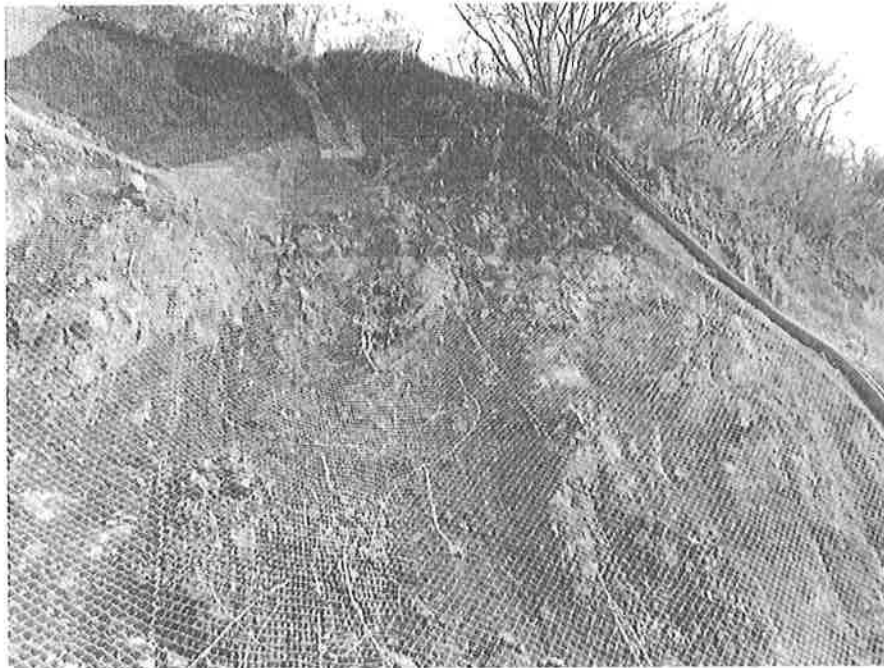
Same area as above photograph, viewed from a different location.

Area to remove by rock excavation is highlighted in orange. South end of area to trim back headscarp and overhanging slope is highlighted in green.

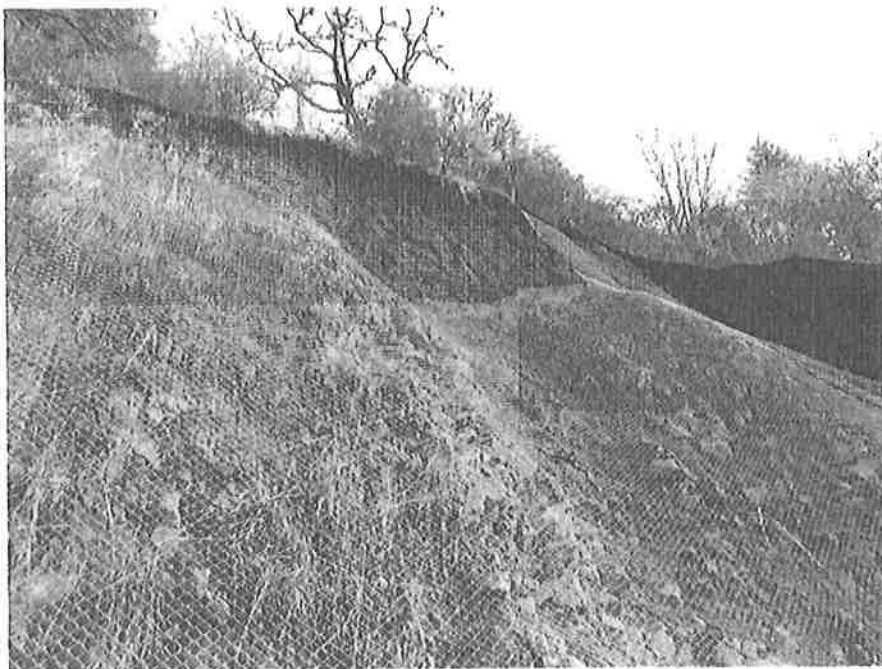
Area to the north of the 2015 rockslide.

The area where the overhanging portion at the top of the slope should be trimmed back by mechanical scaling is highlighted in yellow. The area of the December 2014 rockslide is highlighted in red.

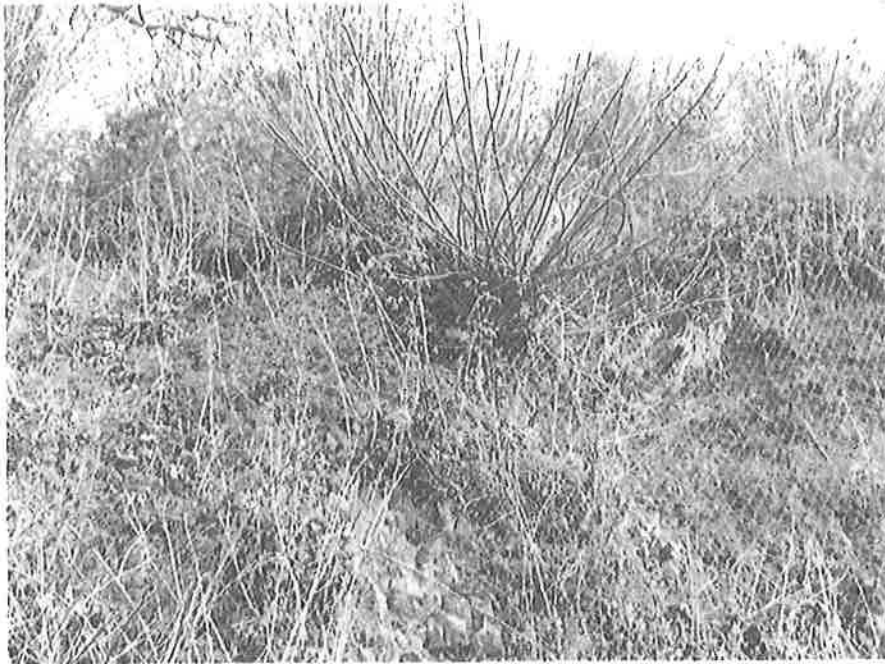
Example of woody vegetation growing through the wire mesh.

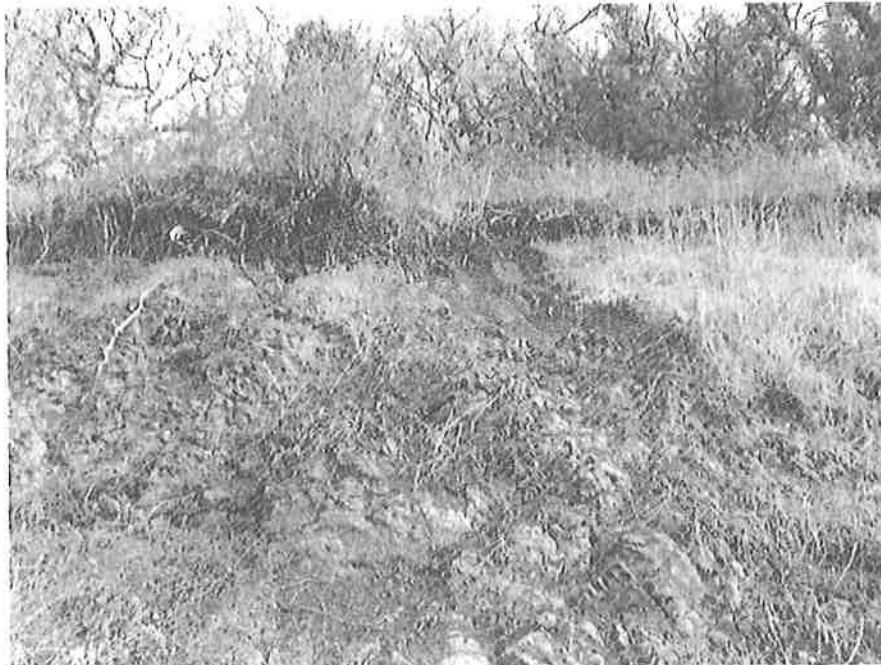
Example of woody vegetation that is growing through the wire mesh.

Overhanging slope
should be trimmed
back when the
bushes growing
through the mesh are
removed.
