# Intensity Distribution and Iseismal Maps for the Nisqually, Washington, Earthquake of 28 February 2001

Open-File Report 02-346

2002

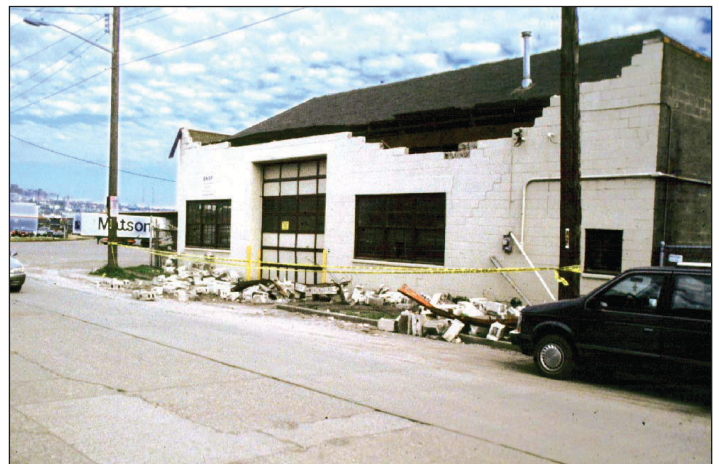
***Figure 12. Partial collapse of URM building wall, Sodo neighborhood of Seattle.***

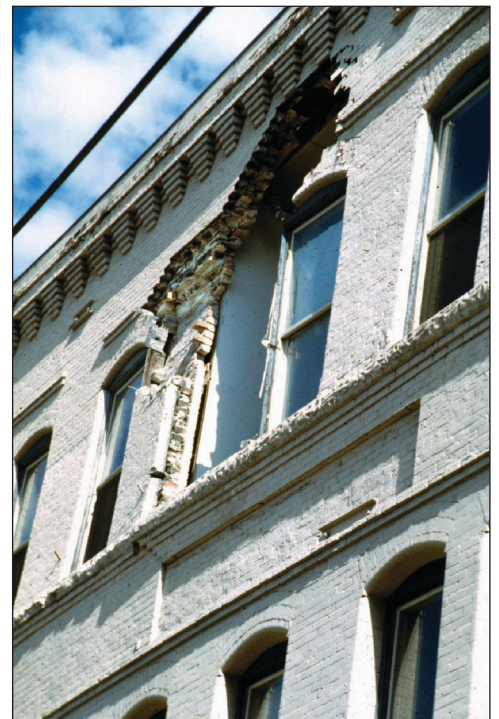
***Figure 13. Damage to upper wall of URM building, Sodo neighborhood of Seattle.***

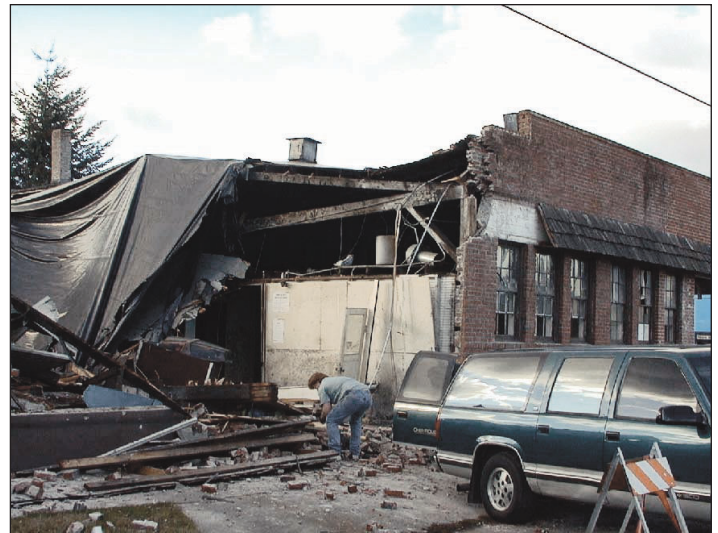
**Centralia (RCII=6.6, MMI=7) (98531 46.725N, 122.967W)**—A cornice was damaged on a downtown hardware store and bricks fell from the tops of several old unreinforced masonry buildings. An abandoned one-story unreinforced brick building that had once housed a garage and auto-glass shop was damaged by the earthquake and collapsed seven days after the earthquake (fig. 14). A large plate-glass window was broken in an automobile dealer-

**Figure 14. Unreinforced building in Centralia, damaged in the earthquake, and partially collapsed seven days after the earthquake.**

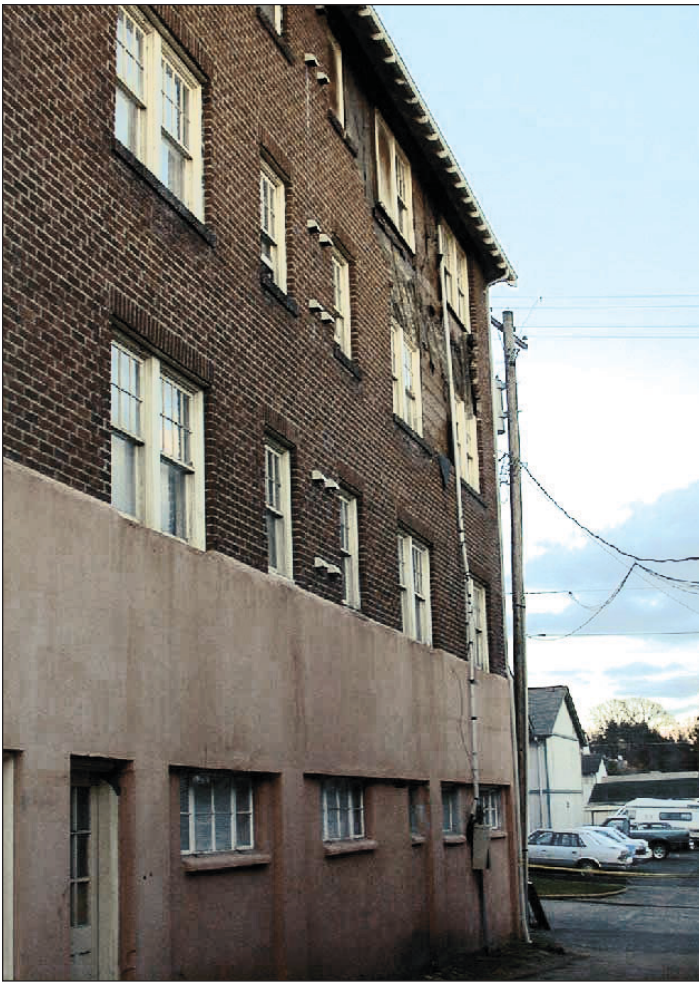
**Figure 15.** Brick veneer was peeled from the upper wall (near street) of this apartment building in Chehalis.

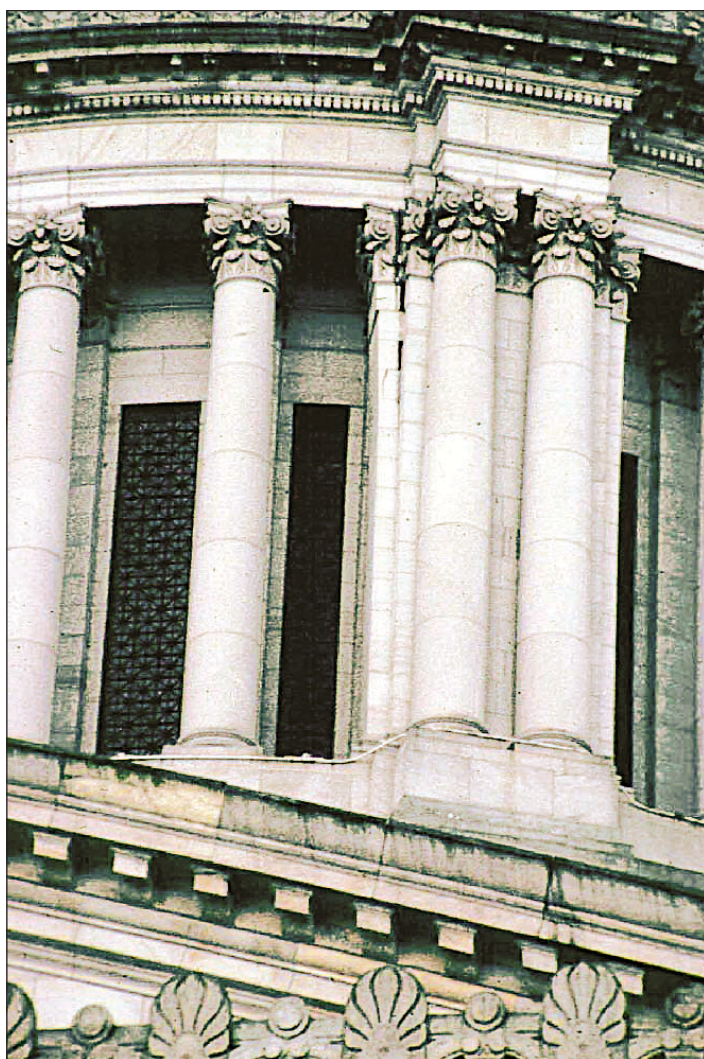
**Olympia (RCII=7.3, MMI=7, except MMI=8 in Capitol Hill) (98501; 47.003N, 122.878W)**—The Capitol Legislative Building was damaged and the legislators forced to move out. There was cracking in some of the ribs of the dome, and “severe cracking of the nonstructural sandstone pilaster from one of the exterior masonry buttresses supporting the dome.... Significant differential movement occurred between the drum [cylindrical wall below the dome] and the lower masonry portion of the building... As a result of the movement of the drum and the dome, horizontal cracking of the architectural plaster occurred at the base of each [of the] interior masonry buttresses” (Pacific Earthquake Engineering Research Center

**Figure 16.** *Damaged pilaster on State Capitol building, Olympia.*

(PEER), p. 8-11; see our fig. 16). Inside the building one chandelier outside the Senate was found hanging from its safety chain and both House and Senate chambers were littered with plaster from the ceilings (Seattle Times (Web), March 5, 2001). A photograph shows a fourth-floor office knee-deep in folders and papers (Seattle Post-Intelligencer (Web), March 1, 2001).

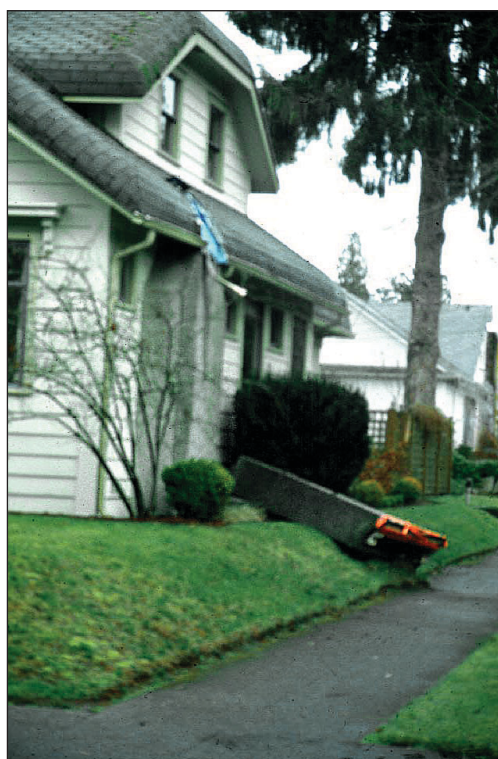
In the residential neighborhood adjacent to the Capitol, the USGS field team found many damaged chimneys and some that had fallen (fig. 17). In some blocks approximately 25% of houses experienced chimney damage. Lincoln Elementary School sustained in-plane cracking of masonry walls (PEER, p. 20-21); its damaged east facade caused the closure of the school for repairs; inside the

**Figure 17.** *Toppled chimney, Capitol Hill neighborhood of Olympia.*

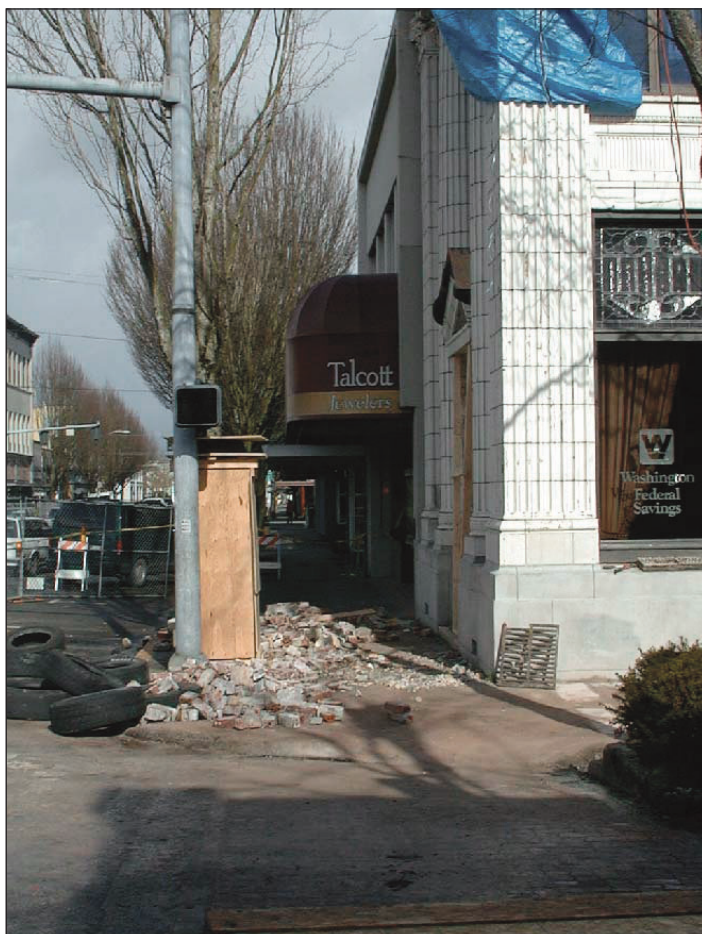
In downtown Olympia, an eight-story hotel on Capitol Way was damaged by differential settling of the west side of the building with respect to the east side; the structure also experienced minor spalling and cracking of reinforced concrete columns in the underlying parking structure, a broken water pipe on the roof that flooded several floors of the building and much overturned furniture in the upper three stories (PEER, p. 11-14, 59-60). In other downtown buildings masonry walls cracked or partially collapsed, plaster fell, lighting fixtures jarred loose and many books and other items fell from shelves (fig. 18).

**Figure 18.** Bricks fallen from an unreinforced masonry parapet litter a sidewalk in downtown Olympia. In the Puget Sound earthquakes of 1949 and 1965, debris falling from buildings killed people on sidewalks below. Fortunately, this did not happen with the Nisqually earthquake.
