Quaternary Geology and Geomorphology of the Lower Deschutes River Canyon, Oregon

Jim E. O'Connor¹, Janet H. Curran², Robin A. Beebee³, Gordon E. Grant⁴, and Andrei Sarna-Wojcicki⁵

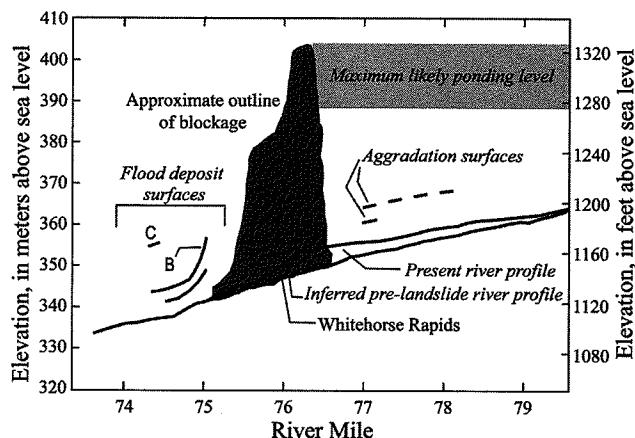
Figure 7. Profile of Deschutes River, and landslide and flood features near Whitehorse Rapids landslide. Deschutes River profile from the 1.5-m-contour (5 ft) river survey of *Henshaw et al.* [1914], conducted in 1911. The river mile locations in that survey are about 0.2 mi downstream of river mile locations shown on current maps. The pre-landslide river profile was based on extrapolation of the surveyed gradient of the Deschutes River from downstream of Whitehorse Rapids. Elevations of flood deposits and aggradation surfaces from site surveys and USGS 7.5-minute topographic quadrangles. 'C' and 'B' indicate locations of stratigraphic sites shown in Figure 6 and discussed in text.

50 m (Figure 7), which would have caused a temporary lake to back up nearly 30 km upstream to the Trout Creek confluence, although there is no evidence that ponding attained that level. Two gravel terraces, 5 m and 10 m above present river level, 1.4 km upstream from the blockage, are inferred to have resulted from aggradation behind the landslide dam. These terraces may indicate that the landslide dam lasted long enough to allow more than 10 m of sand and gravel to accumulate in the valley bottom (relative to the inferred pre-landslide channel profile shown in Figure 7); and that there were at least two periods when the channel was stable at different elevations significantly higher than the present channel elevation. The latter inference suggests that the landslide dam did not fail completely in one breaching episode, but with multiple episodes of incision, and that the time between incision episodes was sufficient for development of distinct aggradation surfaces. The landslide has not yet been completely breached—Whitehorse Rapids, which drops about 12 m in 1 km, is the remains of the landslide dam, and is composed of blocks too large to have been moved during incision. A comparison of the present river profile with the overall channel profile trend indicates that the present channel is as much as 7.5 m higher than the pre-landslide channel elevation (Figure 7).

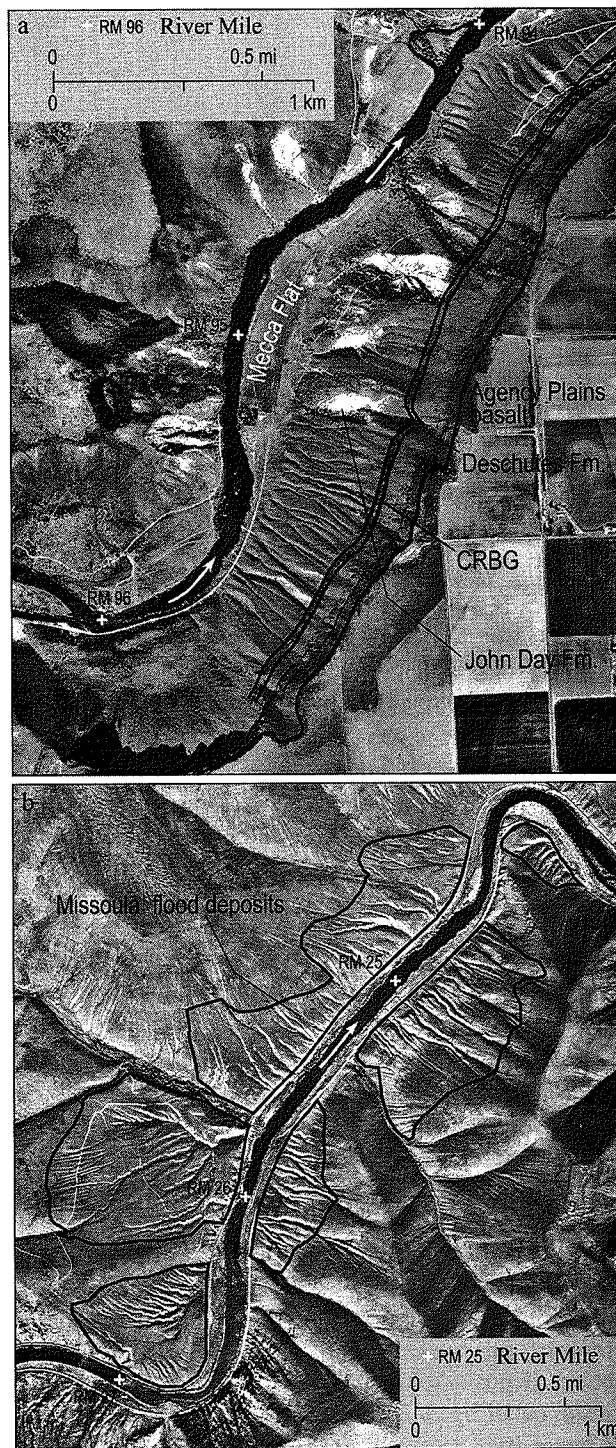
Figure 10. Vertical aerial photographs (1995, Portland General Electric) of gullies and rills. (a) Large gullies and rills in the John Day Formation near Mecca Flat at RM 95. CRBG is Columbia River Basalt Group. (b) Rills developed in Missoula flood sediment near RM 25. Missoula flood sediment mantles valley slopes developed in Columbia River Basalt Group.

Missoula floods. The late Pleistocene Missoula floods resulted from cataclysmic releases of ice-dammed Glacial Lake Missoula [Bretz, 1969], sending 60 to 90 large floods [Atwater, 1986] down the Columbia River between 15 and 12.7 ka [Waitt 1980, 1985; Atwater, 1986]. In the Columbia River valley at the confluence of the Deschutes River, the maximum stage of the largest Missoula flood was about 300 m above sea level or about 250 m deep [O'Connor and Waitt, 1995]. If maintained at steady state, this water would have back-flooded the Deschutes River valley as far upstream as RM 60. Silt, clay, and sand carried in suspension by these floods mantles the valley slopes adjacent to the Deschutes River to an elevation of 275 m above sea level and as far upstream as RM 45 (Figures 3 and 12). Erosion of these fine-grained deposits has been a continuing source of sediment to the lowermost 60 km of the lower Deschutes River (Figure 10b).

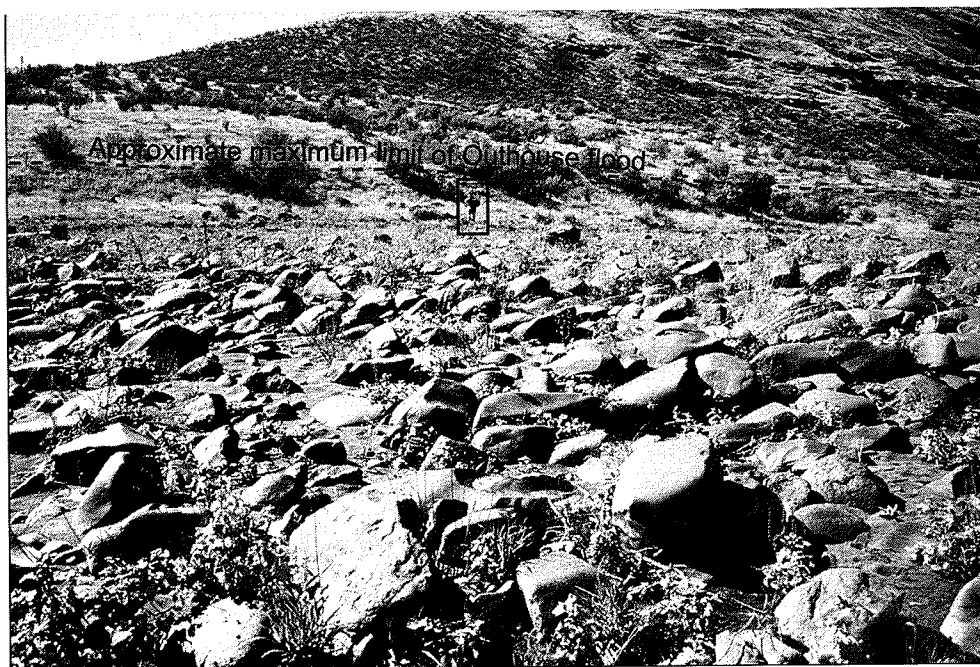
Figure 13. Boulder gravel of an Outhouse flood bar on the left bank at RM 4.2. Intermediate diameters of most boulders between 30 and 50 cm, but some intermediate diameters exceed 1 m. Sand between boulders deposited by the February 1996 flood, which inundated the bar to the elevation at which the person is standing, approximately 4 m lower than the prominent trim-line inferred to have been formed by the Outhouse flood. October 2, 1998 photograph by J. H. Curran.

surfaces away from the main channel. A common depositional location is on the upstream ends of Outhouse flood bars (Figure 13). In these settings, high flows ramp up and slacken against the ascending bar surface. During the February 1996 flood, silt, sand, gravel, and much of the large wood carried by the flood was stranded on the upstream ends of many of these large bars. Wood accumulations locally impeded or concentrated flow, controlling patterns of scour and deposition of these surfaces. These alluvial surfaces may serve as the major sediment storage sites for sand and silt transported into and down the Deschutes River canyon. The sporadic accumulation and release of fine sediment depends on the sequence of flows, flow duration, suspended sediment and wood abundance, vegetation conditions, and the local hydraulic environment. Only the rare floods of magnitude similar to that of February 1996 are large enough to inundate these surfaces and cause significant sediment mobilization.

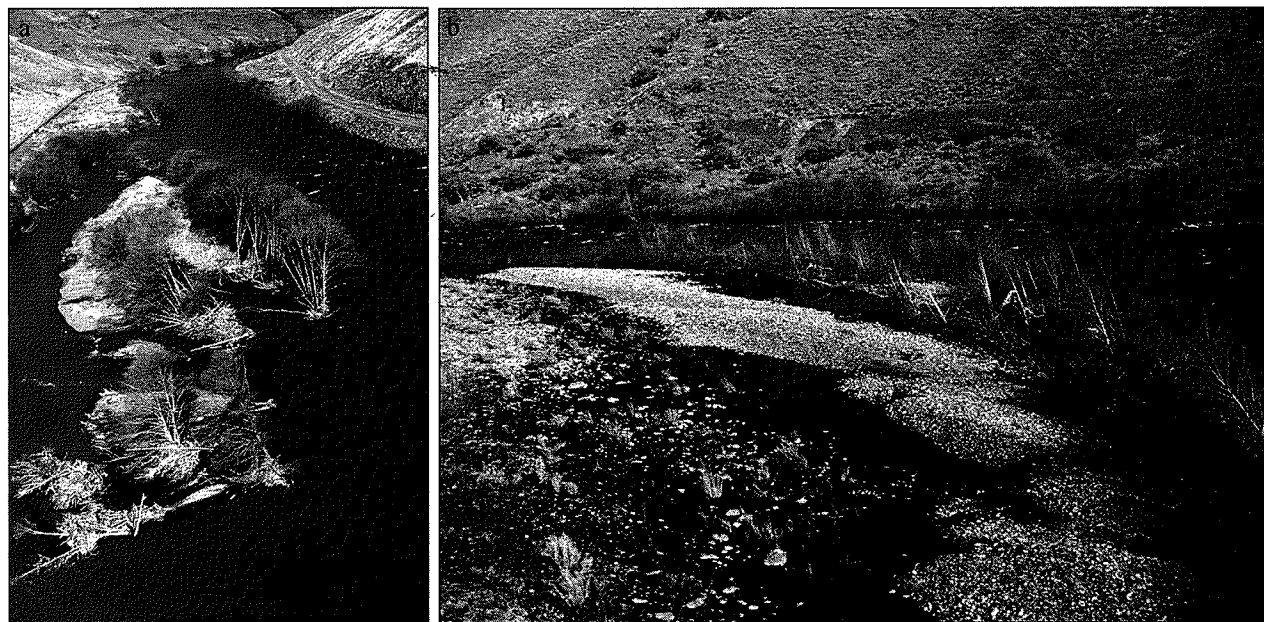
Figure 14. Photographs of effects of the February 1996 flood (February 14, 1996 photographs by H. Fassnacht). (a) View downstream of a partly eroded island with downstream gravel deposits at RM 7.1. (b) View downstream from left bank at RM 8.4 of gravel deposited on point bar in lee of riparian vegetation.

The February 1996 flood eroded some islands and margins of alluvial surfaces flanking the Deschutes River channel, and deposited gravel, sand, and silt in some overbank areas and island margins [Figure 14; Curran and O'Connor, this volume]. But compared to the consequences of large floods on most other alluvial rivers, there were few major or persistent geomorphic effects of the February 1996 flood in terms of bank erosion and deposition, channel scour and fill, and changes in substrate conditions [McClure, 1998; Curran and O'Connor, this volume, Fassnacht *et al.*, this volume]. The major broad-scale effects on the valley bottom due to flooding of this magnitude are the episodic accumulation and erosion of silt and sand overbank deposits on alluvial

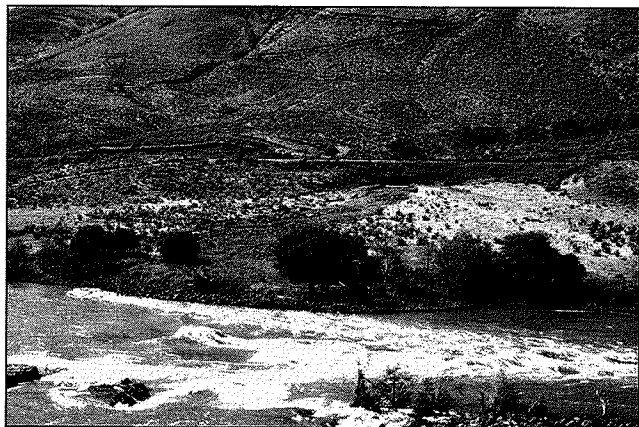
Figure 15. View north of the tributary fan at RM 7.8, where a July 1995 debris flow transported bouldery gravel into the Deschutes River channel, forming "Washout Rapids." Culverts under railroad have diameters of 4 m. June 2, 1998 photograph by J. E. O'Connor.

they are local sources of readily-mobilized coarse-grained sediment. According to Steve Pribyl (Oregon Dept. of Fish and Wildlife, oral communication, 1998), the fan emanating from the Harris Canyon tributary (RM 12) has repeatedly encroached into the Deschutes River channel over the last decade, only to be trimmed back several times by large mainstem flows. Just downstream, the apex of Harris Island has accumulated angular basalt gravel and cobbles that likely derive from the Harris Canyon fan. *Curran and O'Connor* [this volume] more fully discuss locations, sizes, and distribution of tributary fans.
