ENVIRONMENTAL GEOLOGY OF LINCOLN COUNTY

ADDENDUM TO BULLETIN 81. ENVIRONMENTAL GEOLOGY OF LINCOLN COUNTY, OREGON
 (Add to maps)

Oregon Department of Geology and Mineral Industries, Portland, Oregon
 April 5, 1974

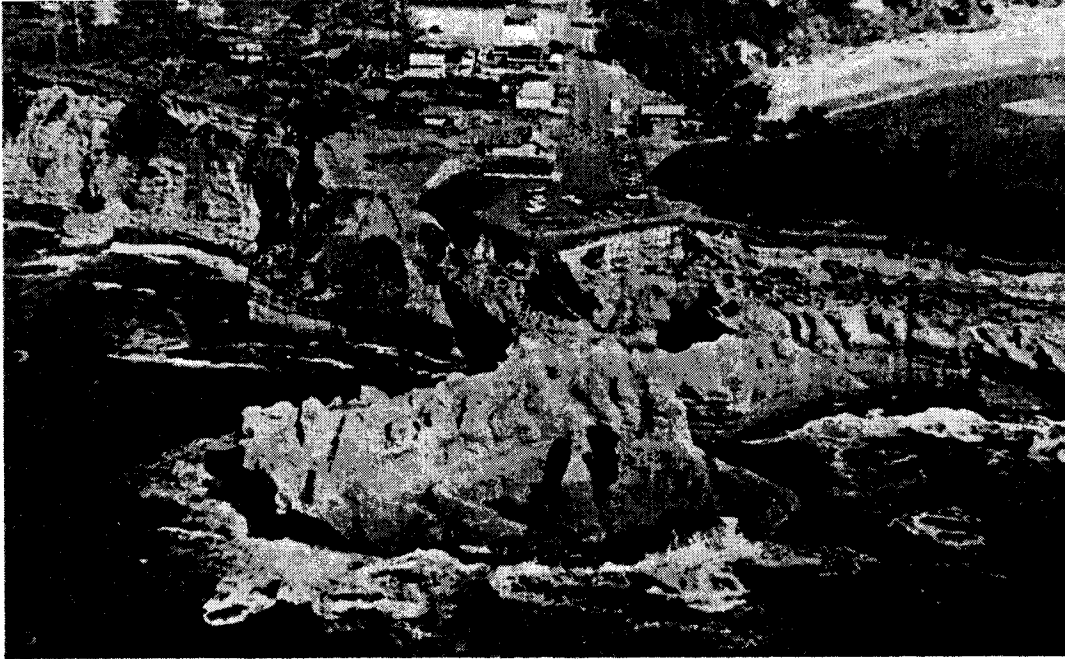
Photo 57. Devils Punch Bowl State Park at Otter Rock, a marine terrace on a sandstone headland. Wave erosion removes terrace sediments faster than the sandstone, continually reducing the margins of the park area.

At Otter Crest, active slump failure occurs both north and south of the Devils Punch Bowl. From Otter Rock south to Yaquina Head, sloughing and slump failures are numerous along the bluff and occasionally threaten to undermine developed property. Bedrock strata of the Nye Mudstone and Astoria Formation underlie the terraces in this area and provide saturated surfaces along which sliding occurs. Large slump failures on both the north and south sides of Yaquina Head in the community of Agate Beach have damaged private property.

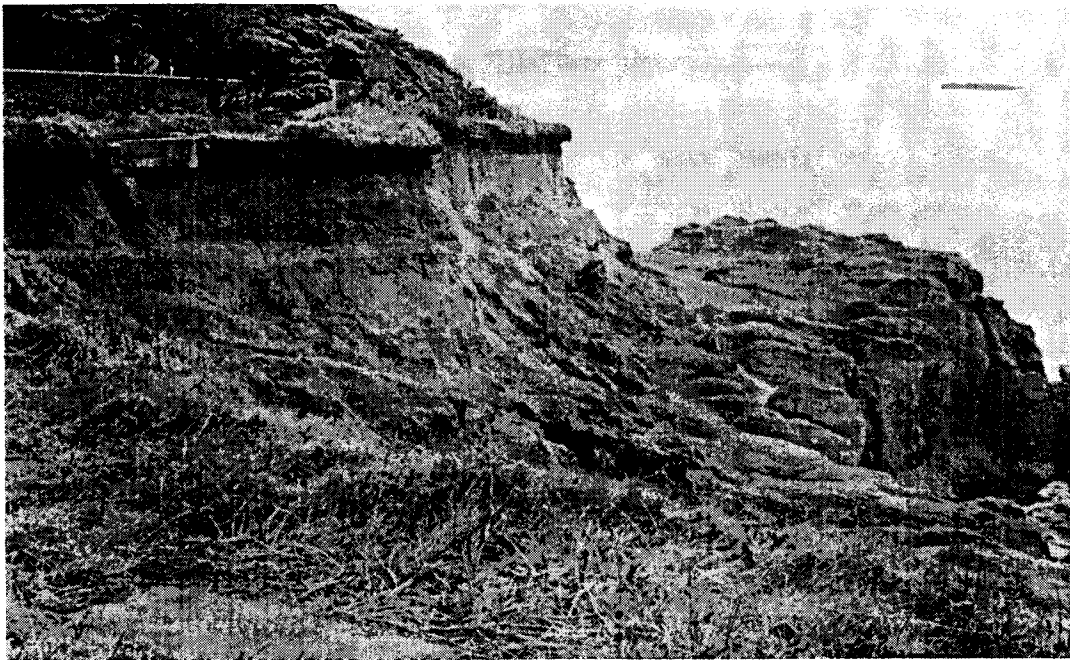
Photo 58. Close-up of Devils Punch Bowl area. Erosion has removed former stairway access to the Punch Bowl on right. Remains of old walkway projects from cliff at left.

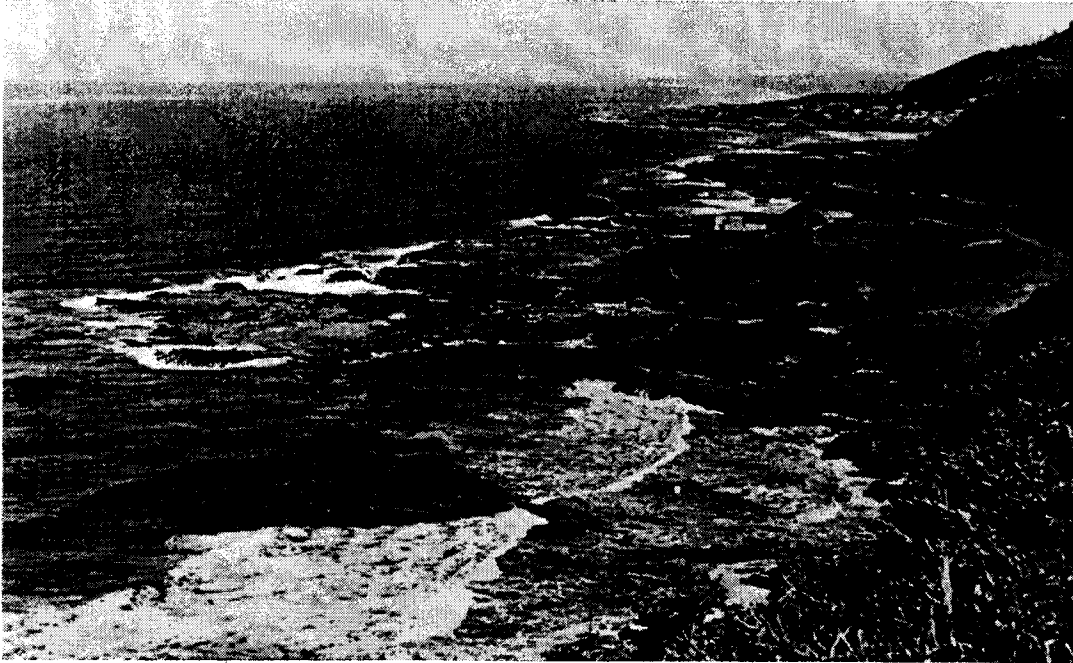
Photo 59. Wave-cut terraces on resistant basalt breccia at Cape Foulweather extend seaward. Basaltic rock is much slower to erode than sedimentary rock.

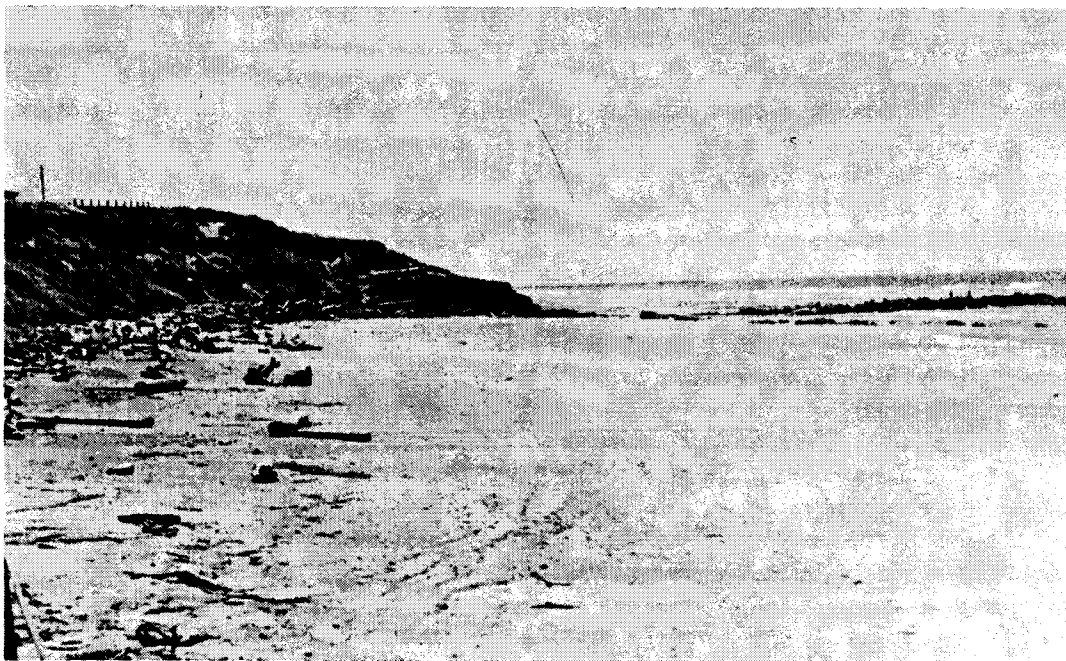
Photo 62. Photo taken from approximately same location in 1973 shows amount of recession of small headland and its terrace platform.

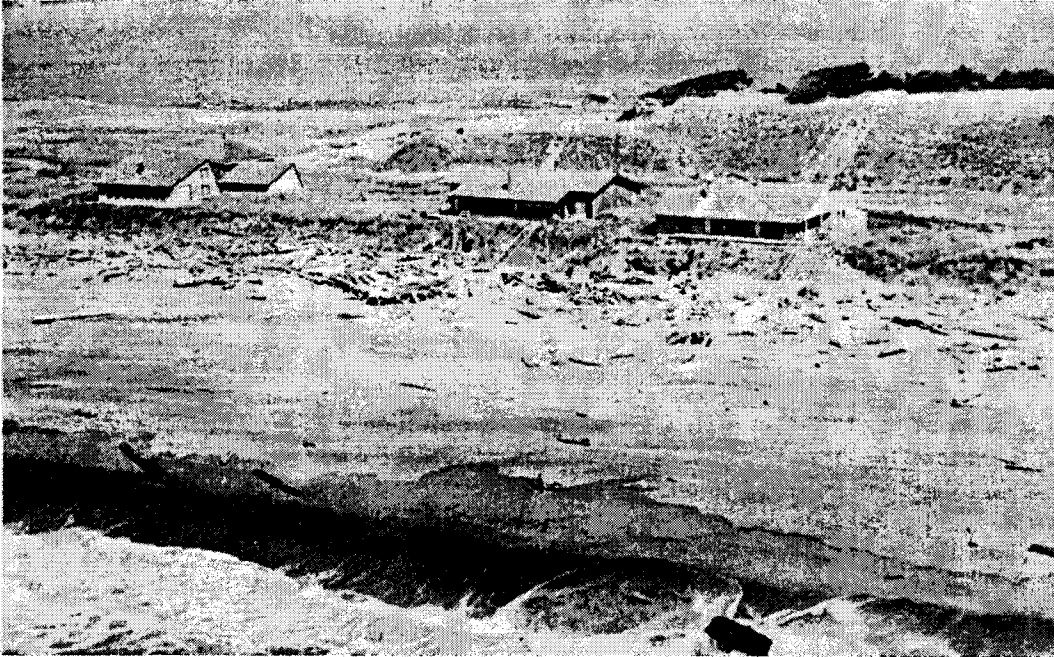
Photo 63. Some of the houses built on the low dunes of Siletz spit. Photo taken in fall of 1972 before severe erosion of spit by winter storms.

During the high winter and spring tides of 1973, parts of the Siletz spit were attacked by the sea and in some places eroded back 75 feet or more. At least one house fell into the sea and the emergency placing of riprap was needed to preserve several others. The precise cause of the erosion has not been definitely identified, although the dominating factors probably included storm severity, the lateral migration of coastal landforms (a phenomenon discussed at length by Sonu, 1973), and natural variations in sand supplied by longshore currents and by the Siletz River.

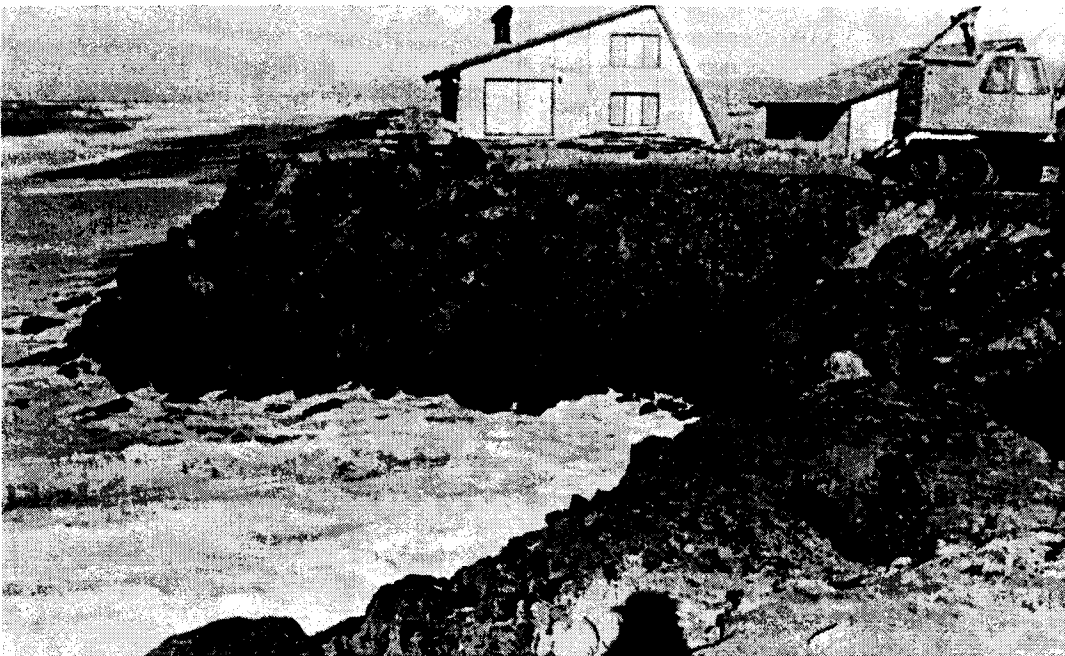
Photo 64. Close-up showing house on left side of above photo where riprap placed earlier at front of house was not sufficient to withstand later storms. Erosion continued to remove sand exposed at either end, requiring additional riprap.

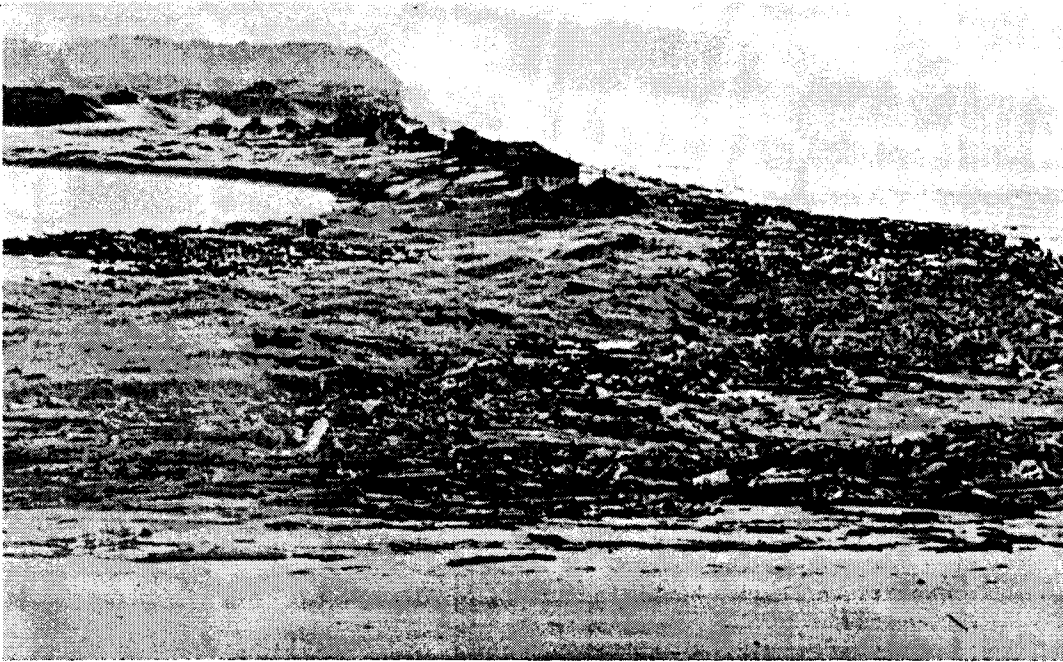
Photo 67. View looking south at Siletz spit showing erosion of inner margin of dune and masses of driftwood deposited by high seas.

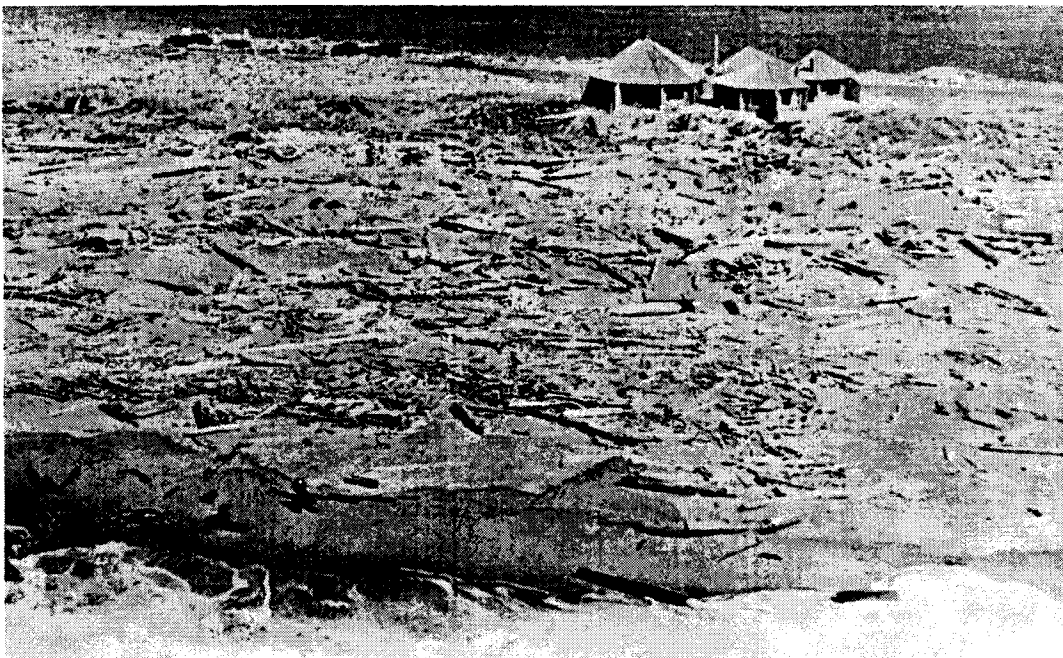
Photo 68. Logs scattered on Siletz spit indicate the level reached by recent storm waves. Photo taken during summer of 1972.

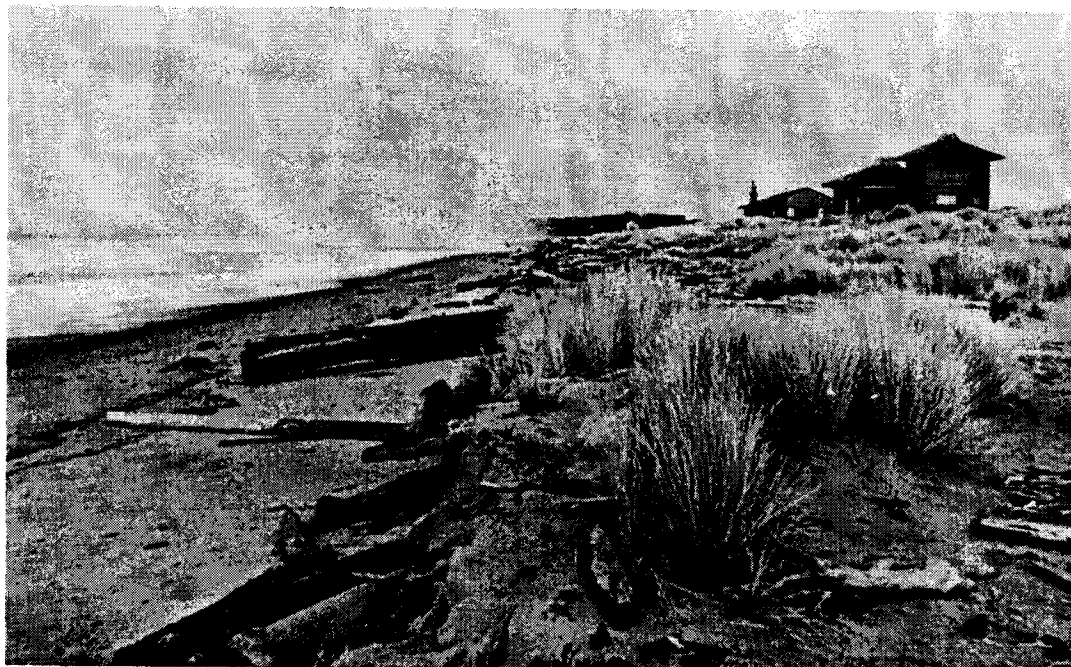
Photo 69. Dune grass planted to stabilize sand is no defense against the might of the ocean, which has eroded the dune, exposing buried logs carried in by previous storms.

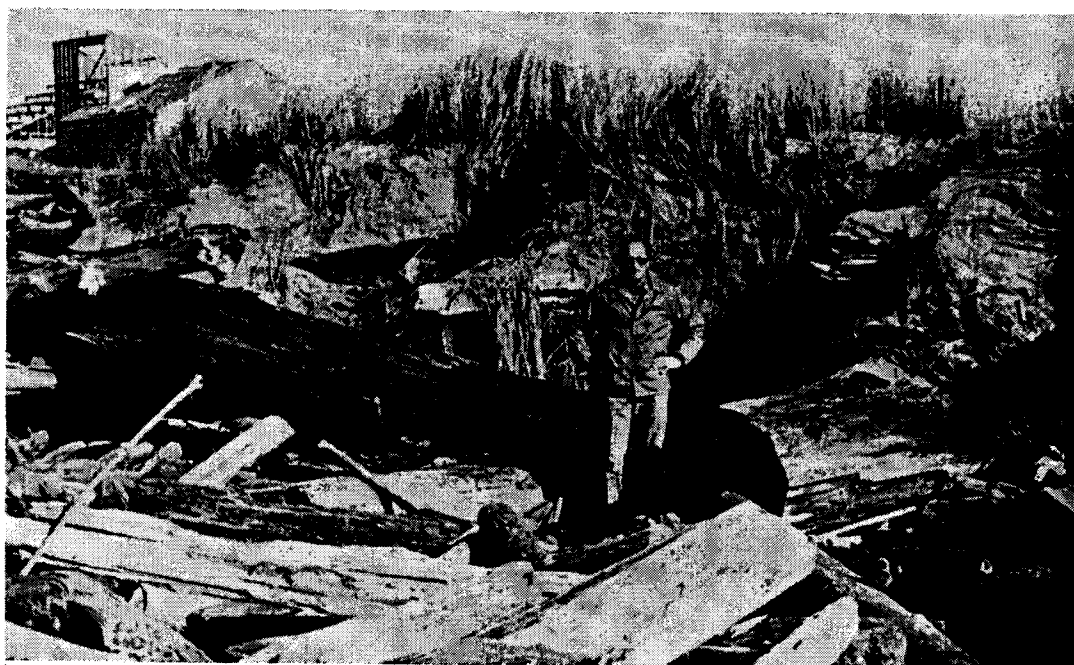
Photo 70. Sawed logs buried under dune sands on Siletz spit indicate that burial postdates 1910, when logging began in upper Siletz River area.
