ENVIRONMENTAL GEOLOGY OF LINCOLN COUNTY

ADDENDUM TO BULLETIN 81. ENVIRONMENTAL GEOLOGY OF LINCOLN COUNTY, OREGON
 (Add to maps)

Active landslides in sections of coastal region of Lincoln County, Oregon

Oregon Department of Geology and Mineral Industries, Portland, Oregon
 April 5, 1974

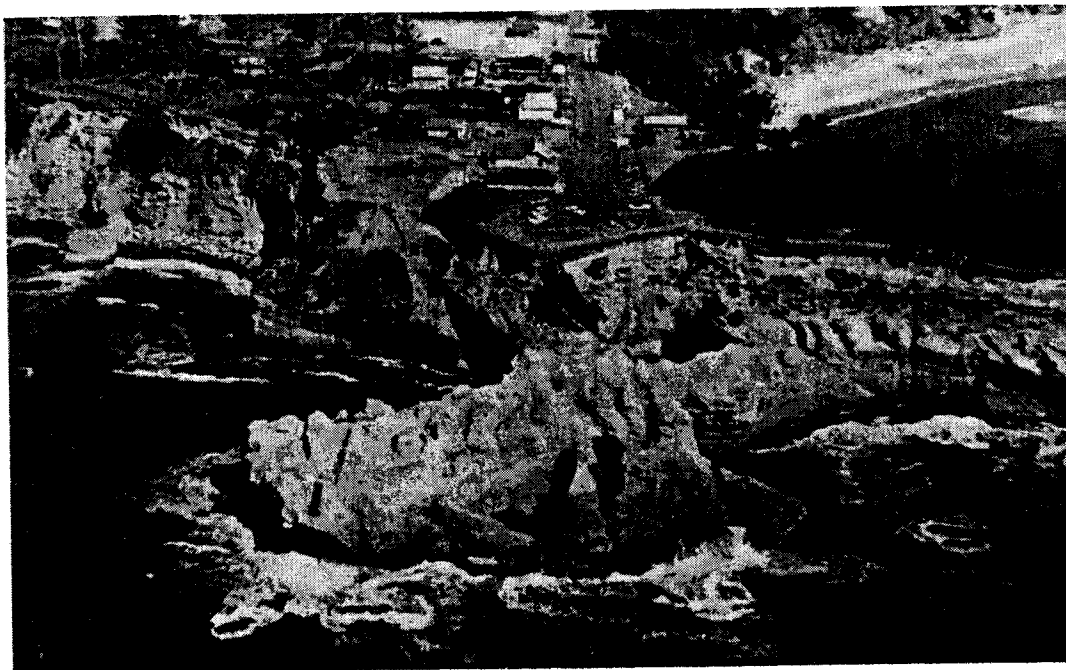
Photo 57. Devils Punch Bowl State Park at Otter Rock, a marine terrace on a sandstone headland. Wave erosion removes terrace sediments faster than the sandstone, continually reducing the margins of the park area.

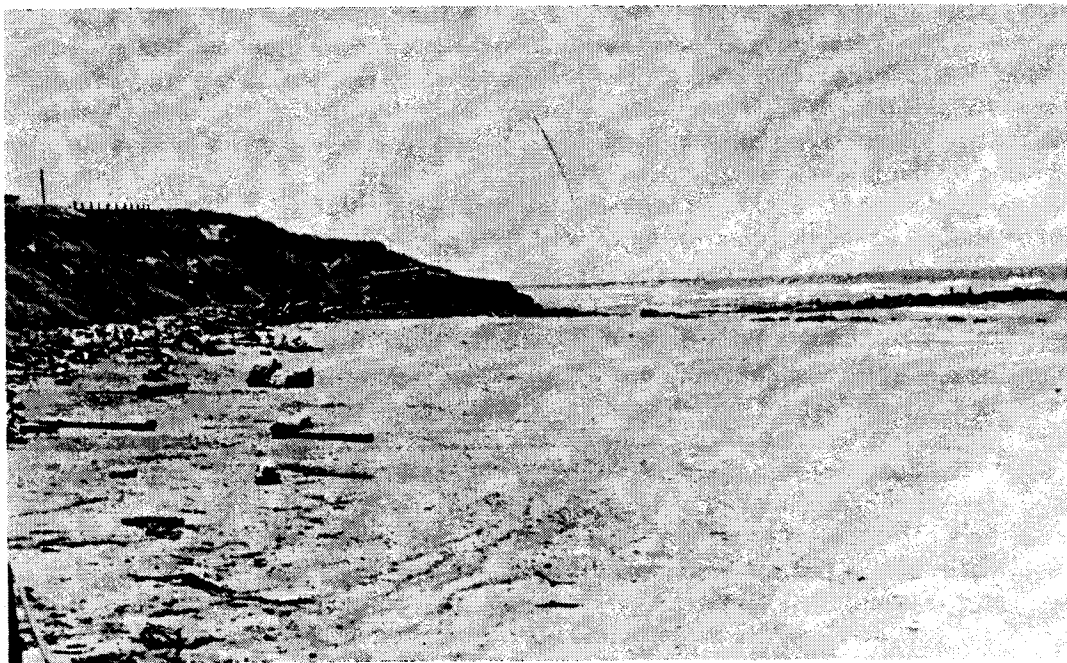
Photo 62. Photo taken from approximately same location in 1973 shows amount of recession of small headland and its terrace platform.

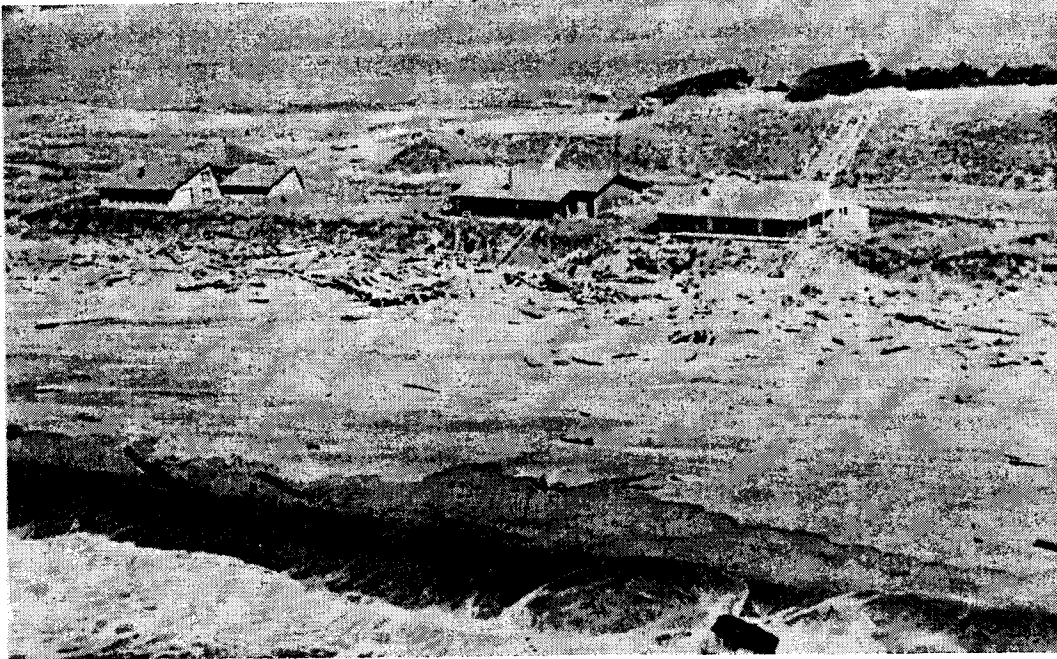
Photo 63. Some of the houses built on the low dunes of Siletz spit. Photo taken in fall of 1972 before severe erosion of spit by winter storms.

During the high winter and spring tides of 1973, parts of the Siletz spit were attacked by the sea and in some places eroded back 75 feet or more. At least one house fell into the sea and the emergency placing of riprap was needed to preserve several others. The precise cause of the erosion has not been definitely identified, although the dominating factors probably included storm severity, the lateral migration of coastal landforms (a phenomenon discussed at length by Sonu, 1973), and natural variations in sand supplied by longshore currents and by the Siletz River.

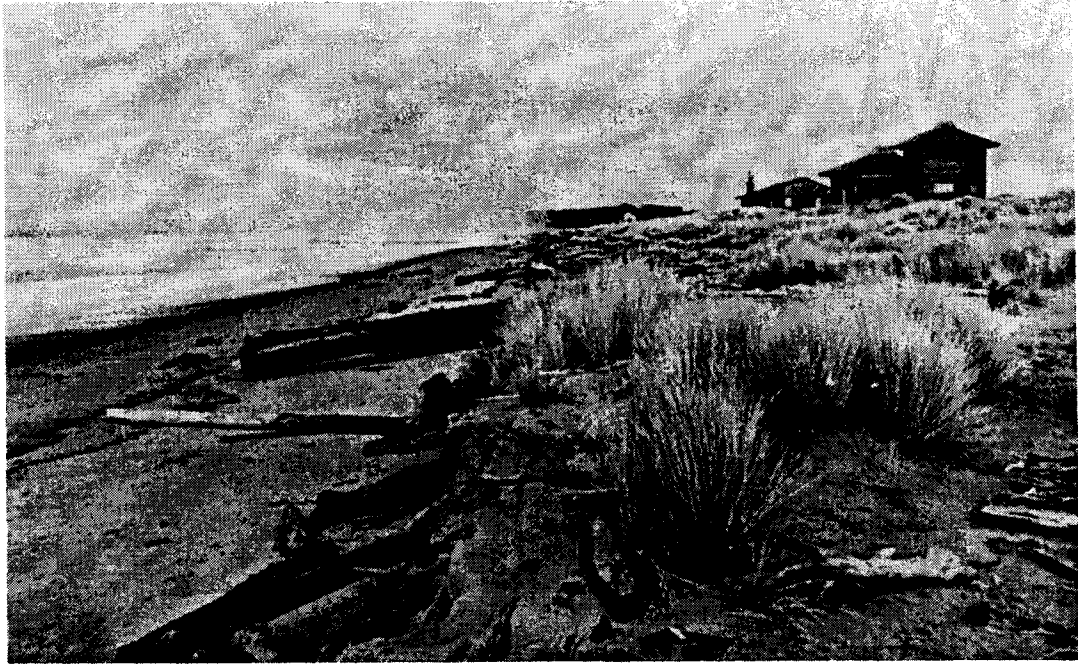
Photo 69. Dune grass planted to stabilize sand is no defense against the might of the ocean, which has eroded the dune, exposing buried logs carried in by previous storms.

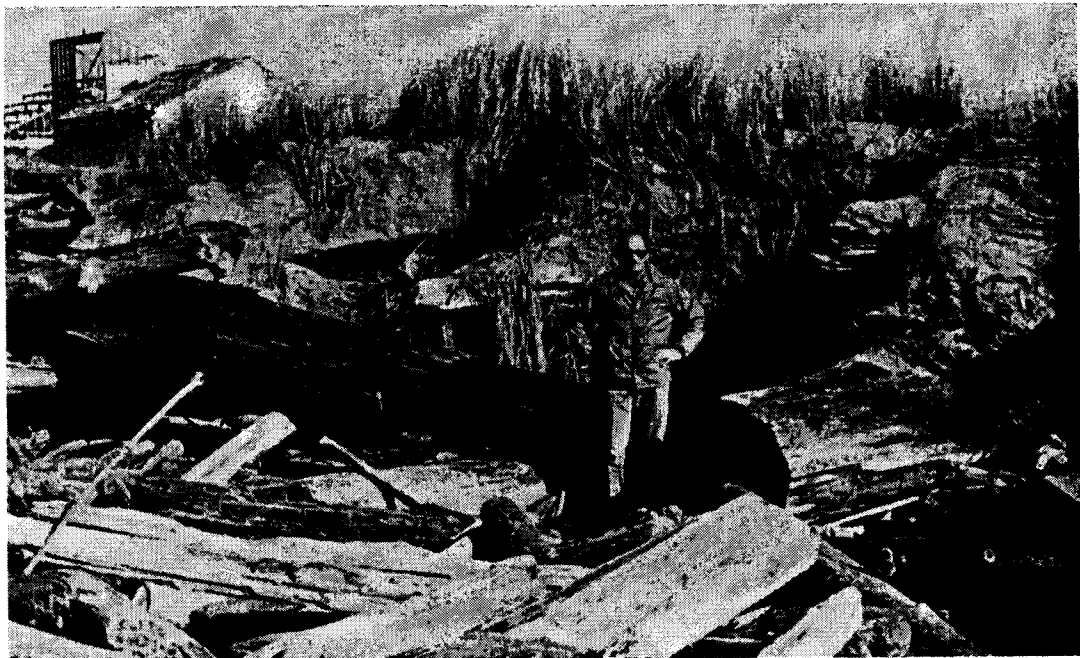
Photo 70. Sawed logs buried under dune sands on Siletz spit indicate that burial postdates 1910, when logging began in upper Siletz River area.
