# El Niño and coastal erosion in the Pacific Northwest

by Paul D. Komar, College of Oceanic and Atmospheric Sciences, Oregon State University, Corvallis, Oregon 97403

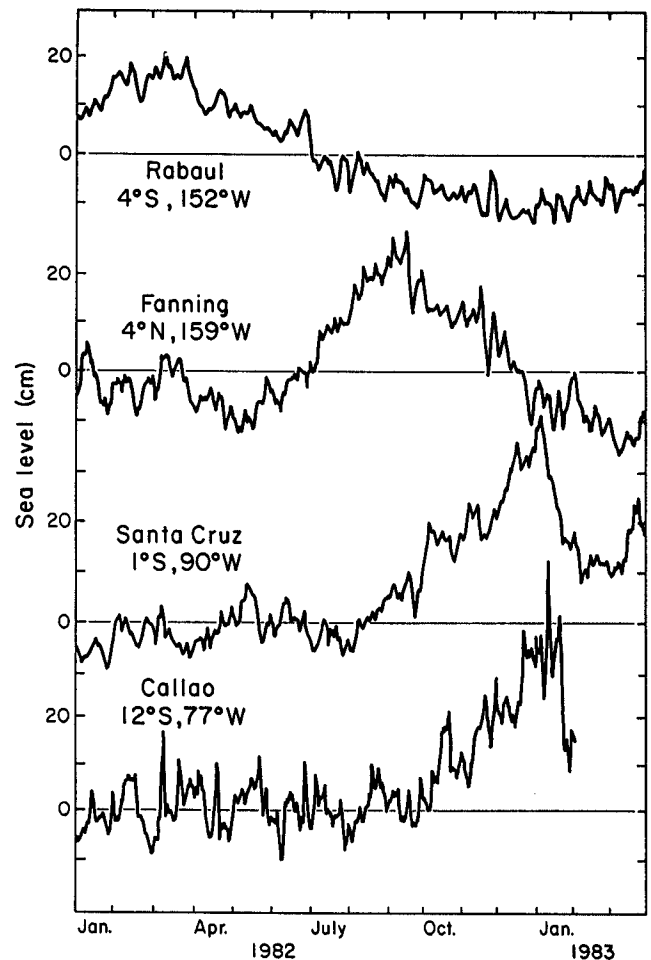
Figure 2. Sea-level waves measured on tide gauges of islands located along the length of the equator during the 1982–83 El Niño event (after Wyrtki, 1984).

Associated with this warm-water movement eastward along the equator is a wavelike bulge in sea level, also depicted in the lower diagram of Figure 1. The eastward progress of the sea-level wave has been monitored at tide gauges located on islands near the equator. Data from a tide gauge can be averaged to remove the tidal fluctuations, yielding a measure of the mean level of the sea during that time interval. Such analyses were undertaken by Wyrtki to demonstrate the eastward movement of sea-level waves during El Niño events (Wyrtki, 1977, 1984). Figure 2 shows the results for the 1982–83 El Niño. From this series one can easily see the passage of the released sea-level wave as it traveled eastward across the Pacific, affecting in turn tide gauges on a series of equatorial islands. Sea level at Rabaul in the western Pacific reached a peak in March or April 1982 and then began to drop. The crest passed Fanning Island south of Hawaii in late August, Santa Cruz in the Galapagos at the end of the year, and reached Callao on the coast of Peru in January 1983.

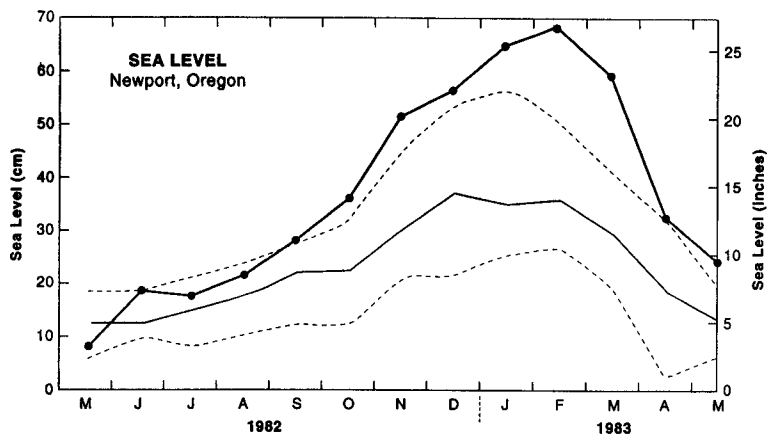
Figure 4. Monthly averaged sea levels measured on the tide gauge in Yaquina Bay, with the 1982-83 El Niño extreme levels (heavy solid line) compared with previous years. The thin solid line in the figure follows the ten-year averages for the seasonal variations, and the dashed lines give the previous maxima and minima measured at Newport (after Huyer and others, 1983).

Alaska (Enfield and Allen, 1980). The wave travels at a rate of about 50 mi per day, so it quickly reaches California and Oregon. The passage of the sea-level wave along the Oregon coast is depicted in Figure 3, which also shows the locations of tide gauges used to monitor its movement. Figure 4 gives the monthly mean sea levels measured by the tide gauge in Yaquina Bay, Oregon, during the 1982–83 El Niño year, contrasting the levels with more normal years (Huyer and others, 1983). As in the analyses of Wyrtki, the tide-gauge record was averaged

to remove the tides, leaving the net difference between the predicted and measured tides for the month. During the 1982-83 El Niño year, sea level reached a maximum during February 1983, nearly 24 in. higher than the mean water surface in May 1982, nine months earlier.

The increased elevations in mean sea level along the Northwest coast during El Niño are only in part due to a sea-level wave originating at the equator. Other factors include changes in water temperatures along the coast and the development of a northward-flowing current. The curves in Figure 4 in part reflect the normal seasonal cycle of sea level that is produced by parallel variations in water temperatures—colder during the summer than during the winter, due to the occurrence of upwelling in the summer. The thermal expansion of the warm water of the winter raises the water level along the coast, while the cold, dense water of the summer depresses the level. There is also a reversal in current directions from winter to summer. During the winter, the current flows toward the north, and the rotation of the Earth (the Coriolis effect) deflects the current toward the right, that is, toward the coast, elevating the level of the sea along the shoreline. These processes tend to occur every year, causing sea levels along the Northwest coast to be higher during the winter than the summer. But in an El Niño year, these processes are more intense: the water during the winter is warmer than usual and the northward current stronger. So these factors add to the sea-level wave moving northward from the equator to produce the observed extreme water levels during an El Niño winter.

It is seen in Figure 4 that the 1982-83 sea levels were truly exceptional, reaching some 8-16 in. higher than previous winter maxima, about 14 in. above the aver-

deep-water significant wave heights on the order of 20–25 ft (“significant wave height” is the average of the highest one-third of the waves). The strongest storms occurred during January and February 1983, simultaneous with the occurrence of the highest water levels (Figure 4). Given this combination, it is understandable that extensive erosion took place during the El Niño winter of 1982–83.

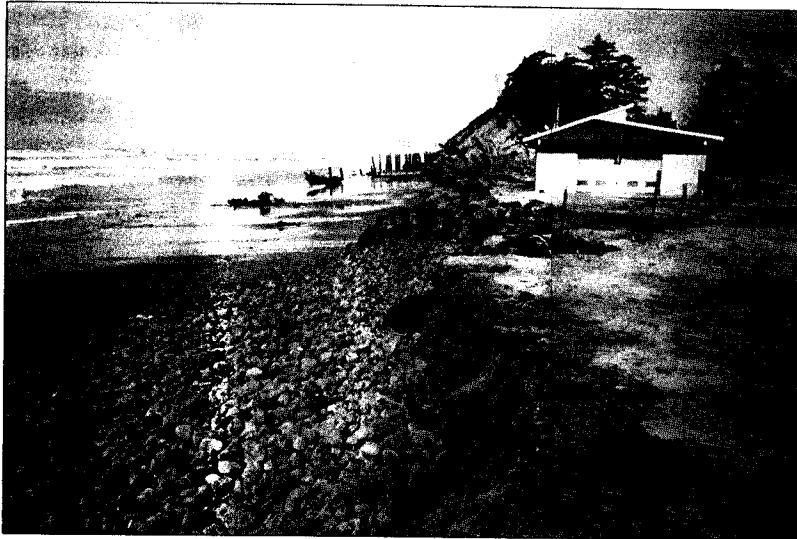
Figure 8. Recent erosion at Cape Lookout State Park on Netarts Spit has cut back the large coastal dunes and is now eroding the campground.

Erosion of Cape Lookout State Park during the 1997–98 El Niño year has essentially picked up where the 1982–83 event left off (Figure 8). The last remnants of the log seawall are rapidly disappearing, leaving the tall iron beams that had supported the logs sticking up from the beach—the beams remaining after the 1982–83 erosion were cut off by the Parks and Recreation Department. Additional dune erosion has occurred, and

the public bathrooms were in danger of being undermined by waves until a line of riprap was placed for protection. High water elevations have combined with storm wave runup to wash over into the park lands, depositing a large amount of beach sand in the campground. Such extensive washovers did not occur during the 1982–83 El Niño event.

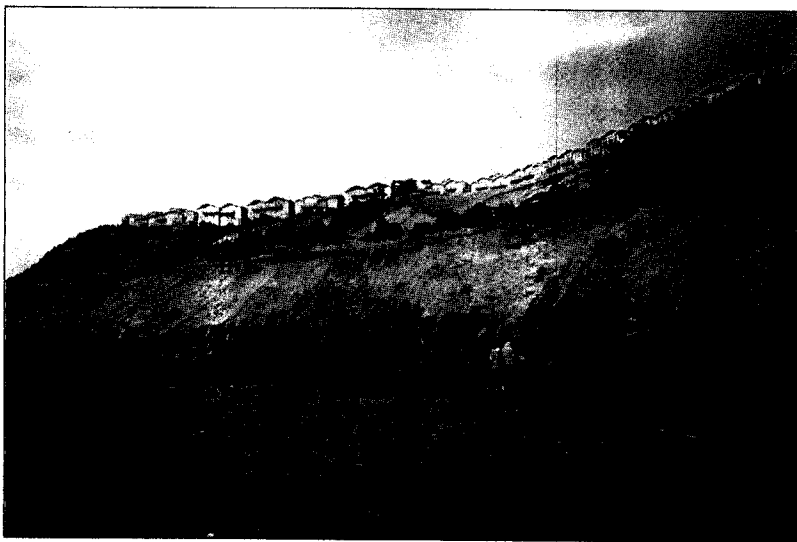
Figure 9. The Capes, north of Netarts Bay, is a recent development of condominiums, located on the edge of an old massive landslide.

Most dramatic and newsworthy during the 1997–98 El Niño year has been the erosion at The Capes, a development consisting of expensive condominiums recently built on the high bluff to the immediate north of the inlet to Netarts Bay (Figure 9). The site is

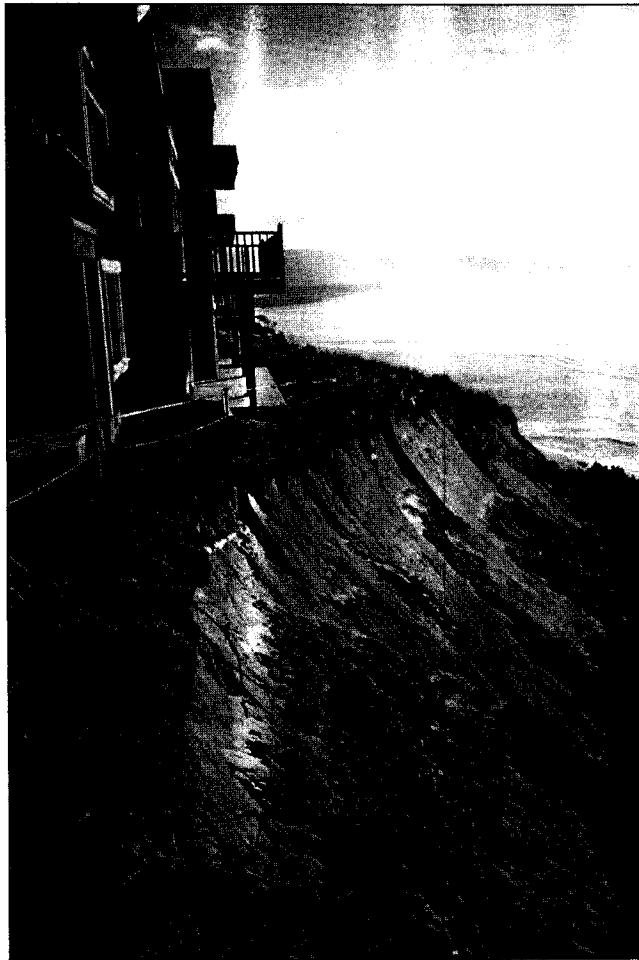
Figure 10. Homes at The Capes. Erosion of the toe of the landslide during the 1997-98 El Niño winter has caused the slide to become unstable, and slippage is threatening the first line of homes.

The runup of the stronger waves now combines with the elevated mean water levels associated with El Niño, allowing the runup to reach the toe of the high bluff below The Capes. The resulting toe erosion has made the bluff unstable, and slippage of the land now poses the immediate threat to the front line of condominiums (Figure 10). Unfortunately, the condominiums had been constructed with only a 10-ft setback distance—insufficient, considering the potential for erosion and instability of the site. So now many of the homes have immediately been placed in danger.

The development site is located atop an old massive landslide. The lower portion, now exposed by the toe erosion, consists of a layer of mud that is extremely mobile. Rather than participating in the rotational slippage typical of many landslides, this mud appears to be squeezed out like toothpaste by the weight of the overlying material. This overlying material is sand of old dunes deposited atop the bluff—sand that has minimal internal strength, so that it tends to cascade downslope, much like the loose sand of an active modern dune. Thus, only part of the problems at The Capes can be attributed to the occurrence of El Niño and its erosion processes. The preexisting hazardous conditions are that the development was constructed on a landslide, the upper part of which consists of dune sand. The present instability and movement of the landslide can, however, be attributed to the 1997–98 El Niño occurrence and its erosional impact, which has cut away the toe of the landslide.
