# Floodplain Formation and Cottonwood Colonization Patterns on the Willamette River, Oregon, USA

**ABSTRACT** / Using a series of aerial photographs taken between 1936 and 1996, we trace coevolution of floodplain and riparian forest on the Willamette River. Within-channel barforms appear to be the predominant incipient floodplain landform and habitat for primary succession. Interlinked development of bar(s) and erosion of near banks, filling of channels, and establishment and growth of cottonwoods and willows results in coalescence with older floodplain. Size

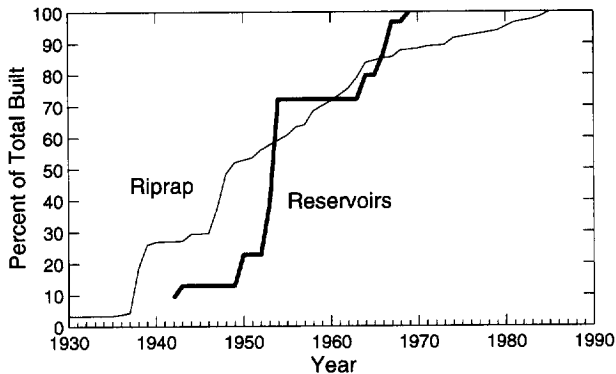
**Figure 2.** Cumulative totals of US Army Corps flood-control reservoirs and riprap construction over time. For reservoirs, "percent of total built" refers to the flood-control capacity based on the drainage area above the dams.

During the period considered in this study, construction of a US ACE flood-control reservoir system and emplacement of boulder revetments (riprap) to stabilize channel banks have had large effects on the fluvial geomorphic regime. Between November 1941 and October 1968, ten major flood control reservoirs were constructed (Shearman 1975). This system regulates many major tributaries from the Cascades above Salem; however, there are no dams on the mainstem (Figure 1). Approximately 43% of the area above Albany drains into reservoirs (US Army Corps of Engineers 1989). About 76 km of channel bank has been stabilized with riprap between river km 88 and 301 (US ACE 1984). Figure 2 shows cumulative construction of reservoirs and riprap.

River flow shown in the photographic record varies between 69 and 767 m<sup>3</sup>/sec at the Albany gage, about a 3-m range in stage, sufficient for bars and islands to become submerged or exposed and for channels to become connected or disconnected. Reservoirs and riprap built during the observation period influence river dynamics. The 60-year photographic record may be divided into three periods defined approximately by reservoir and riprap construction: (1) before, 1936–1950; (2) during, 1950–1967; and (3) after, from 1967 onward. Riprap location is shown on the aerial photographs (Figure 2).

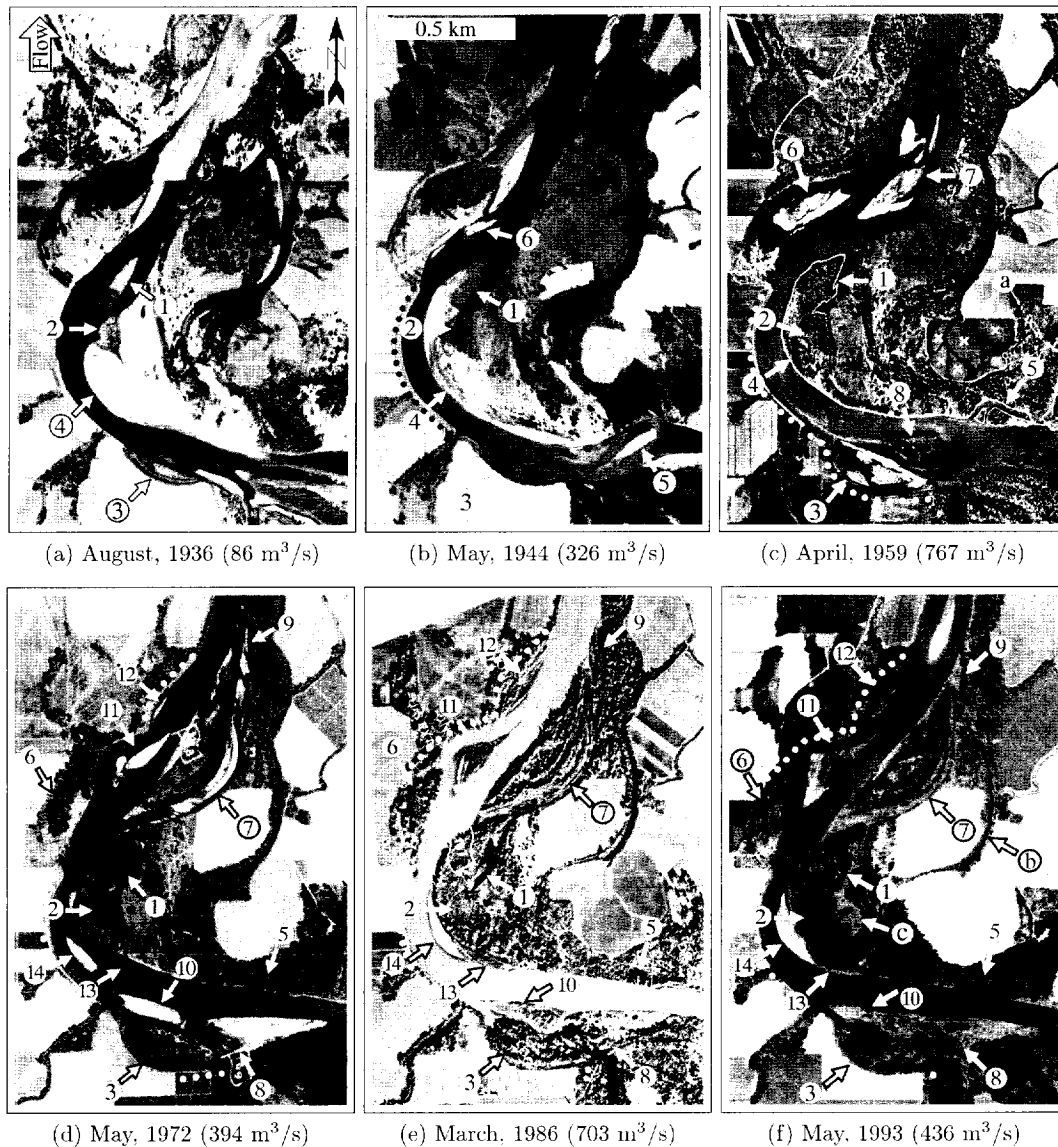
**Figure 4.** Historical series at river km 269, with calendar year and flow at the Albany gage given below each photograph. Scale bar is shown in the 1944 frame. Dotted lines, black or white, show location of shoreline revetments.

Figure 4 shows development and incorporation of 14 gravel barforms into floodplain. We follow several from bare gravel to forested floodplain. Shoreline revetments are noted. Channel maps from 1852 show this region braided, with several secondary channels (Hoerauf 1970).

*Frame 1944.* Mid-channel bar 1 has grown larger and acquired vegetation, while the upstream end of a secondary channel is closing as it joins lateral bar 4. Bar 2 is now completely vegetated with tree crowns visible. Bar 3 remains unchanged in size, but mature cottonwoods signify that it has become an island. Newly emergent bars 5 and 6 appear, and the river margin has eroded opposite each. Lateral bar 4 acquires some scattered trees. Riprap is added to the outside edge of the main channel bend.

*Frame 1959.* What began as bar 1 now supports mature cottonwoods. Here attached to lateral bar 4, creating a backwater area, it may still be an island at

higher river stages. Bar 2 has mature cottonwoods. Bar 3 has grown laterally, while riprap has been added to prevent the secondary channel from eroding further into older floodplain. Mid-channel bar 5 has been

reworked substantially and become a small island. Bar 6 has grown significantly, replacing the eroded landform that supported a patch of forest in 1944. Dissected central bar 7 emerges. Incipient bar 8 remains sub-

merged at this relatively high stage but has caused some erosion into lateral bar 4. Label a points toward six coalesced islands, each marked by a white x, composing mature floodplain. Some combination of factors in this agricultural field has revealed the pattern of bars formed from coarse gravel and channels filled with finer sediment.

been colonized by cottonwoods. The dissected barform 7 has coalesced into one contiguous forested island with, among other patterns, three arcuate bands of trees. The secondary channel adjacent to 7 has filled with multiple bars of smaller scale, one of which is identified as 9. Gravel bar 8 is now emergent with vegetation at its downstream end. Gravel bars 10, 11, 12, and 14 are newly emergent, while the presence of submergent bar 13 is evidenced by erosion into lateral bar 4. Riprap has been placed along the river margin near bar 12.

*Frame 1986.* The previously emergent bars 9–12 have all been colonized, with some tree crowns evident. More riprap has been added to stop further erosion opposite

bar 11. Bar 13 has emerged and been colonized. While the evolution of central bar 14 is uncertain, we label the renewed deposition attached to bar 4 as 14.

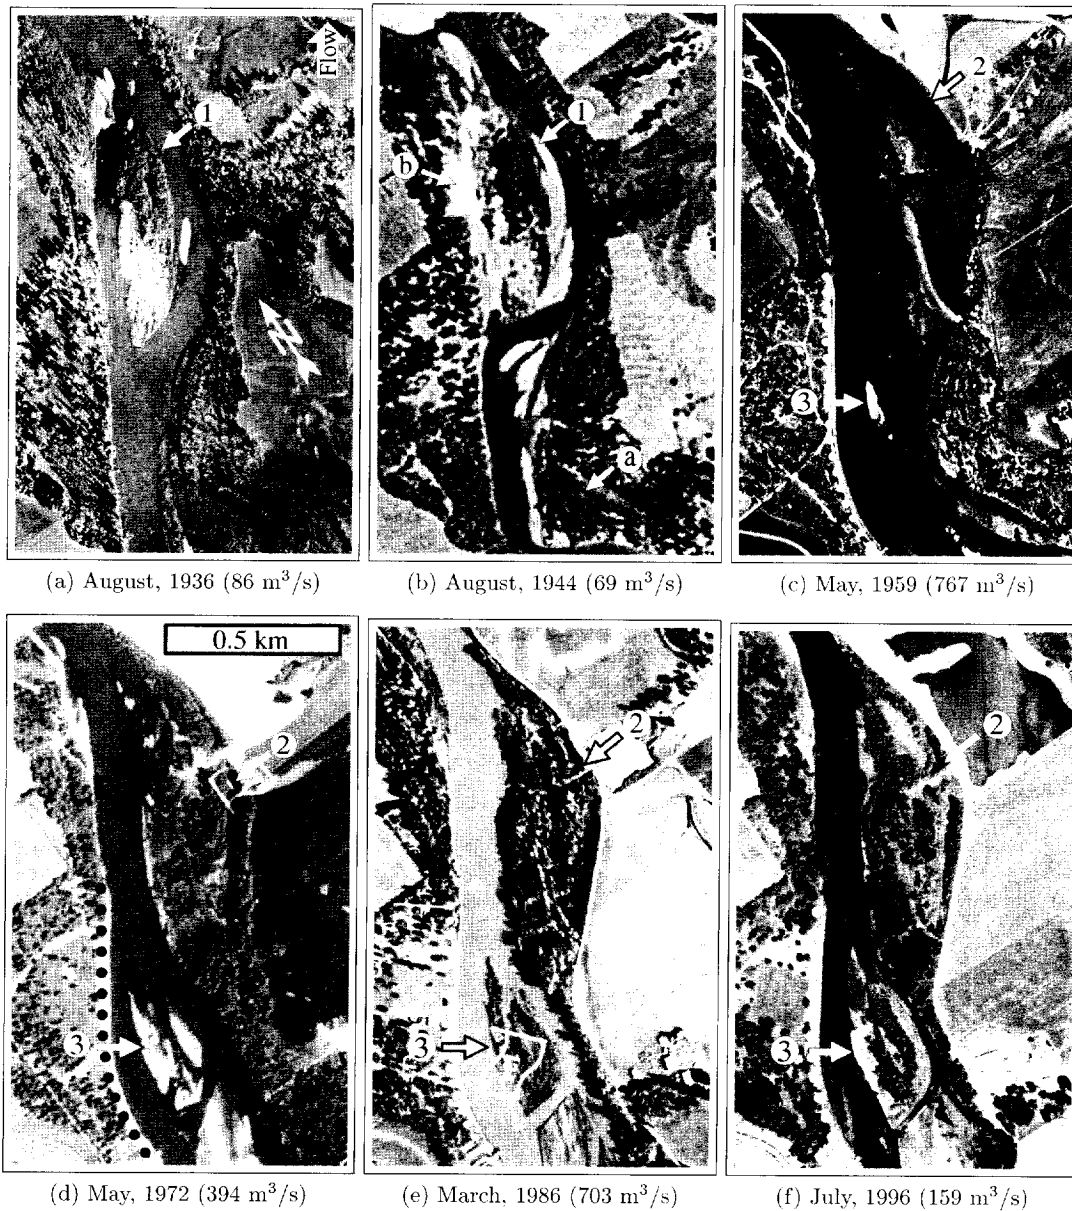
**Figure 5.** Historical series at river km 216, with calendar year and flow at the Albany gage given below each photograph. Scale bar is shown in the 1972 frame. Dotted lines, black or white, show location of shoreline revetments.

*Frame 1936.* Island 1, its downstream half densely vegetated, has diverted flow to scallop both right and left river banks.

*Frame 1944.* At this river stage, lowest shown in the sequence, island 1 appears attached to the left bank by bare gravel b.

*Frame 1959.* Bar 2 has formed and attached to older floodplain. Island 1 and its associated vegetation appear to have been removed by flooding. What portion of bar 2 material derives from Island 1 is unclear. Bar 3 is emergent, and riprap has been constructed along the left bank. Young riparian forest labeled a in the 1944 frame has been eroded away.
