## Rapid 3-D analysis of rockfalls

**Greg M. Stock**, National Park Service, Yosemite National Park, El Portal, California 95318, USA; **Antoine Guerin**, Risk Analysis Group, Institute of Earth Sciences, University of Lausanne, Lausanne, Switzerland; **Nikita Avdievitch**, National Park Service, Yosemite National Park, El Portal, California 95318, USA; **Brian D. Collins**, U.S. Geological Survey, Menlo Park, California 94025, USA; **Michel Jaboyedoff**, Risk Analysis Group, Institute of Earth Sciences, University of Lausanne, Lausanne, Switzerland.

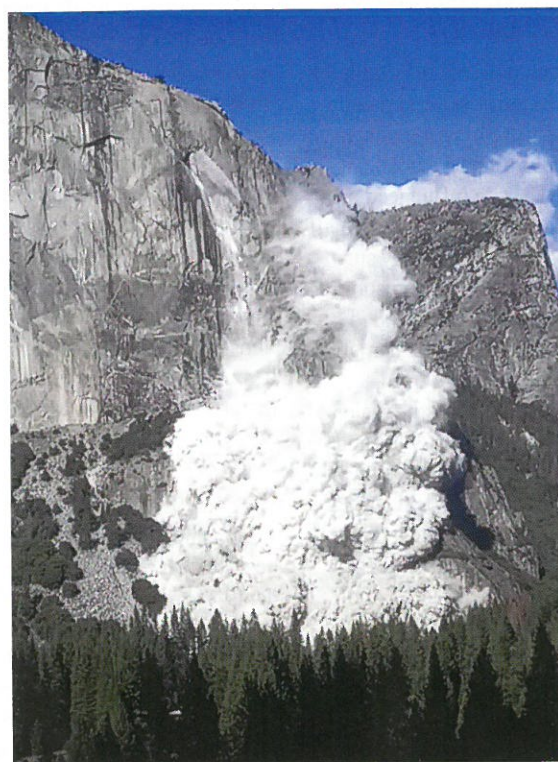
Figure 1. A 9,811 m<sup>3</sup> rockfall from the southeast face of El Capitan at 14:21 PST on 28 Sept. 2017. Photo by Przemek Pawilkowski.

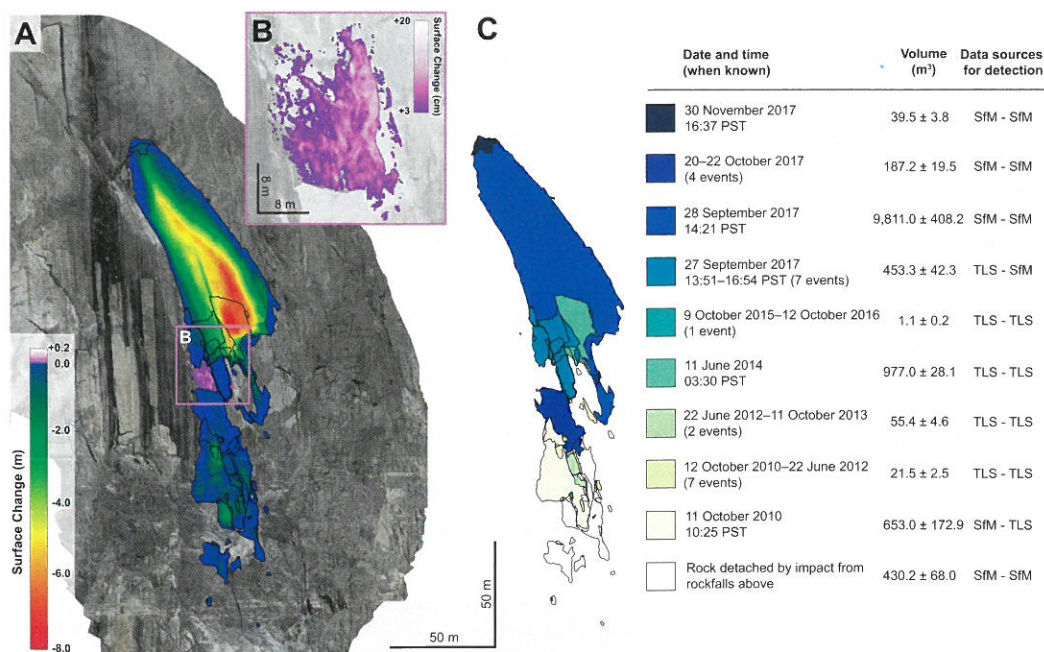
**Figure 2. Spatial and temporal progression of rockfalls from the southeast face of El Capitan between Oct. 2010 and Nov. 2017. (A) Structure-from-Motion (SfM) model with color overlay showing the spatial progression of rockfalls, derived by comparing SfM models against earlier terrestrial laser scanning data (TLS). Negative surface change represents rockfall thicknesses; positive surface change, shown in (B), represents outward displacement of a rock sheet by up to 20 cm. (C) Temporal progression of rockfalls occurring between Oct. 2010 and Nov. 2017.**

after the larger 28 Sept. rockfall, comparing the new SfM model against data collected the previous day (Fig. 2). The 28 Sept. rockfall was 120 m tall, 45 m wide, and up to 8 m thick, with a total volume of  $9,811.0 \pm 408.2 \text{ m}^3$ . The impact of the collapsed slab on the cliff below dislodged another  $430.2 \pm 68.0 \text{ m}^3$ . Thus, the 28 Sept. rockfall was 23 times larger than the rockfalls that occurred the previous day. Within 24 hours, the NPS was able to disseminate this information to the public via press releases and social media.

rockfalls mostly consisted of rock sheets tens of meters tall and wide but usually <1 m thick (Fig. 2A); more widely spaced regional joints influenced detachment of the larger-volume rockfalls. Finally, whereas differencing of SfM and TLS models typically yields negative surface change indicative of material loss, models generated after the Oct. 2017 rockfalls revealed an area of positive surface change. Here, a rock sheet 23 m tall, 14 m wide, and tens of cm thick rotated outward up to 20 cm along a vertical hinge line on its western side (Fig. 2B). The sheet is bounded on three sides by rockfall scars, and likely displaced during or immediately after the 22 Oct. 2017 rockfall. This geometry, combined with a simplified fracture mechanics analysis, indicates that the sheet should detach with another 20% of fracturing along the partially attached side. Although the 3-D data do not allow us to predict exactly when this will occur, they do define the precise location and volume of this future rockfall.
