Wilcox, A. C., J. E. O'Connor, and J. J. Major (2014), Rapid reservoir erosion, hyperconcentrated flow, and downstream deposition triggered by breaching of 38 m tall Condit Dam, White Salmon River, Washington, *J. Geophys. Res. Earth Surf.*, 119, 1376–1394, doi:10.1002/2013JF003073.

## Rapid reservoir erosion, hyperconcentrated flow, and downstream deposition triggered by breaching of 38 m tall Condit Dam, White Salmon River, Washington

**Abstract** Condit Dam on the White Salmon River, Washington, a 38 m high dam impounding a large volume (1.8 million m<sup>3</sup>) of fine-grained sediment (60% sand, 35% silt and clay, and 5% gravel), was rapidly breached in October 2011. This unique dam decommissioning produced dramatic upstream and downstream geomorphic responses in the hours and weeks following breaching. Blasting a 5 m wide hole into the base of the dam resulted in rapid reservoir drawdown, abruptly releasing ~1.6 million m<sup>3</sup> of reservoir water, exposing reservoir sediment to erosion, and triggering mass failures of the thickly accumulated reservoir sediment. Within 90 min of breaching, the reservoir's water and ~10% of its sediment had evacuated. At a gauging sta

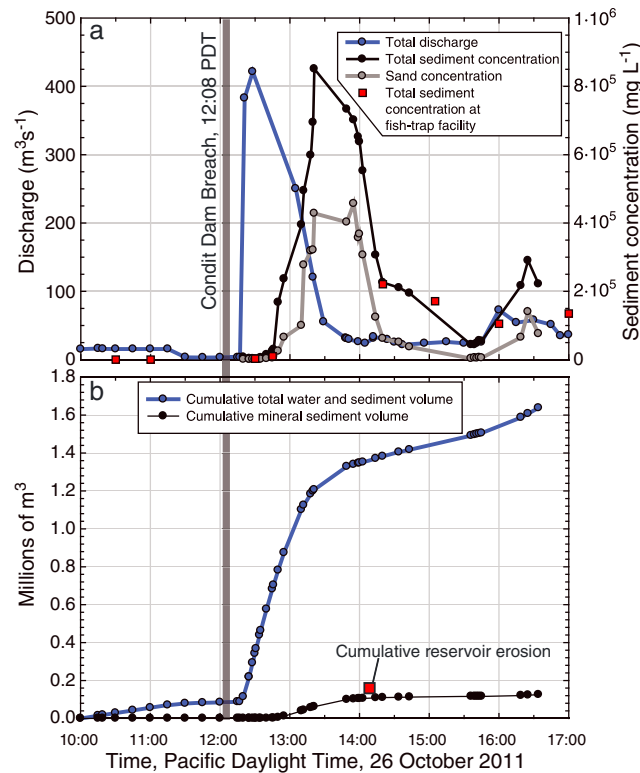
**Figure 4.** Time series of the first 5 h following breaching of Condit Dam of (a) discharge and sediment concentrations measured at sites 2.3 km (gauge) and 3 km (fish trap) downstream of the dam site; and (b) cumulative total volume discharge (sediment plus water volume) and estimated sediment volume discharge passing the gauging site 2.3 km downstream of the dam site, and estimated cumulative reservoir erosion as of 14:08 (red square). Vertical gray bar indicates time of breach. Source data provided in Table S1.

sediment concentration, as well as relations between flow characteristics and resulting deposits (Figures 4 and 5). At the USGS gauge, flow was  $3.1 \text{ m}^3 \text{ s}^{-1}$  immediately prior to breaching, temporarily diminished from  $\sim 20 \text{ m}^3 \text{ s}^{-1}$  base flow of the previous few days by intentional halting of reservoir outflow in preparation for breaching. The turbid and turbulent flood wave released by breaching arrived at the gauge at 12:17, 9 min after breaching (Animations S4 and S5), indicating a mean velocity of the flow front of  $4.3 \text{ m s}^{-1}$ . Flow stage increased for another 11 min, and flow reached a peak discharge of  $421 \text{ m}^3 \text{ s}^{-1}$  at 12:28 (Figures 4 and 5b), a discharge about equaling the 100 year recurrence interval flow. Flow declined swiftly, and by an hour later at 13:30 was about  $55 \text{ m}^3 \text{ s}^{-1}$  (Figure 4).

Sediment transport lagged the flood crest (Figure 4). From pre-breach sediment concentrations ranging between  $5$  and  $15 \text{ mg L}^{-1}$ , concentrations increased to about  $3000 \text{ mg L}^{-1}$  (0.1% by volume) at peak discharge. But as flow diminished, sediment concentrations increased rapidly, attaining  $850,000 \text{ mg L}^{-1}$  at 13:21, 53 min after peak discharge (and 72 min after breaching). Sediment concentrations subsequently diminished but remained mostly above  $100,000 \text{ mg L}^{-1}$  through our last measurements of the day at 16:34. Measurements at the fish trap site downstream show patterns in sediment concentration similar to those at the gauging station (Figure 4).

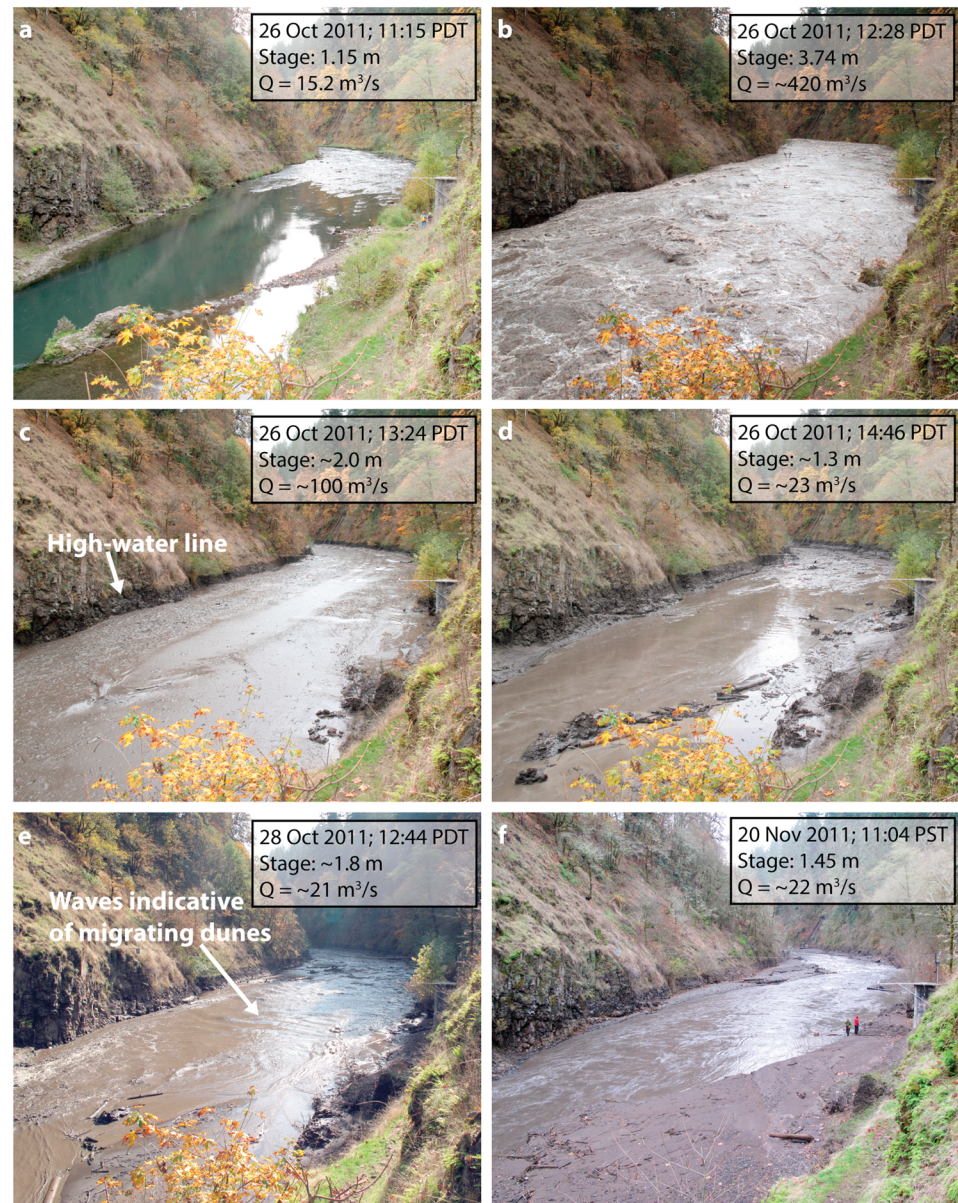
**Figure 5.** White Salmon River at USGS gauge site 2.3 km downstream of dam site, looking downstream: (a) 53 min before breaching; (b) 20 min after breaching, at discharge peak; (c) 76 min after breaching, at peak sediment concentration, with high water line evident; (d) ~2.5 h after breaching, discharge has returned to background and sediment concentration is falling; (e) 2 days after breaching, when channel has aggraded and migrating dunes indicate substantial sandy bed-material transport; and (f) 25 days after breaching, showing bar emergence.

this high-sediment concentration, flow remained loud and turbulent. Flow transformed markedly between 13:10 and 13:21 (Figure 5c), with both turbulence and sound substantially dampened. During this period, sediment concentration increased to  $850,000 \text{ mg L}^{-1}$  (32% by volume) and the relative sand content of the entrained sediment doubled to more than 50% (Figure 4). Flow at this time appeared viscous and placid, quietly rafting large coherent blocks of reservoir sediment along with abundant wood and organic debris (Figure 5c and Animations S4 and S5). Sediment concentration remained high, and flow remained smooth and quiet until about 14:00 when concentration dropped below  $500,000 \text{ mg L}^{-1}$  (20% by volume), after which turbulence and sound level increased.

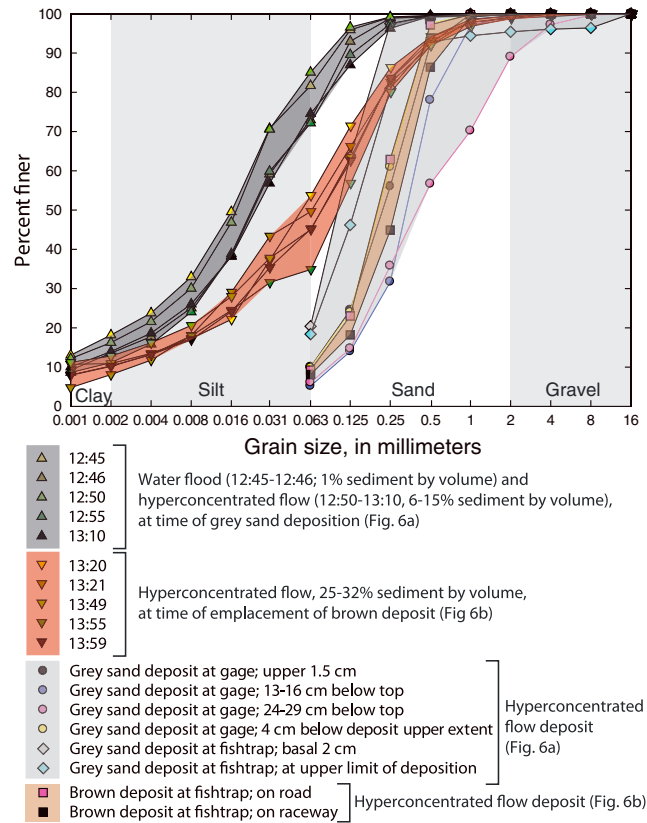
**Figure 7.** Grain-size distributions of suspended-sediment samples as flow reached hyperconcentrated phase (triangles, with sample time indicated) and associated deposits (shown in Figure 6) from 26 October 2011 Condit Dam breach. Complete particle size data are provided in Table S2.

The grey deposit was composed chiefly of massively textured to faintly laminated, poorly sorted ( $1.1\phi$ – $1.9\phi$ ) [Folk, 1980] medium sand (Figure 6a). The deposit fined upward slightly, with the median grain size ( $d_{50}$ ) ranging from about 0.4 mm at the base to 0.2 mm at the top. The correlative deposit at the fish trap facility had a similar composition with a  $d_{50}$  of about 0.2 to 0.3 mm. At all sites, the deposit was composed of approximately 80–90% sand (Figure 7 and Table S2).

The lower brown deposit is also poorly sorted sand (sorting coefficient  $\sim 1.2\phi$ ), but it contained abundant organic detritus and had faint horizontal and planar laminae (Figure 6b). In contrast to the grey deposit, there is no size grading evident from top to bottom; samples (from the White Salmon fish trap facility) had  $d_{50}$  values of about 0.25 mm and total sand contents of 90% (Figure 7). The

principal physical differences between the brown and grey deposits were the amount of organic content and the narrower sediment-size distribution and more evident lamination within the brown deposit (Figure 7).

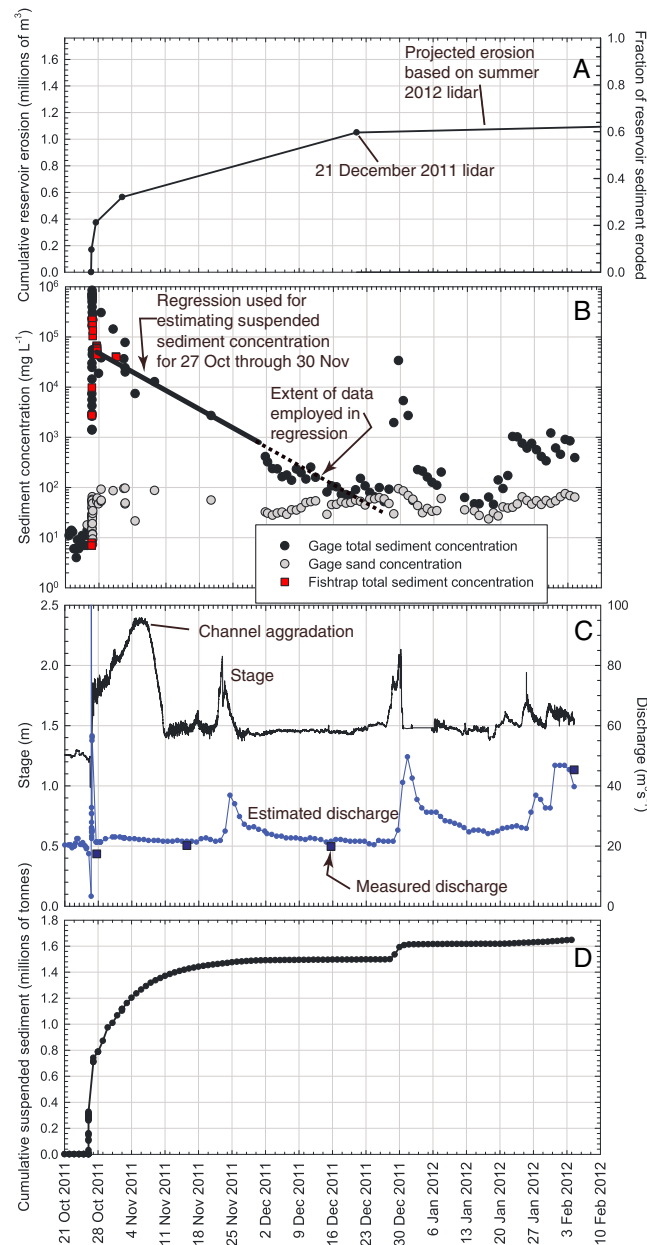
**Figure 8.** Time series, from 21 October 2011 to 4 February 2012, of (a) cumulative reservoir erosion (and fraction of total reservoir sediment eroded), (b) downstream suspended sediment concentration at two sites (gauge 2.3 km downstream of dam; fish trap 3.0 km downstream), (c) stage and discharge (at gauge), and (d) cumulative suspended-sediment flux at gauge site. Gradual stage rise and fall (Figure 8c) from ~27 October to 9 November illustrates bed aggradation and passage of bed material sediment wave. Source data provided in Table S1.

Measurements at the gauge site and fish trap facility showed that sediment concentration declined significantly in the days and weeks after breaching (Figure 8b). By the day after breaching, sediment concentration had decreased to about 50,000 mg L<sup>-1</sup>. Owing to channel aggradation and consequent difficulties with maintaining clear pump-sampler intakes, sediment concentrations measured from pump samples are highly variable for the 2 weeks after breaching. These difficulties also resulted in few samples between 2 November and 1 December. However, limited dip samples and depth-integrated cross-section measurements at the gauge site between 2 and 8 November show sediment concentrations between 10,000 and 25,000 mg L<sup>-1</sup>. By 1 December, resumed pump samples show sediment concentration had declined to less than 500 mg L<sup>-1</sup>, although concentrations rose during periods of high flow (Figure 8c). During this post-breach period, the sand content of the suspended load remained high—generally over 30% and briefly attaining 90% during episodes of high concentration.

After the channel attained its maximum aggradation level in early November, the river incised through the fill. By 10 November, the river had incised nearly 1 m and attained a stable stage of about 1.5 m (Figure 8c), about 0.2 m higher than low-flow stage before dam breaching. Bed conditions, however, had changed markedly from pre-breach conditions. Pools had filled with gravel, and sand-and-gravel bars flanked the channel. High-frequency stage oscillations between 11 and 21 November (Figure 8c) may indicate return to bed load transport of mostly sand and passage of low-amplitude dunes.
