A cross section of stream channel restoration

G. Mathias Kondolf

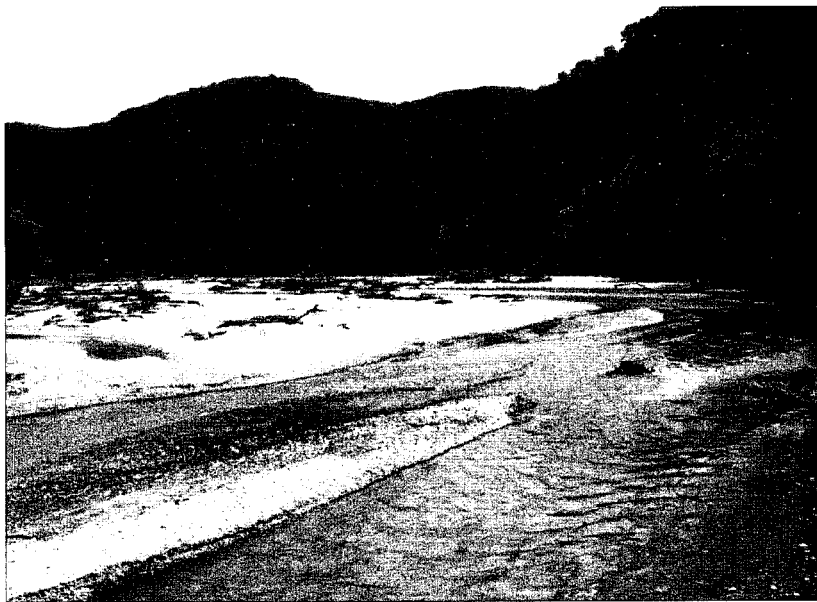
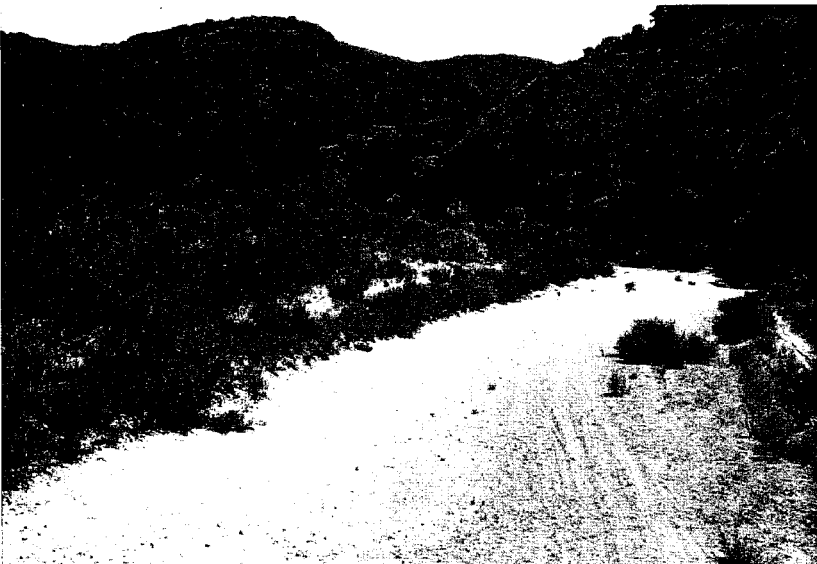
Figure 2. Photographs of the Carmel River looking upstream from the Schulte Road bridge

(a) In 1983, showing the wide, unstable, braided channel following extensive bank erosion

(b) In 1992, five years after construction of the restoration project

water to groundwater (Kondolf et al. 1987). The alluvial water table was locally drawn down over 30 ft (10 m), resulting in massive die-off of willows and other riparian vegetation, destabilization of the banks, and massive erosion during moderate floods (6-8-year return period) beginning in 1978. Near the Schulte Road Bridge, channel width increased from about 80 ft (25 m) to 1,000 (300 m), changing from a single-thread meandering channel with well-vegetated banks to a braided sand-and-gravel channel with eroding banks (Kondolf and Curry 1986).

The Monterey Peninsula Water Management District (MPWMD), a regional agency that regulates the private water purveyor, established a river management program and embarked on a project to restore a single-thread meandering channel (with a riparian corridor) to a 3,200-ft (980-m) long reach upstream of Schulte Road. The goals were to restore channel stability and improve aquatic habitat for anadromous steelhead trout (*Oncorhynchus mykiss*) by narrowing the active channel and restoring bank vegetation. A two-stage channel was created: an active channel with capacity for the 2-year flood, and a floodplain (with capacity in excess of the 100-year flood) on which lines of willows were planted in a herringbone pattern to slow over-bank velocities and direct water back into the active channel. The active channel margin was planted with willows for bank protection, reinforced with post-and-wire revetment along the outside bends (Figure 2). Because the low water table problem has not been solved, the willow plantings cannot survive without drip irrigation (Matthews 1990).

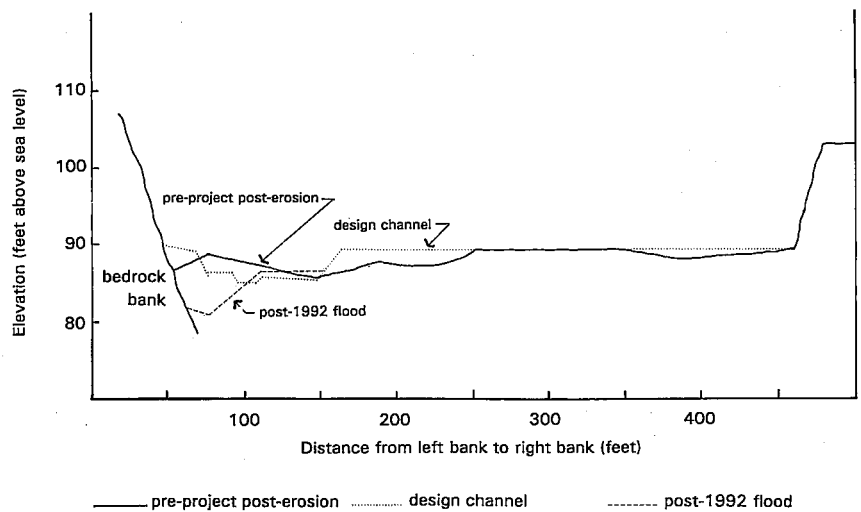
Figure 3. Cross sections of the Carmel River approximately 700 ft (200 m) upstream of Schulte Road bridge

(Note: This figure shows pre-project conditions after severe bank erosion of 1980-1983), as-built project conditions in 1987, and channel conditions following the 1992 runoff season (return period of peak flow 6 years). Looking downstream. Cross sections from W.V.G. Matthews

To evaluate the success of the Schulte Road project in terms of channel stabilization, cross sections for pre-project and post-project conditions were compared with channel conditions in 1992 after passage of a flood with a return period of approximately 6 years (Figure 3). The low flow channel migrated against the granitic bedrock of the left bank, scouring a pool 10 ft (3 m) below the constructed floodplain surface. This is considered a positive adjustment, as it creates good habitat and effectively recreates the pool described at this site by Steinbeck (1945) in *Cannery Row*. Overall, the 3,200-ft (980-m) long project remained stable in the 6-year flow. Because this project relied upon riparian vegetation for bank stabilization, its success may be largely due to the absence of large floods in the years immediately following plantings. This allowed willows to establish themselves and develop a dense root mat to resist flood scour. If floods had occurred in the first two years following planting, it is likely that the willow seedlings would have been scoured. In a subsequent, larger flood in 1993, this project was undamaged, but two nearby restoration projects constructed in the fall of 1992 failed, probably largely because vegetation had not yet become
