Middle Fork Willamette Watershed Council

Elijah Bristow Riparian Restoration and Reforestation (Phase 1) Monitoring Report for OWEB Project #204-204

May, 2008 Prepared by Eve Montanaro

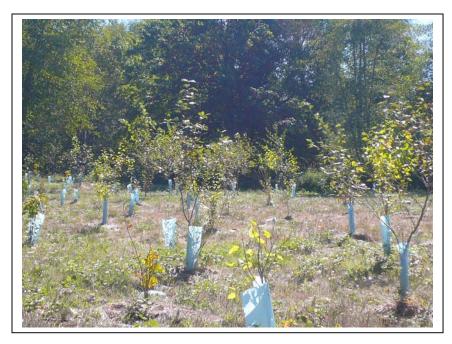
Tree growth and survival appears to be compromised in the northern-most section of Phase 1. Trees in this area lack the height demonstrated in other areas of Phase 1 and some loss has been noted. Upon review of this situation, it was determined that this area was the most difficult to plant because of the gravely soil substrate in this zone. The soil is comprised mostly or rocky substrate, most likely the site of an abandoned depositional bar. We will replant this section if the trees do not survive past summer 2008.

Tree survival and growth is good with a 66-90% survival rate after four years.

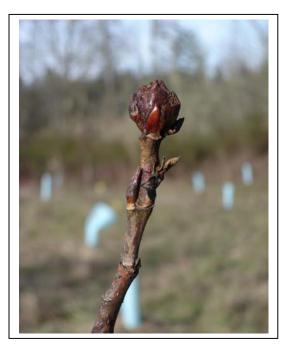
The overall damage has increased from last years' measurements, in large part due to the progression of disease that is prevalent among the Cottonwoods (*Populus balsimifera*) as seen to the right. Though the disease appears often, it has rarely proven fatal for the trees. The actual effect it will have on the survival of the Cottonwoods in the future is hard to speculate at this time. Another possible reason for increased damage is the fact that these trees are now outgrowing their protection and are more vulnerable to browsing from local animals.

The forestry agent indicated that in a worst-case scenario the cottonwoods might lose all of their leaves during this first year yet would most likely survive. Since we were not concerned with tree form, the decision was made not to treat for any of these threats. An assessment of
