# RESTORING ANDERSON CREEK

A case history addressing methods for constructing a complex, non-tidal stream channel

One in a series of three case histories about the South Slough NERR's Winchester Tidelands Restoration Project

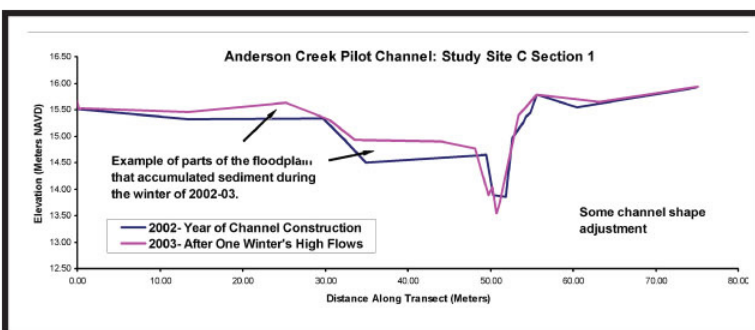
**Figure 11.** Anderson Creek pilot channel cross sections, in 2002 right after channel construction, and in 2003 after one high flow season (see Figure 5 for locations).

Sediment redistribution continued as flow levels dropped in spring and summer. Sediments also accumulated in the high-flow channel and floodplain (see Figure 11).

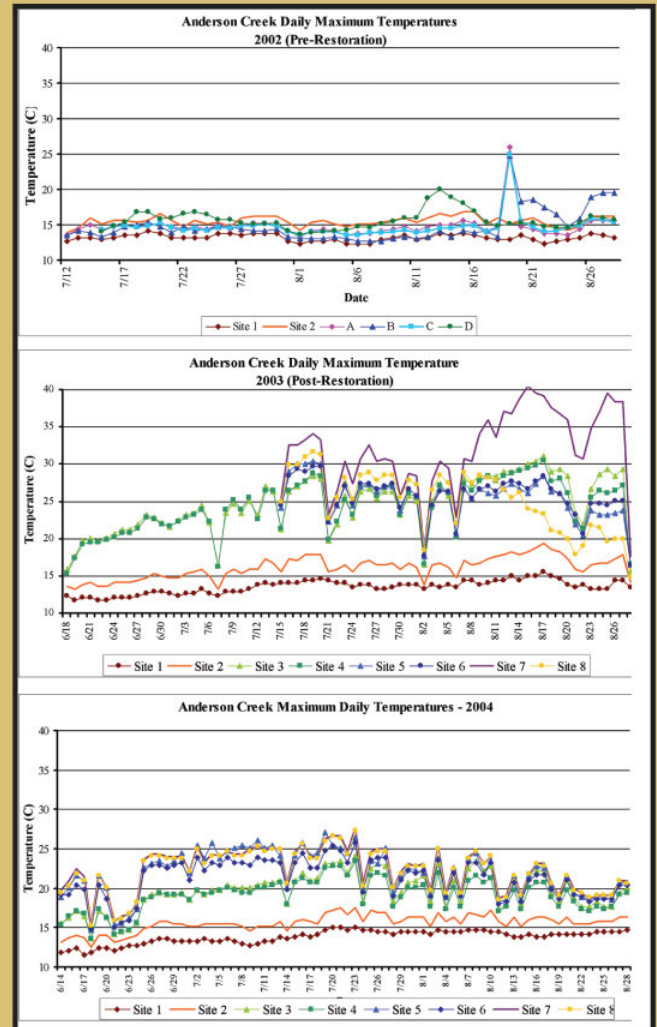
**Figure 13.** Temperature change in the Anderson Creek pilot channel, 2002 to 2004. Temp loggers 1 and 2 were placed upstream from the project area. Temp loggers 4, 5, 8 were located in pool sites; 3, 6, 7 in riffle sites. Temp loggers A-D were located in the Anderson Creek ditch before filling.

Water temperature was measured with nine temperature loggers (Onset Computer Corporation, TidBiT® data loggers,  $\pm 0.4^\circ$  F). Temperature loggers were placed at the heads of both tributaries of Anderson Creek above the project area to record temperature before water entered the project site (sites 1 and 2 in

Figure 13). The remaining temperature loggers were placed in pairs in pools (potential summer rearing habitat for salmonids) and in adjacent shallow riffles in the new Anderson Creek channel. To ensure accuracy, TidBiT temperatures were compared monthly with temperatures taken at each location using a National Institute of Standards and Technology (NIST) thermometer. Temperature was tracked during the warm summer months (June to September), the period when high stream temperatures are most likely to affect juvenile salmonids. The near-term daily maximum stream temperature goal for coho salmon survival in Anderson Creek is 18° C (based on a seven-day average), the maximum temperature that juvenile coho can tolerate for extended periods of time. The long-term maximum stream temperature goal is 16° C identified for optimum juvenile salmonid growth (U.S. EPA 2003).

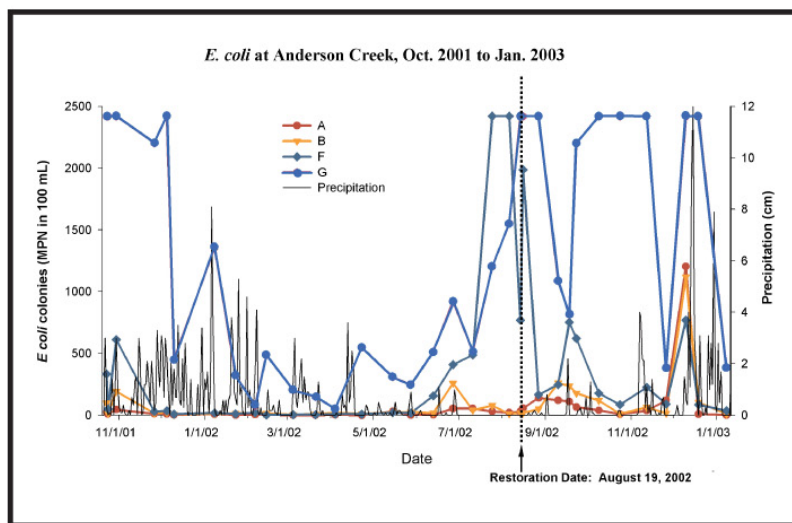
**Figure 15.** Bacteria (*E. coli*) values at Anderson Creek. Sample sites A and B are above the project site. Site F is in the lower part of Anderson Creek and site G is in Winchester Creek above

the confluence with Anderson Creek. (MPN — most probable number — refers to the statistical method used to estimate bacteria colonies)

In Anderson Creek, Reserve staff found that bacteria levels did not increase except briefly during removal of a beaver dam before the filling of Anderson ditch, which presumably released coliform bacteria associated with beaver feces (see Figure 15).
