6

Landslides and Related Phenomena

6.1 Introduction to Landslides

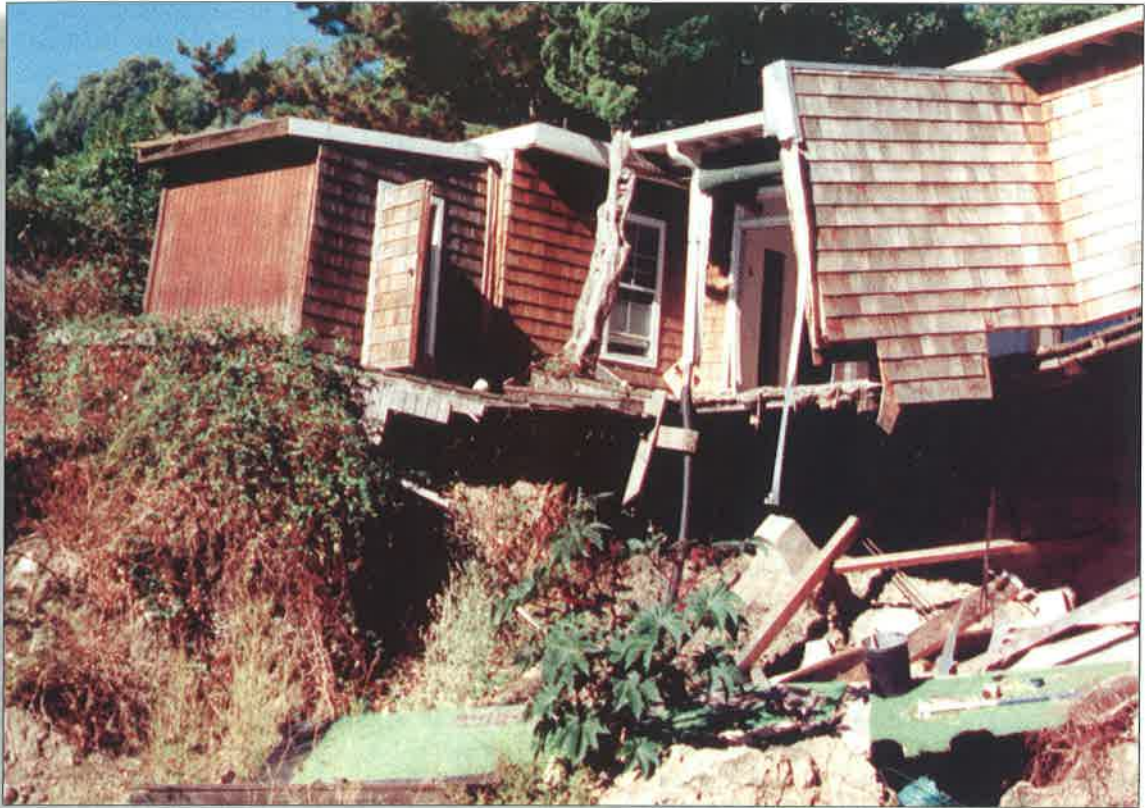
Reactivated prehistoric landslide destroyed this home in Southern California. (Edward A. Keller)

This landslide in the foothills above the community of Santa Barbara, California, is threatening several homes and has the potential to block a nearby stream channel, perhaps causing a flood hazard. The homes built on these slopes were constructed on top of a prehistoric landslide, and the present problem results from reactivation of that slide. In order to minimize the landslide hazard of this area and many others in the United States, we need to carefully recognize and map prehistoric as well as historic landslides to avoid building homes and other structures on unstable lands.

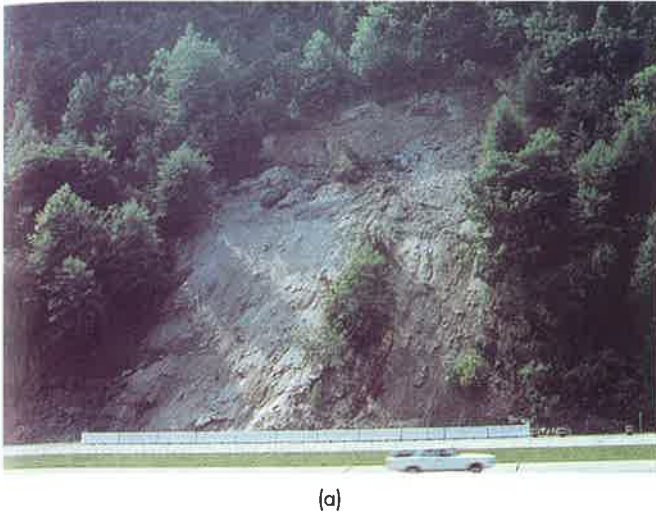
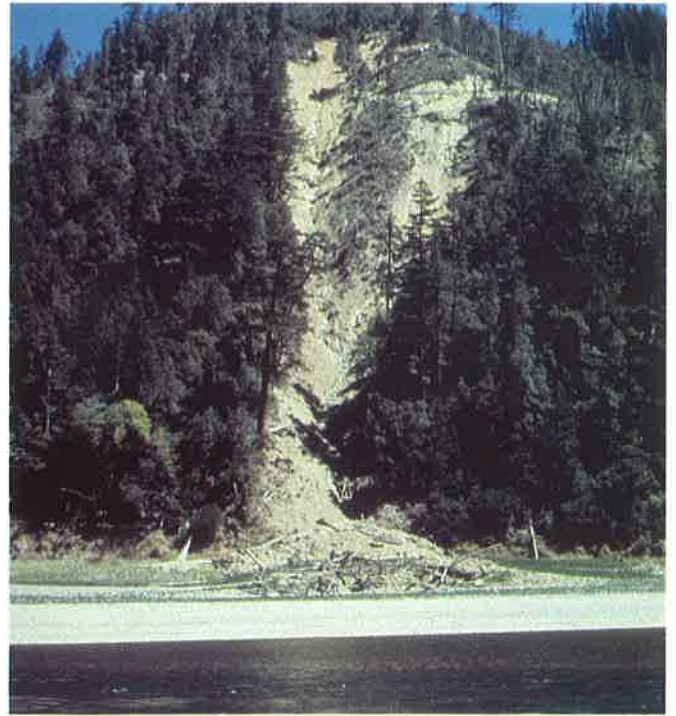
▲ **FIGURE 6.7** (a) Shallow soil slip (North Carolina); (b) shallow debris flow (Klamath River, California). Note the long narrow track and debris on the bank of the river. The logging road near bend of the failure may have helped destabilize the slope. (Edward A. Keller)

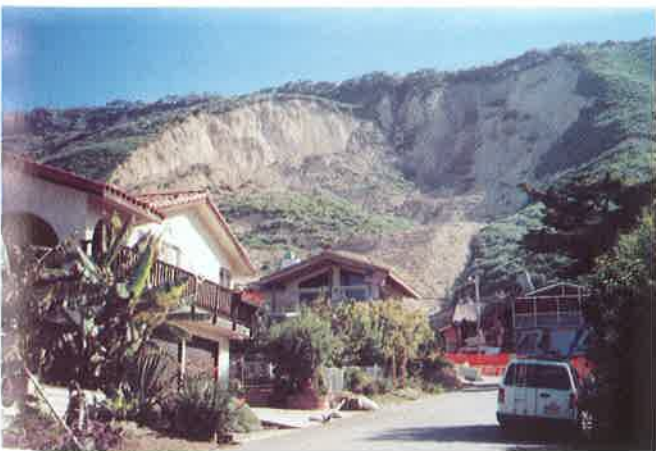
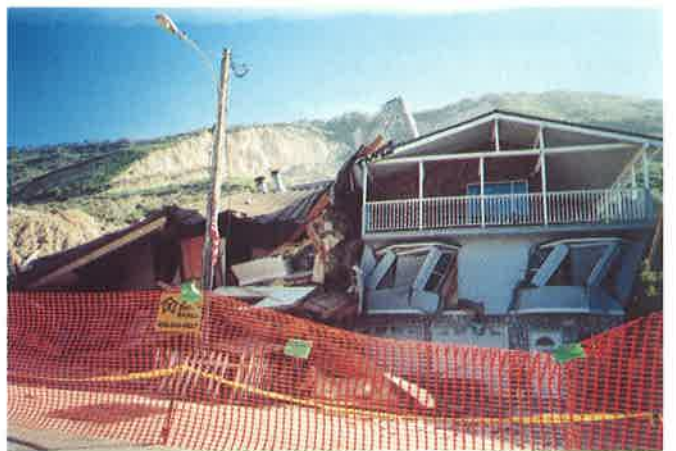
▲ **FIGURE 6.8** Complex landslide consisting of an upper slump block and lower flow at La Conchita, California, in 1995 (a). Close-up of destruction of home in La Conchita. The house was originally three stories (b). (Edward A. Keller)

Most problems concerning slope stability and vegetation are complicated but related to disturbing, changing, or removing vegetation on or above slopes. Figure 6.8 shows a complex landslide that failed in 1995. The steep slope where the slide occurred is a 40,000-year-old seacliff. At the top of the slope, the topography becomes relatively flat, and an av-

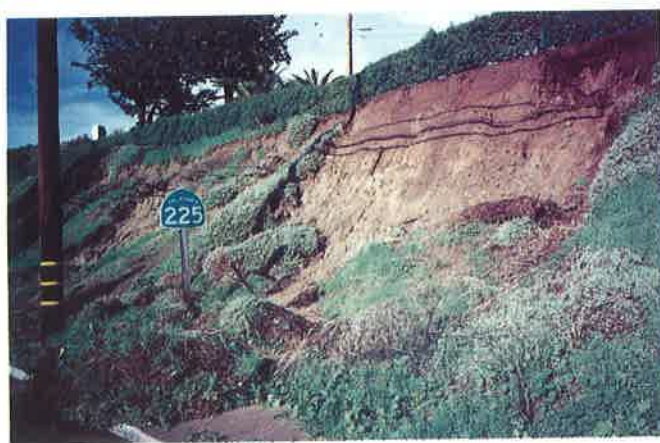
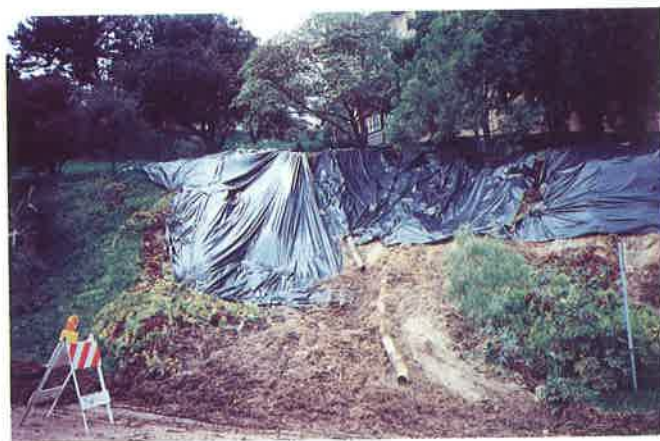
▲ **FIGURE 6.9** Shallow soil slips on steep slopes covered with shallow-rooted ice plants near Santa Barbara, California. (a) An embankment on a road; (b) beneath a home. (Edward A. Keller)

In some cases the *presence* of vegetation increases the probability of a landslide, especially for shallow soil slips on steep slopes. One type of soil slip in southern California coastal areas occurs on steep-cut slopes covered with ice plants (Figure 6.9). During especially wet winter months, the shallow-rooted ice plants take up water, adding considerable weight to steep slopes (each leaf stores water and looks like a small canteen!) and increasing the driving forces. By intercepting rainfall, the plants also cause an increase in the infiltration of water into the slope, which decreases the resisting forces. When failure occurs, the plants and several centimeters of roots and soil slide to the base of the slope.

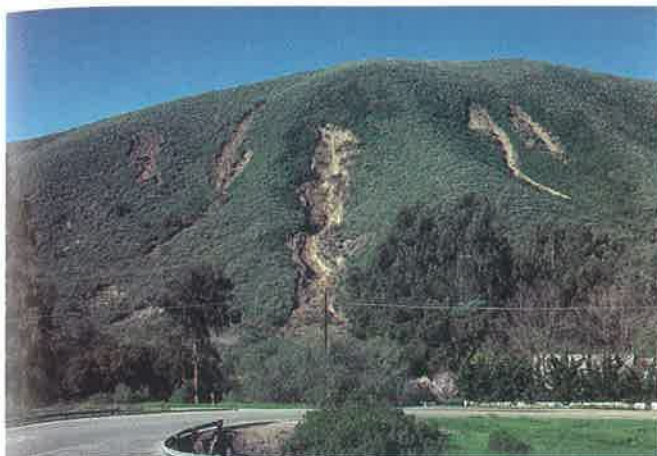
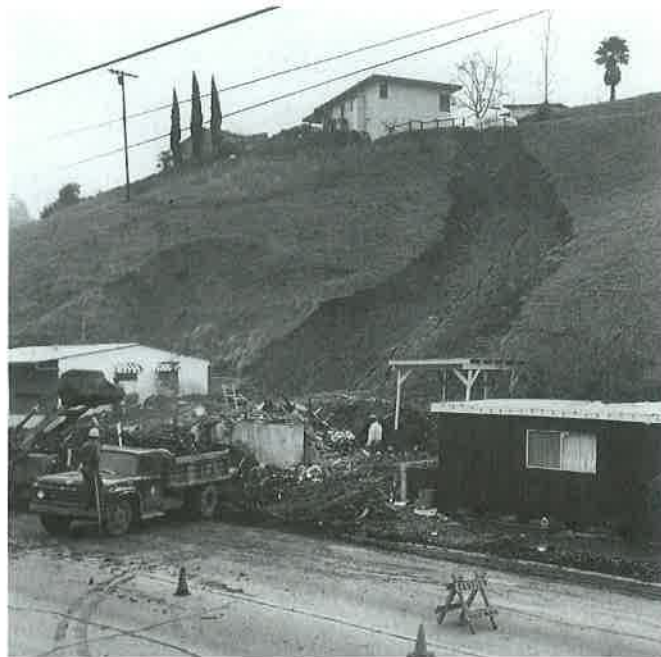
▲ **FIGURE 6.10** (a) Shallow soil slips on steep southern California, vegetated slopes. (Edward A. Keller) (b) Home in southern California destroyed by debris flow that originated as a soil slip. This 1969 event claimed two lives. (John Shadle/Los Angeles Department of Building and Safety)

Soil slips on natural steep slopes are a more serious problem in southern California (Figure 6.10). In this case chaparral (dense shrubs or brush) facilitates an increase in water infiltrating into the slope, lowering the safety factor. One study concluded that, in some instances, susceptibility to soil slip may be greater on vegetated slopes than on slopes where vegetation had been recently removed by fire. This should not be interpreted to mean that burning reduces the landslide hazard. Even though soil slips may sometimes be reduced by removal of vegetation, they are not eliminated; in addition, the grain-by-grain erosion caused by rain splash and sheet wash on the surface greatly increases. The eroded sediment tends to fill up the ravines (steep stream valleys) with a meter or more of debris that may be mobilized into debris flows and mudflows during wet winters (5).

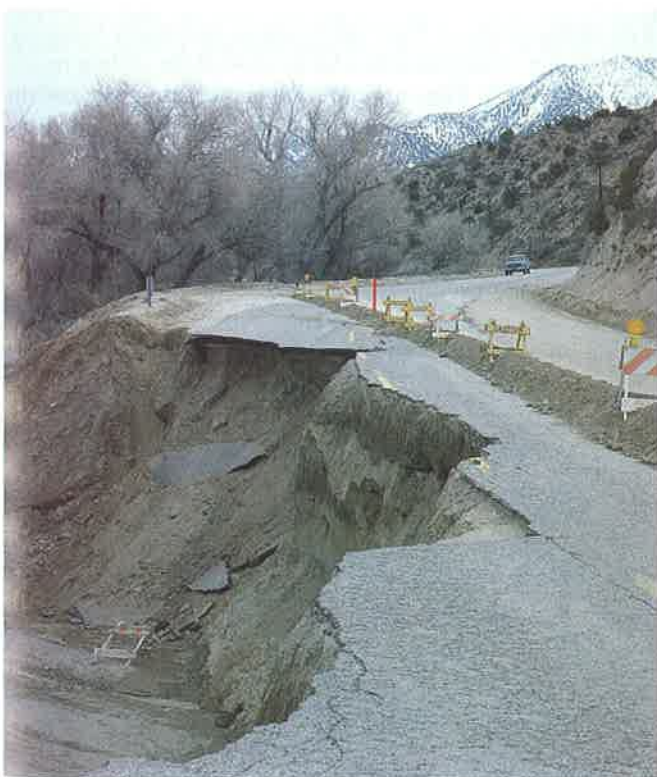
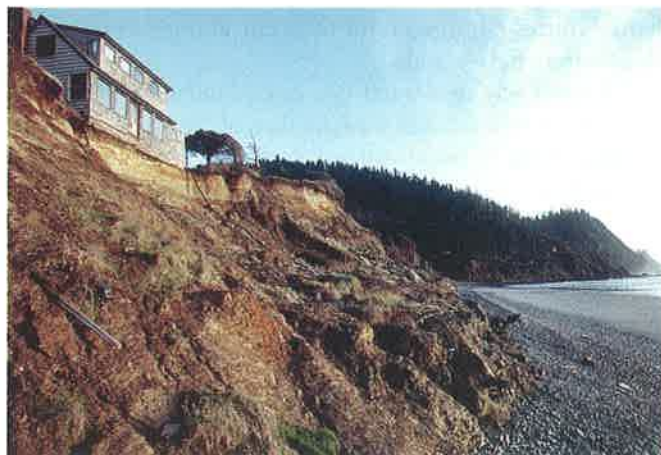
◀ **FIGURE 6.11** (a) Stream bank erosion caused this failure, which damaged a road, San Gabriel Mountains, California. (Edward A. Keller) (b) Beachfront home being threatened by a landslide, Cove Beach, Oregon. (Gary Braasch/Tony Stone Images)

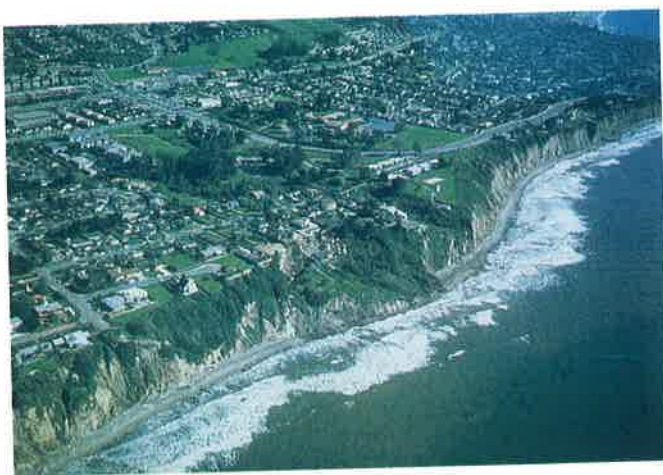
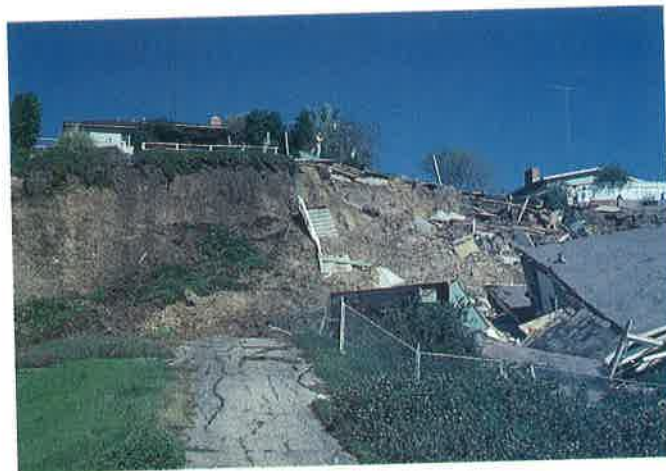
▲ **FIGURE 6.12** (a) Aerial view of landslide along the Santa Barbara coastal area. Note bulge in coastline; (b) close-up of the slide that destroyed two homes. The slide is a reactivation of an older failure. (Don Weaver)

Landslides affect 60 percent of the length of seacliffs in southern California (see Figure 6.12), and the retreat of the seacliff is probably controlled by landslides (14). Similar estimates for slopes are not available, but the complex geology and terrain features, as well as evidence from old landslide scars and landslide deposits, suggest that

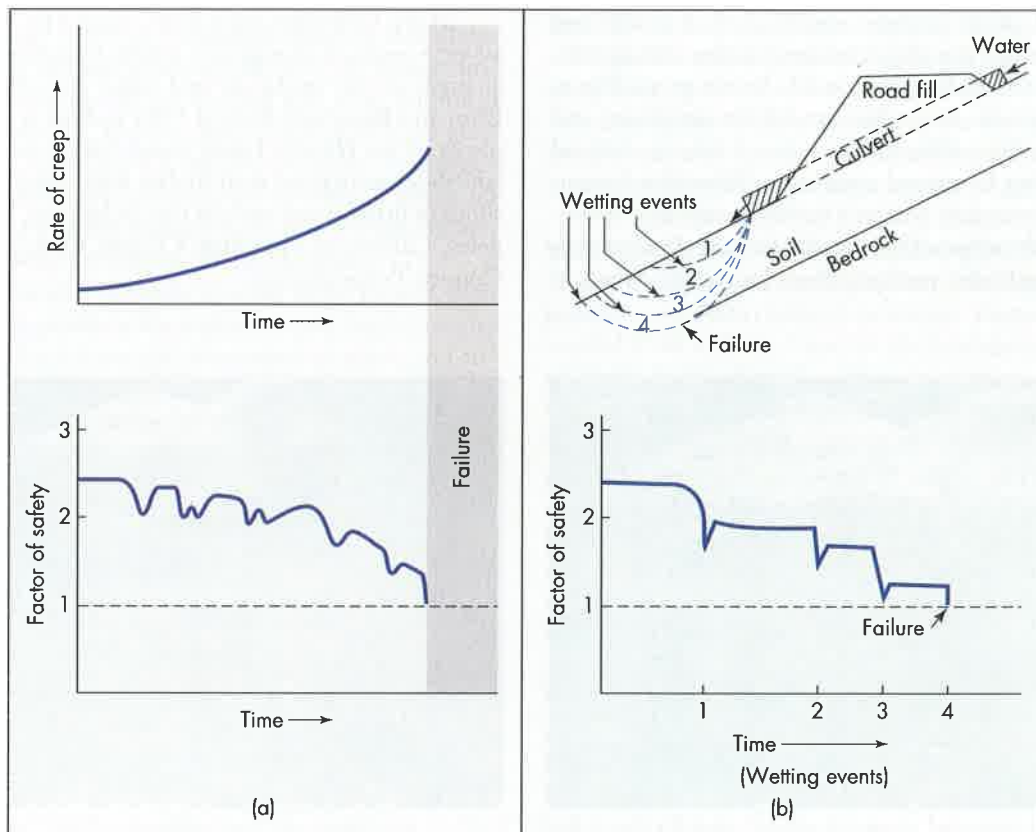
▲ **FIGURE 6.14** Idealized diagrams showing the influence of time on the development of a landslide: progressive creep (a) and progressive wetting (b). Progressive creep is symptomatic of a decreasing safety factor, whereas progressive wetting may cause a reduction in the resisting forces and thus produce a lower safety factor. (Diagram [b] after C. S. Yee and D. R. Harr, 1977, *Environmental Geology*, vol. 1, p. 374)

The Role of Time The forces on slopes often change with time. For example, both driving and resisting forces may change seasonally as the moisture content or water-table position alters. These changes are greater in especially wet years, as reflected by the increased frequency of landslides in or following wet years. In other slopes, a continuous reduction in resisting forces may occur with time, perhaps due to weathering, which reduces the cohesion in slope materials, or to a regular increase in water pressure from natural or artificial conditions. A slope that is becoming less stable with time may have an increasing rate of creep until failure occurs (Figure 6.14a).

A slope's factor of safety may also decrease with time because of progressive wetting, which causes disarrangement of the soil particles in the slope, lowering internal friction and thus the strength of the slope materials. Figure 6.14b illustrates this phenomenon as a result of road build-

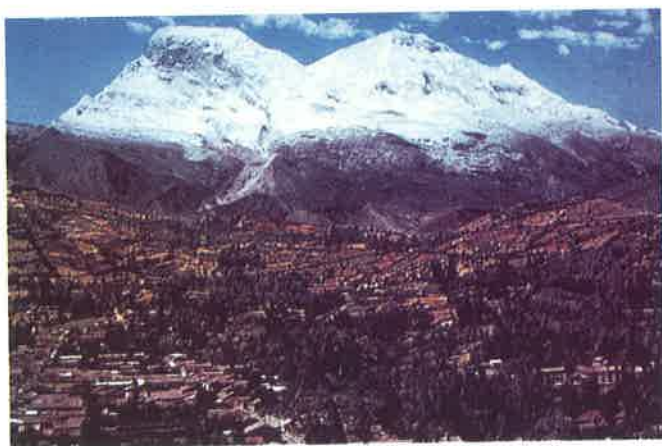
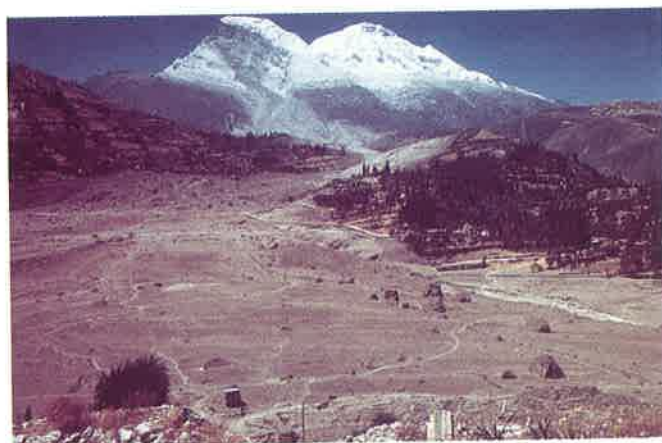
▲ **FIGURE 6.15** Yungay, Peru, prior to the earthquake and debris avalanche (a); and after the earthquake and debris avalanche (b). The debris avalanche had its origin near the north peak of Nevado Huascaran (the right peak in the photograph). Generated by the earthquake, the debris avalanche moved a distance of approximately 14 km downslope and 4000 m lower in only 3 to 4 minutes (average speed of approximately 320 km/hr). (Lloyd S. Cluff)

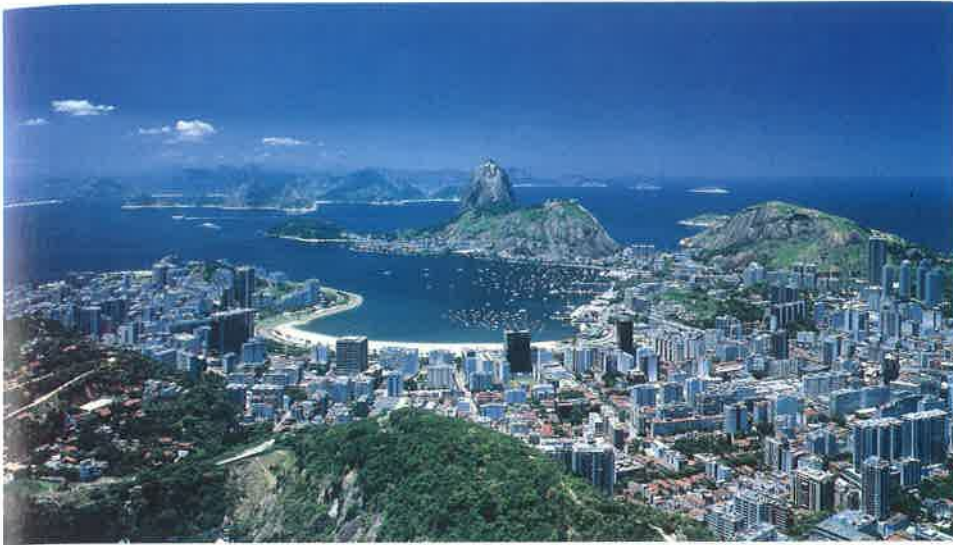
◀ **FIGURE 6.16** Panoramic view of Rio de Janeiro, Brazil, showing the steep (sugarloaf) hills. Combination of steep slopes, fractured rock, shallow soils, and intense precipitation contribute to the landslide problem, as do human activities such as urbanization, logging, and agriculture. Virtually all of the bare rock slopes were at one time vegetated, and that vegetation has been removed by landsliding and other erosional processes. (Tony Stone Images)

With a population of more than 6 million people, Rio de Janeiro may have more slope-stability problems than any other city its size. The city is noted for the beautiful granite peaks that spectacularly frame the urban area (Figure 6.16). Com-

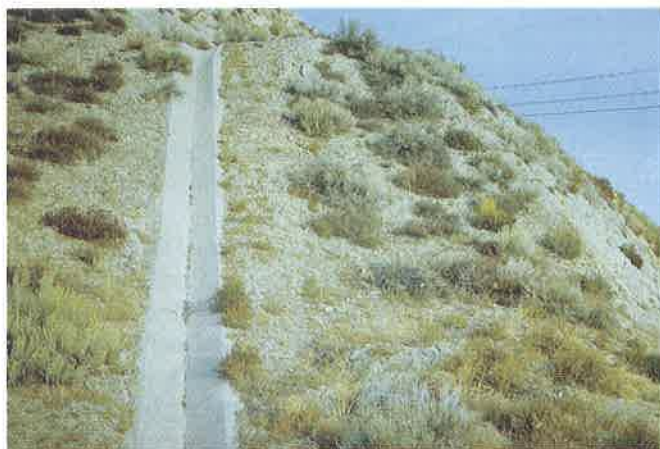
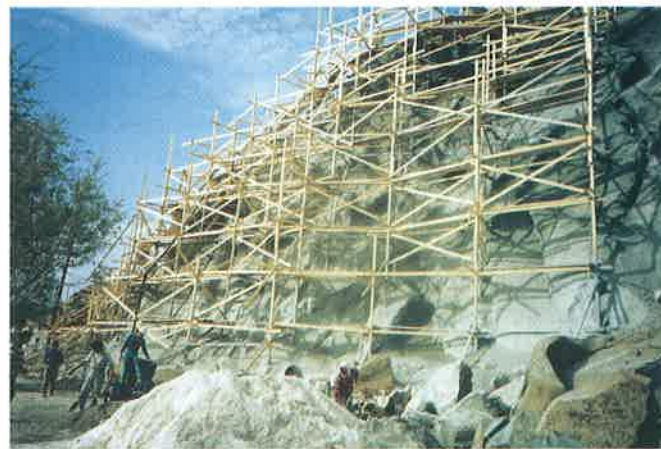
▲ **FIGURE 6.18** (a) Drains on a roadcut to remove surface water from the cut before it infiltrates the slope. (b) Covering a slope with a soil-cement in Greece to reduce infiltration of water and provide strength. (Edward A. Keller)

Drainage Control Surface and subsurface **drainage control** measures are usually effective in stabilizing a slope. The basic idea is to keep water from running across or infiltrating into the slope. Surface water may be diverted around the slope by a series of drains. This practice is common for roadcuts (Figure 6.18a). The amount of water infiltrating a slope may also be controlled by covering the slope with an impermeable layer, such as soil-cement, asphalt, or even plastic (Figure 6.18b). Groundwater may be inhibited from entering a slope by excavating a cutoff trench. The trench is filled with gravel or crushed rock and positioned so as to intercept and divert groundwater away from a potentially unstable slope (2).

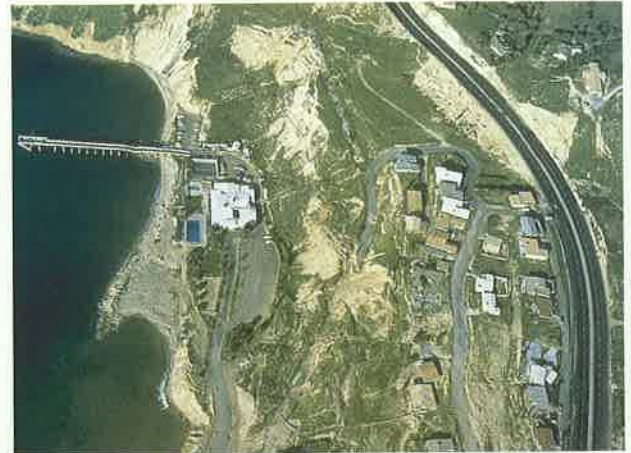
▲ **FIGURE 6.E** (a) Entrance to the Portuguese Bend development (Edward A. Keller) and (b) aerial view of the Portuguese Bend landslide. Note kink in the pier near the toe of the landslide. Eventually most of the homes as well as the swim club and pier shown here were destroyed by the slow-moving landslide. (John S. Shelton)

During a two-decade period of activity, one home on the Portuguese Bend landslide moved about 25 m and constantly shifted in position. Other homes have moved up to 50 m in the same time, and some people living in homes about 1 km from the ocean apparently adjusted to the slow movement and the ever-changing view! Structures remaining in the active slide area had to be adjusted every year or so with hydraulic jacks, and utilities are on the surface. With one exception, no new homes have been constructed since the landslide began to move. The remaining occupants have elected to adjust to the landslide rather than bear total loss of their property. Nevertheless, few geologists would probably choose to live there now.

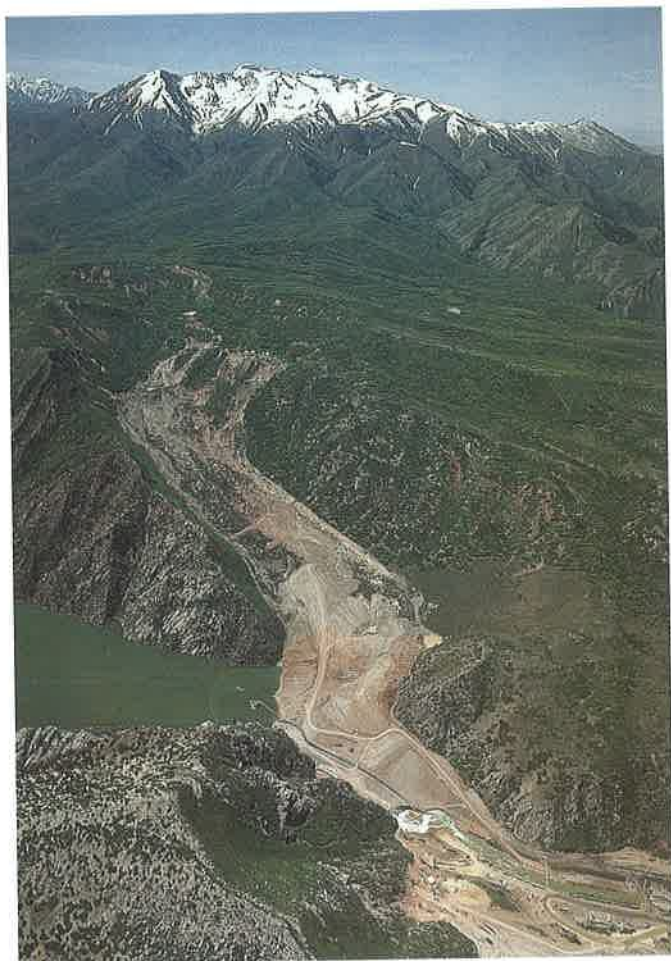
▲ **FIGURE 6.20** Thistle landslide, Utah. This landslide, which occurred in 1983, involved the reactivation of an older slide. The landslide blocked the canyon, creating a natural dam, flooding the community of Thistle as well as the Denver-Rio Grande Railroad and a major U.S. highway. (Michael Collier)

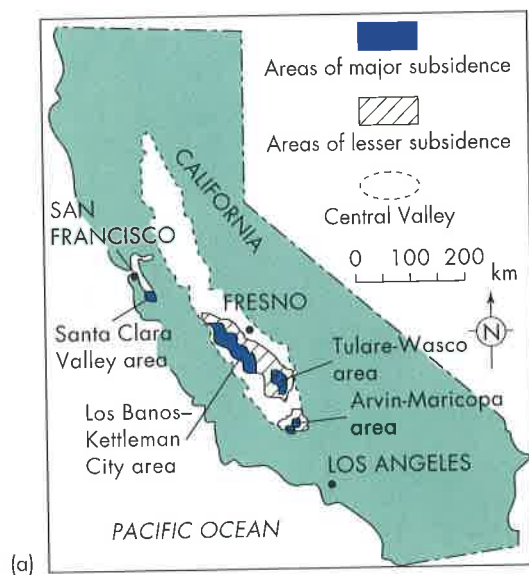
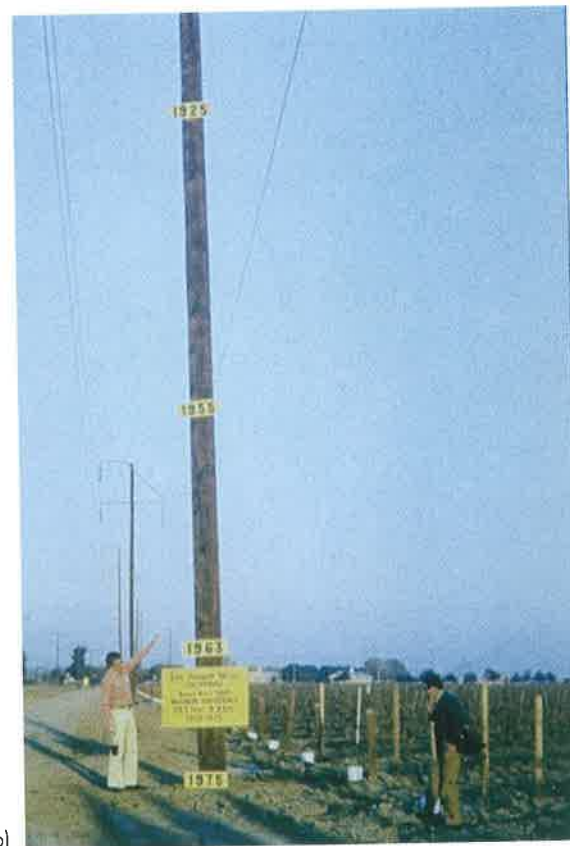
▲ **FIGURE 6.22** (a) Principal areas of land subsidence in California resulting from groundwater withdrawal. (After W. B. Bull, 1973. Geological Society of America Bulletin 84. Reprinted by permission.) (b) Photograph illustrating the amount of subsidence in the San Joaquin Valley, California. Marks on telephone pole are positions of the ground surface in recent decades. The photo shows approximately 8 m of subsidence. (Courtesy of Ray Kenny)

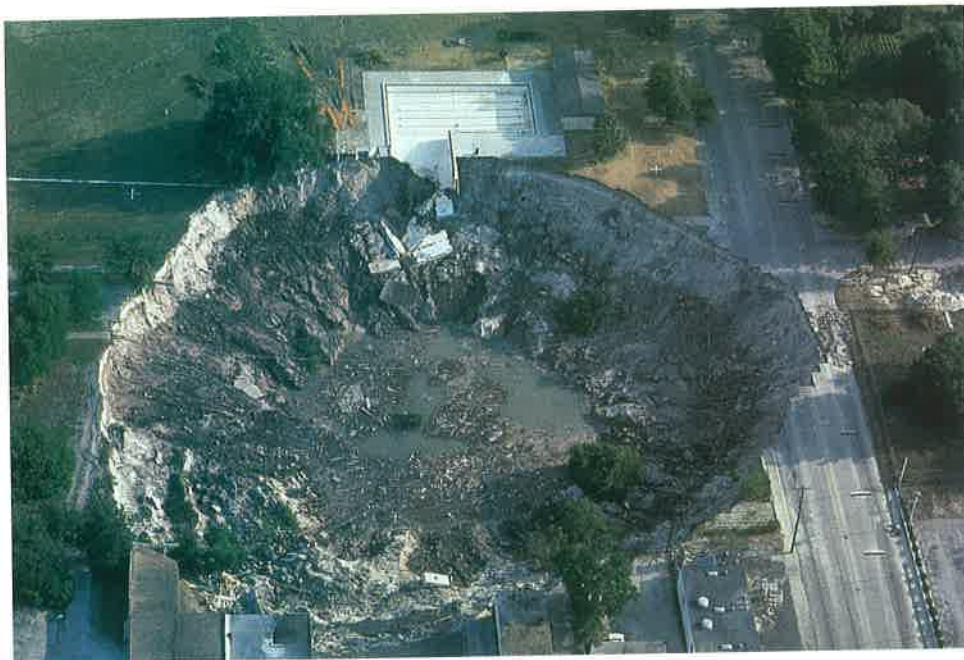
► **FIGURE 6.24** The Winter Park, Florida, sinkhole that grew rapidly for three days, swallowing part of a community swimming pool as well as several businesses, houses, and automobiles. (Leif Skoogfors/Woodfin Camp and Associates)

The Winter Park sinkhole formed during a drought, when groundwater levels were at a record low. Although exact positions cannot be predicted, their occurrence is greater during droughts; in fact, several smaller sinks appeared at about the same time as the Winter Park event.
