Abstract

Hydraulic Connectivity of Floodplains and Channels: River Restoration Strategies in the Willamette Valley

Will Edwards Jr., Earth and Physical Science Department, Western Oregon University, Monmouth, Oregon, 97361 Email: wedwards13@wou.edu

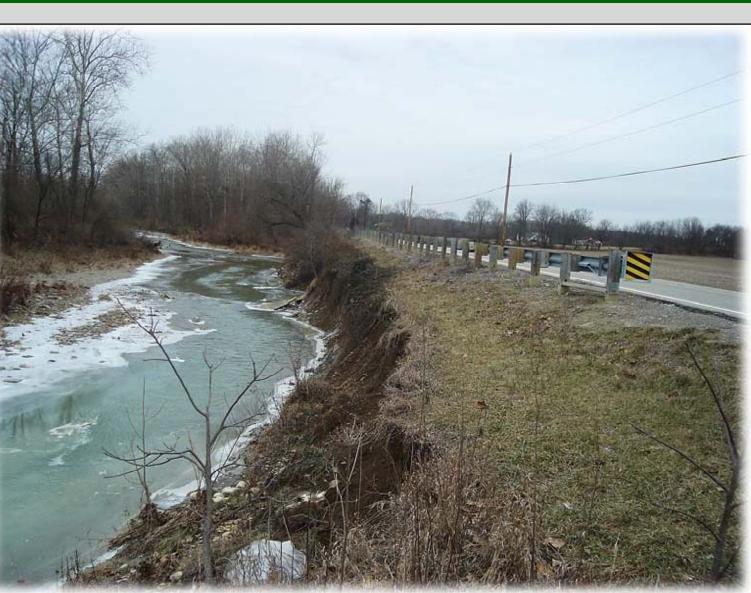
Figure 2. streamlined river erodes banks by a highway that cross cuts its floodplain

Solution: Installing large-woody debris structures into the river will secure a low energy environment by interrupting the moving current. These interruptions will create scour pools directly downstream from the debris, provide shaded shelter and resting points for migrating salmon. The interrupted stream will begin to deposit sediment in these scour pools which will begin the construction of natural gravel bars and banks for riparian vegetation.

Problem: For 100 years streams have been shortened and cleared out to allow the quick and unobstructed removal of timber by loggers and waste removal from cities. The removal of this woody debris has increased the speed of streams in the Willamette valley. With increased speed comes increased bank erosion, down cutting and widening of streams. This leads to prematurely abandoned floodplains and loss of riparian vegetation and the habitat between river and land, like gravel bars and wetlands.

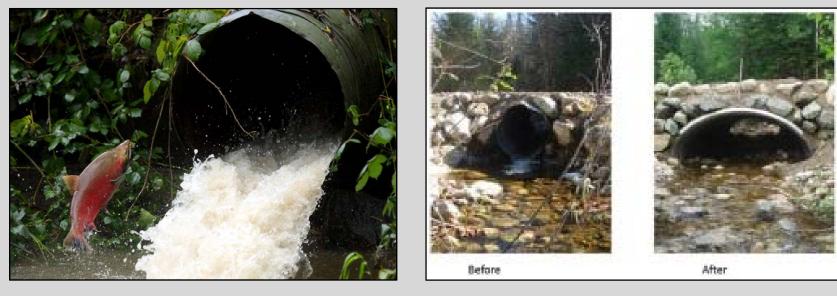
Figure 4. Effects of culverts on fish passage.

Culverts beneath roads cause backups on the upstream side of the road, creating swampy, stagnant environments, while downstream the narrow culvert bottle-necks the stream creating a high pressure release of water which erodes the bed directly beneath the culvert. Given enough time and a culvert will erode the bed below water level and it becomes a hanging culvert; restricting fish passage (Fig. 4). Expansion of road culverts will lessen the bottle neck effect that they have on fish passage.
