# Forest engineering implication of storm-induced mass wasting in the Oregon Coast Range, USA

Charles L. Rosenfeld

*Department of Geosciences, Wilkinson Hall 104, Oregon State University, Corvallis, OR, 97331-5506, USA*

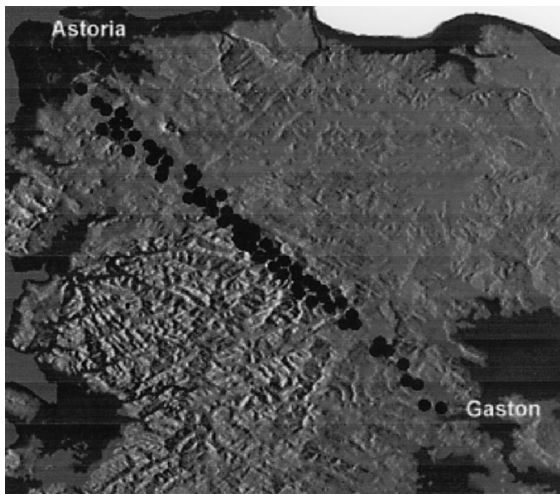
Fig. 1. Shaded relief map of the survey area, showing the location of 71 mass wasting events observed along the 109-km transect from Gaston to Astoria, OR, USA.

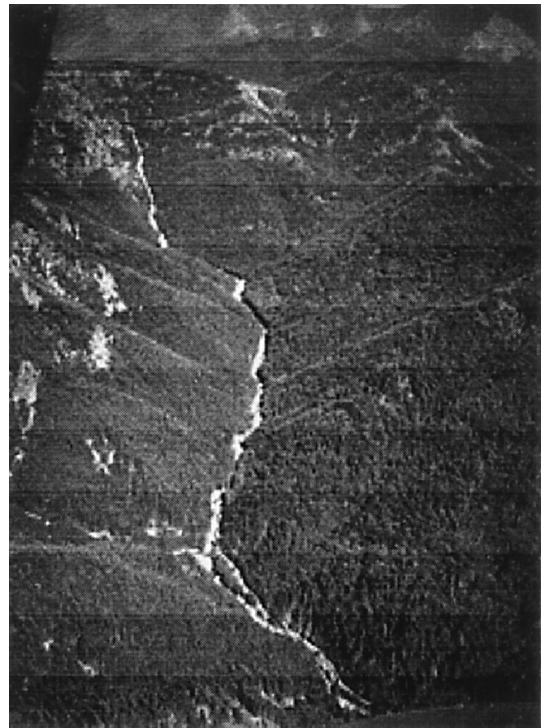
Fig. 2. View of a large debris torrent which scoured the channel of a perennial stream in the Upper Nehalem River watershed for a distance exceeding 3500 m.

Over half of the events observed were shallow debris slides or torrents. Typically, these events occurred on steep slopes ( $> 30^\circ$ ) and were predominantly associated with sedimentary bedrock. Depth estimates range from 2 to 5 m, with maximum length exceeding 3000 m (Fig. 2). Topographically, 71% of the debris slides originated in swales along steep slopes, with 32% of the events delivering sediment to ephemeral channels with over 50% directly impacting perennial channels. These impacts include both channel scour (sometimes exposing bedrock) and deposition of landslide and large organic debris. Since these events were precipitation-induced, the

flow in the channels was sufficient to ‘wash’ the landslide debris, and no channel impoundments were observed. Although these events resulted in significant turbidity along the affected streams, most perennial channels quickly developed gravel bars and pools along their affected reaches (Fig. 2). In some cases, however, ephemeral channels along slopes were scoured into bedrock sluices (Fig. 3).

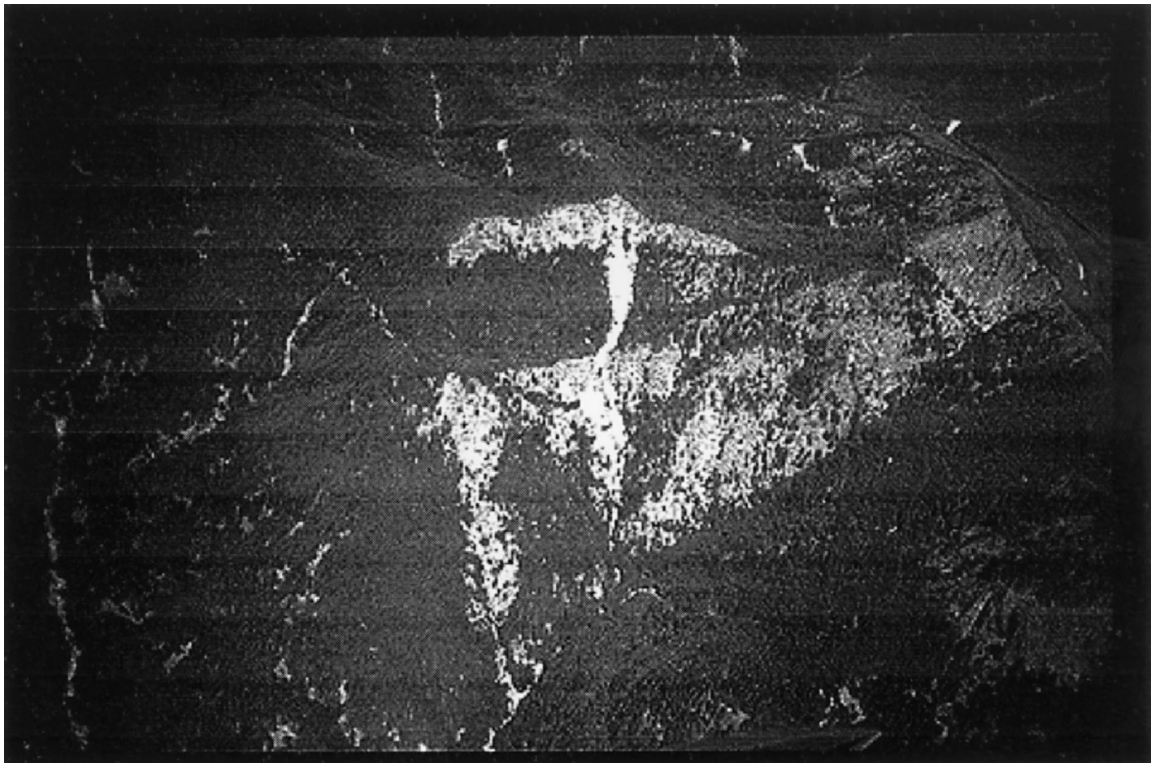
Fig. 3. Multiple shallow slides and debris torrents are seen here in a photo over the sedimentary terrain near the middle of the survey transect.

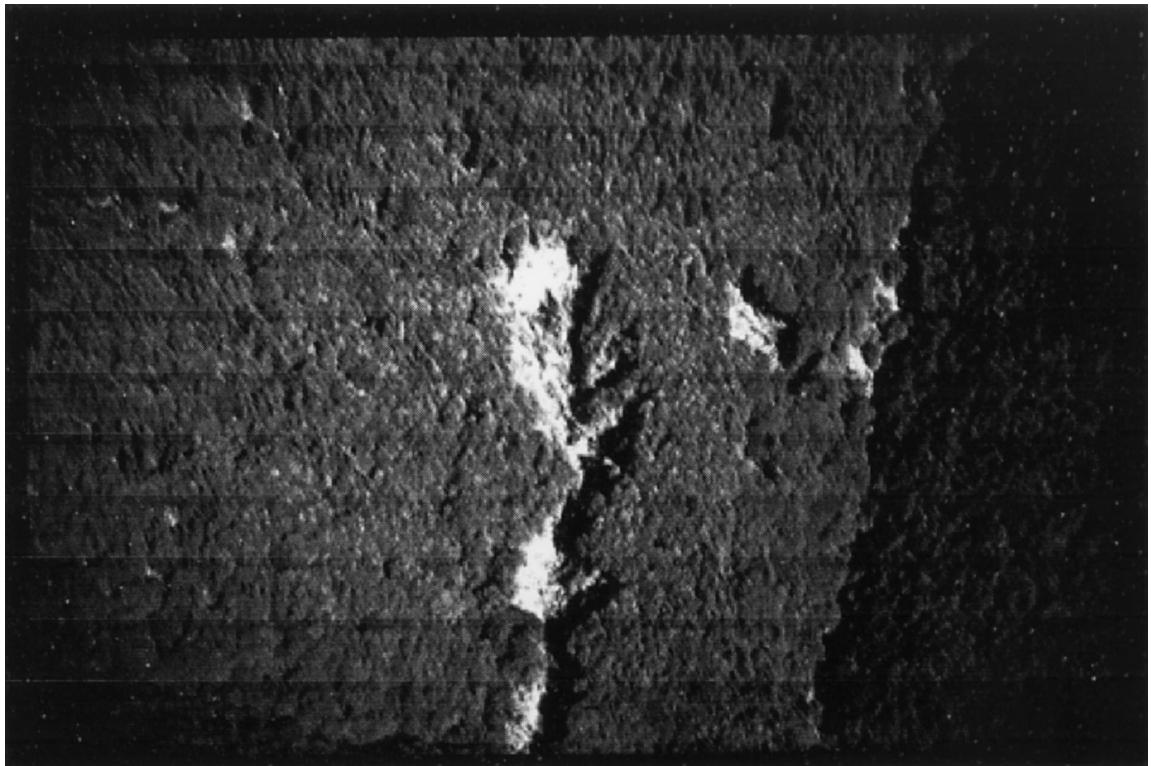
Fig. 4. Shallow slides dominate the slope in the center of this image, while toppled trees give evidence of saturated bank failure along the channel at the right.

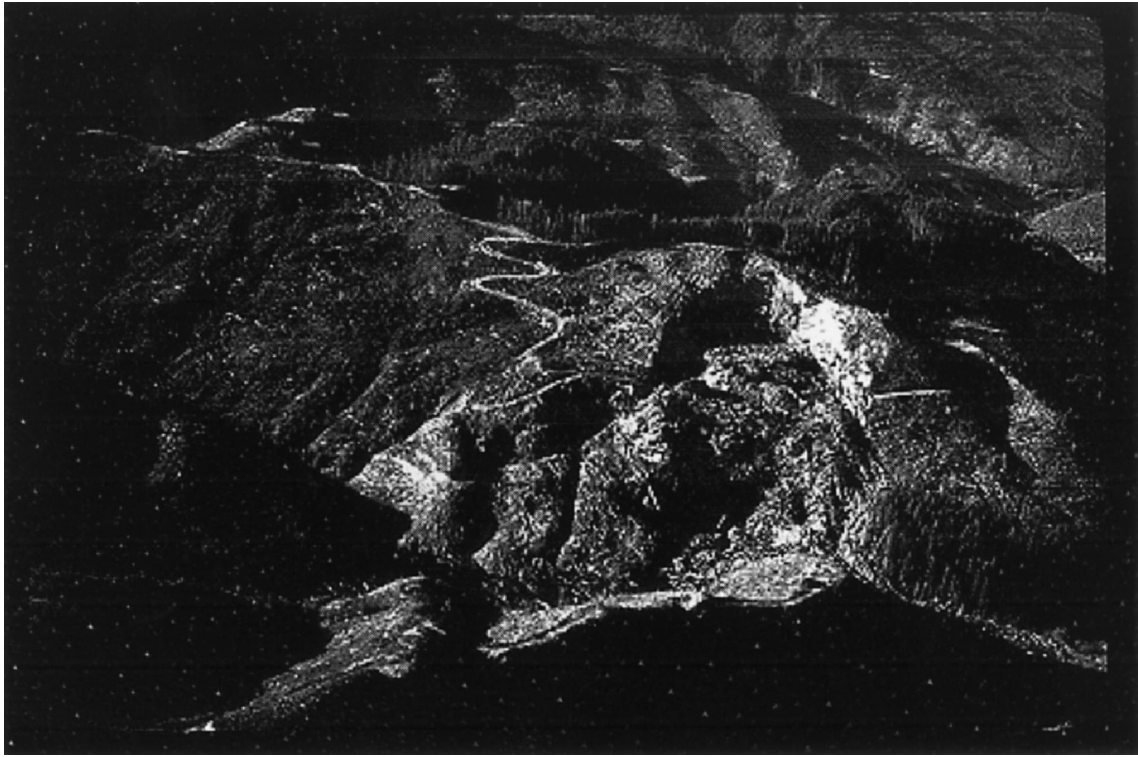
Fig. 5. An earlier slump-earthflow with evidence of subsequent motion is typical of deep-seated failures whose response to precipitation events is difficult to document.

Deep-seated slump/earthflow failures occurred in only 9% of the observed events, and all, but one, were along a slope underlain by soft sedimentary rocks. Whether these were new failures or re-activations of earlier events is unclear (Fig. 5), although each exhibited signs of recent deformation and sediment contribution along its flanks. Undoubtedly, movements along many such previous failures probably went 'undetected' in our survey.

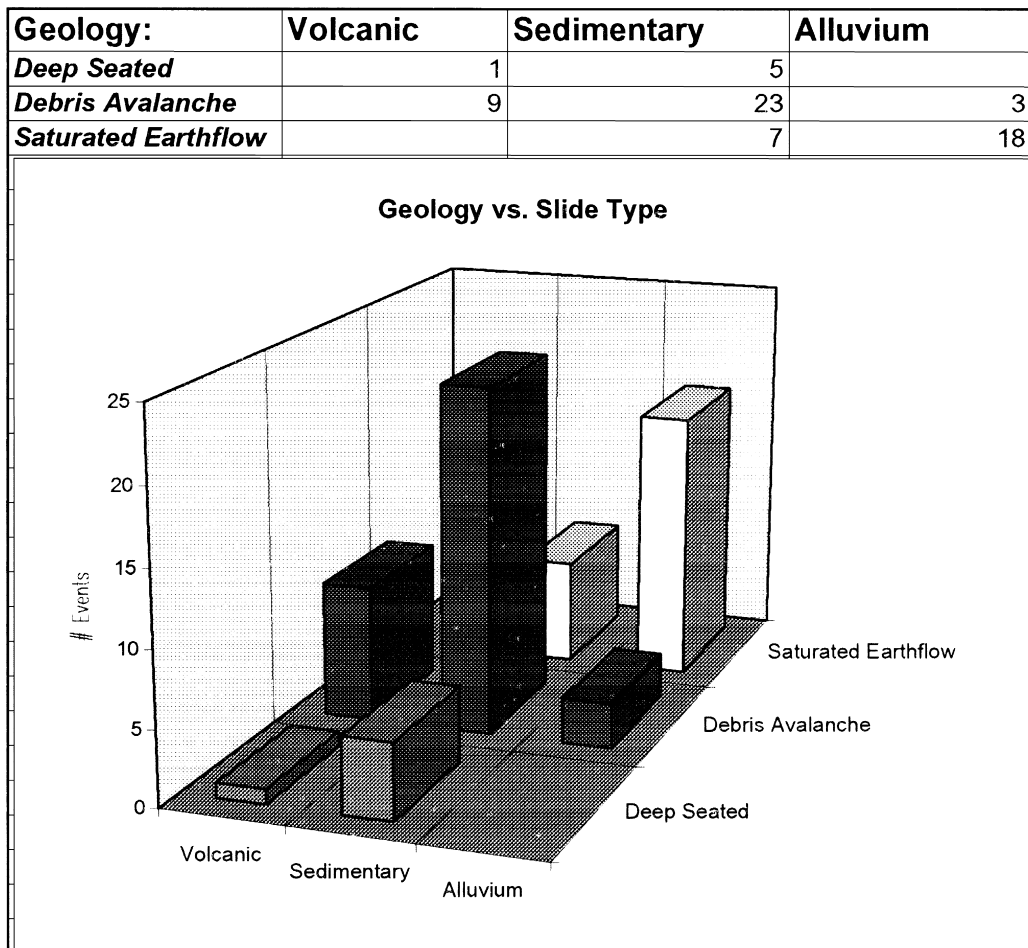
Fig. 6. The relationship of bedrock type to failure mechanisms in the events observed in this survey.

Some very clear relationships related to the mechanics of the individual events are seen in Fig. 6. Almost all occurrences of alluvial material failures were classed as saturated earthflow and bank failures of slow to moderate motion rates. Although most rapid debris slides/avalanches occurred in sedimentary bedrock areas, these failures evenly reflect the distribution of volcanic and sedimentary bedrock types along our transect.

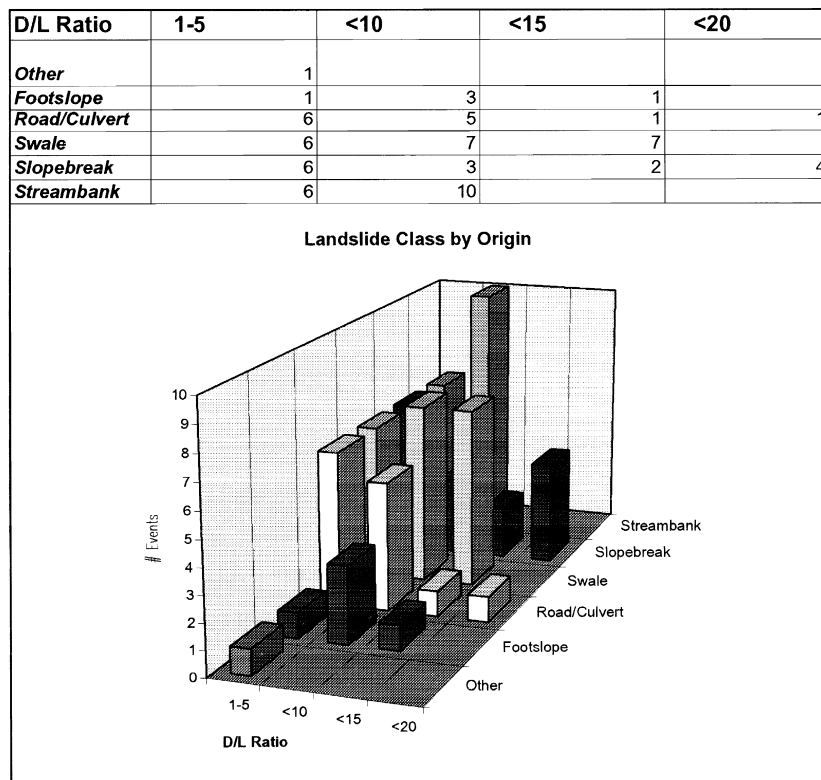
Fig. 7. The relationship of topographic position and roads to the depth/length ( $D/L$ ) ratio.

events (Fig. 7). The classification ( $D/L$  ratio) index of Crozier (1973) was used to further explore the relationship between the morphometry of the landslide events and the topographic position and forest cover type of the initial failure (Fig. 8). The classification index is based on length measurements and depth of failure estimates. Although the videography may be viewed in 'stereo', the depth estimates are rough at best. We estimated shallow failures at  $< 2$  m, intermediate depths at 5 m, and deep-seated failures at  $> 10$  m. This divides topographic position into six classes: roads and timber harvest landing areas; significant breaks in slope of greater than  $15^\circ$ ; swales along valley-side slopes; footslope areas with colluvial transitions to valley bottoms; lower banks adjacent to stream channels; and other locations such as divides or debris fans. Drainage swales and bedrock-controlled 'slope breaks' dominated the failure areas on 'natural' slopes, with man-made sites (mainly roads) contributing 42% of the total slope

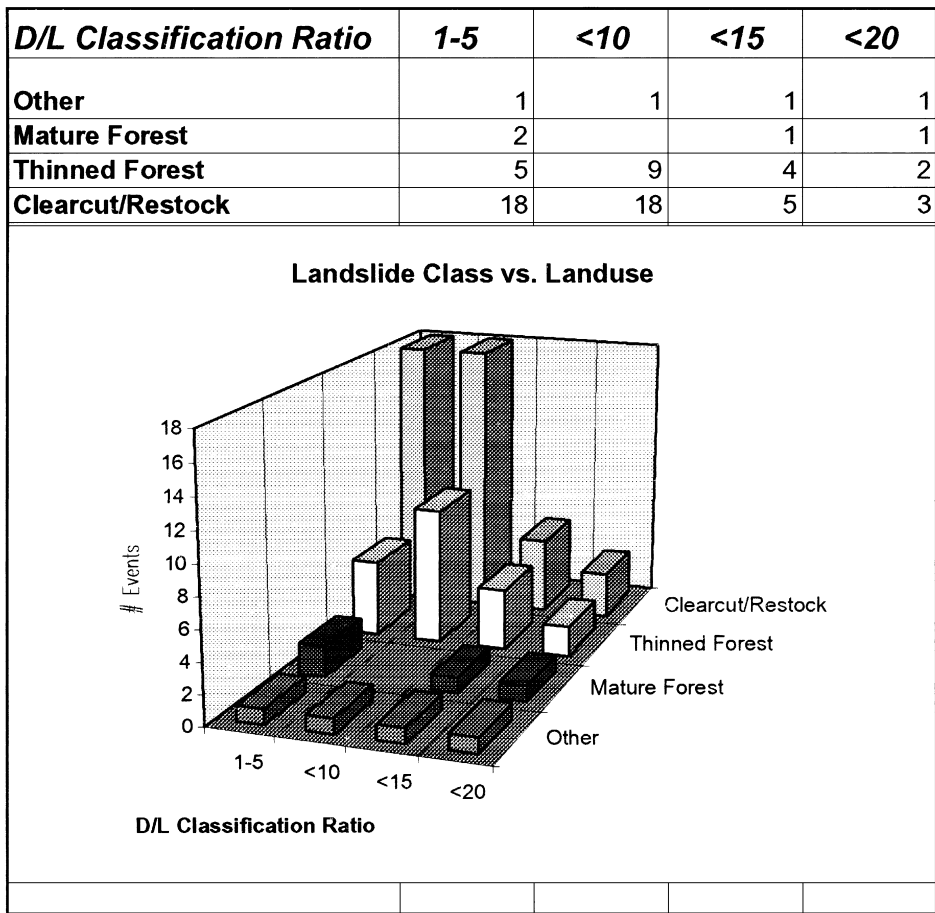
Fig. 8. The number of events in each landslide class by land cover characteristics.

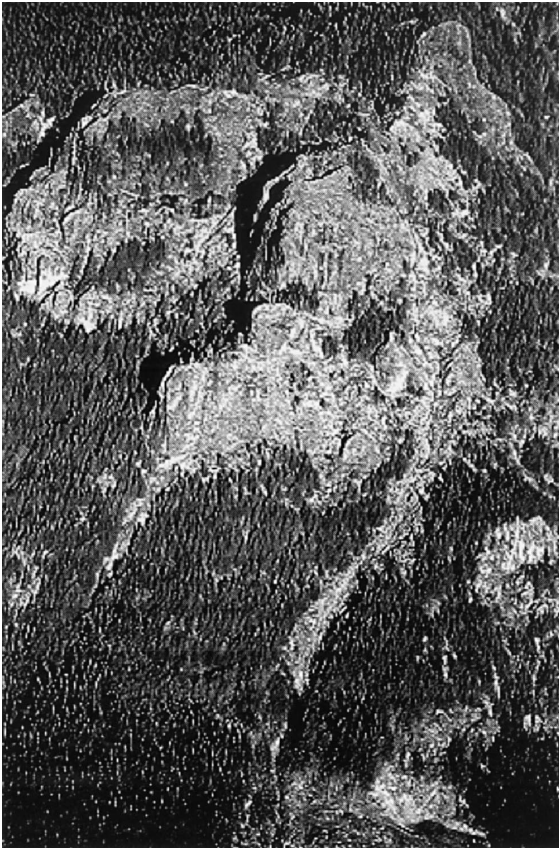
Fig. 9. A rockfall-debris avalanche in steep volcanic terrane.

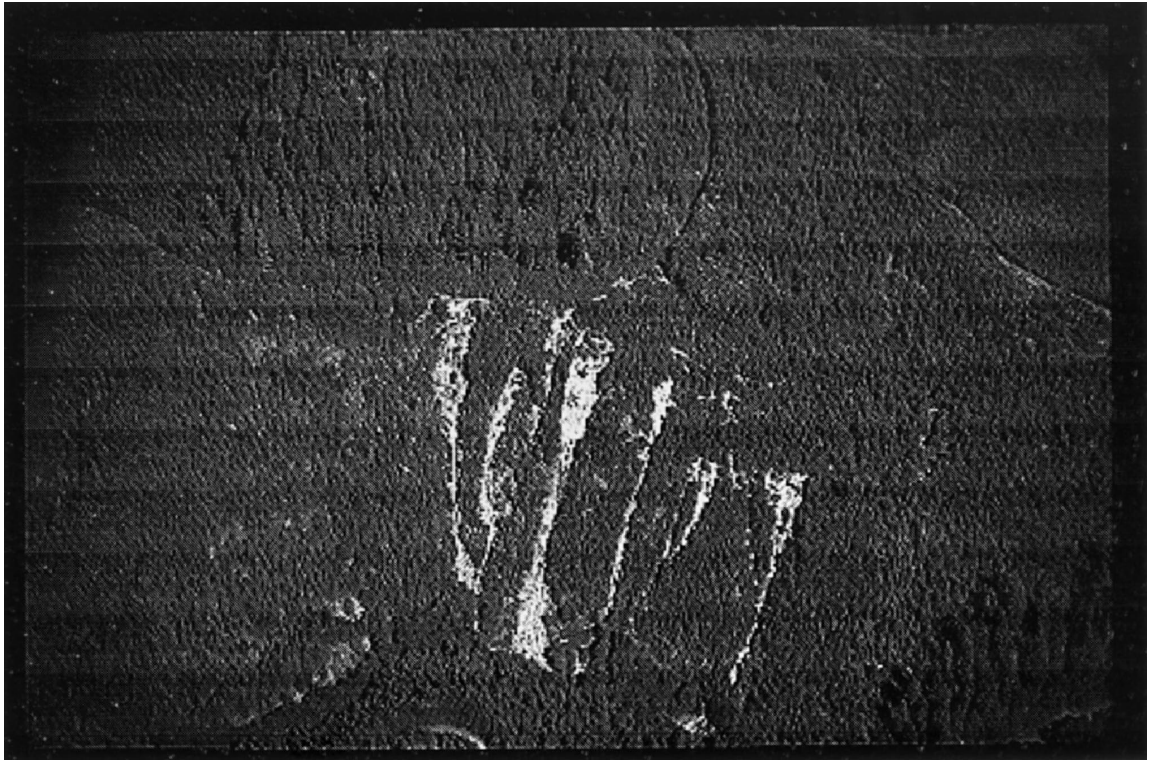
Fig. 10. Multiple debris avalanches occurring in adjacent swales along a sandstone ridge.

Failures along drainage swales tended to occur along the upper slope, just below Horton's zone of 'no erosion' (Fig. 10). All of these occurrences were observed in areas of managed forest, with the larger volume slides associated mainly with thinned middle-aged stands. It is unlikely that observational error would account for this relationship, and the author suggests that wind-toppled trees exposed deeper 'root throw' on the older stands, resulting in larger volume debris torrents and avalanches. Elevation and aspect played an apparently significant role in shallow debris slides, with north-facing slopes accounting for nearly 80% of the slides above 800 m. This is attributed to frost heave which effectively decoupled surface soils when the warm rains saturated the ice-needle-inflated surfaces.

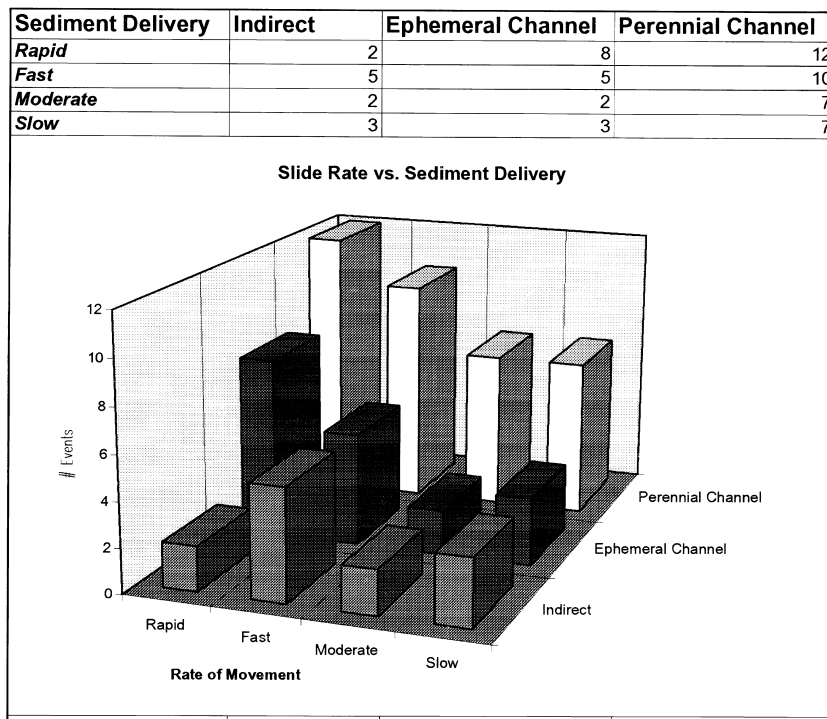
Fig. 11. The effects on sediment delivery by estimated velocity of the event.

To understand the implications of these storm-induced failures upon watershed values, the contribution of debris directly to ephemeral and perennial channels was recorded (Fig. 11). Direct sediment contribution to channels occurred in 83% of the total number of events in our survey. Given the precipitation intensity at the time of the storm, it may be assumed that active flow was occurring in all of the channels surveyed. However, channel flow normally does not occur in the small first- and second-order channels during the drier summer months, and such channels were noted in our observations. Neither size of the event, nor the velocity (which would extend its effects along a channel) had any apparent relationship with the types of channels affected. In other words, channels of all orders were apparently directly affected by mass wasting in equal proportion. Mass wasting debris deposited by a storm in February will be washed by higher winter flow discharges which wash away fine sediment, leaving the gravel and cobble fraction as bars and riffles (Fig. 12). Although the short-term turbidity resulting from this sorting process may inhibit anadromous fish migration up the streams, the resulting gravel beds and

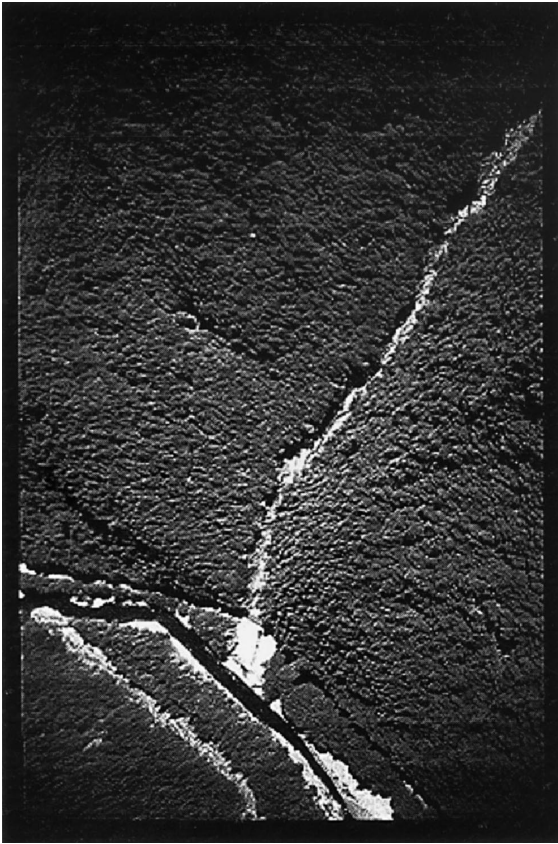
Fig. 12. A debris avalanche 'track' carried a large volume of material across the floodplain, and formed new bars downstream in the perennial channel.
