# Cascadia Deep Earthquakes

## 2008

Cascadia Region Earthquake Workgroup  
Sharing Information to Promote Mitigation

Also published as Open File Report 2008-1 by the Washington Division of Geology and Earth Resources

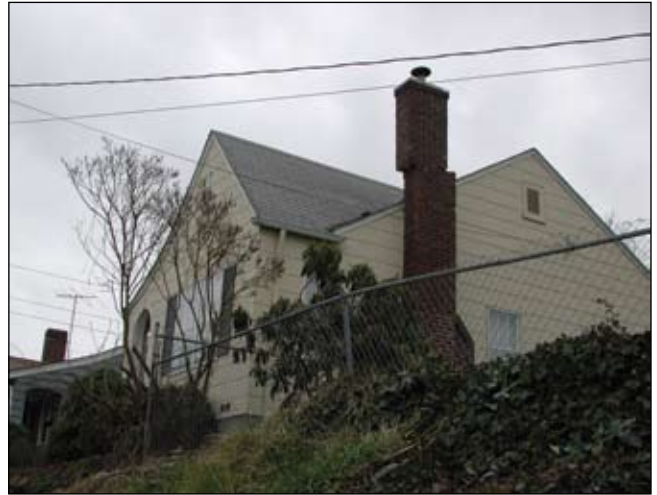
Chimney failures are a common problem for homeowners after an earthquake. The above chimney did not fall but remained a safety hazard until it was rebuilt. Photo: Michael Polenz, DGER

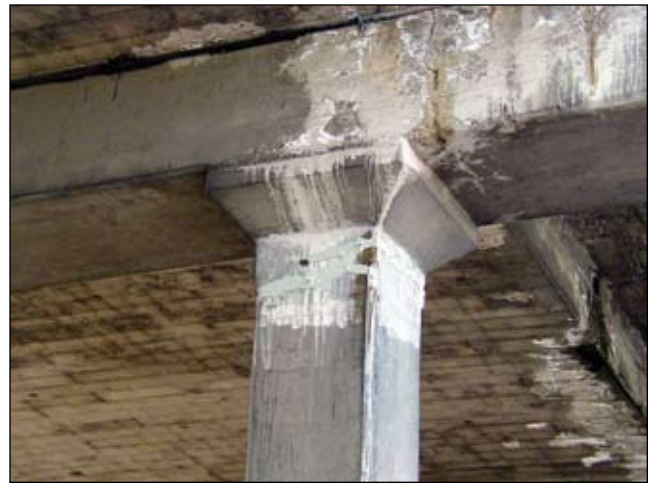
**The South Park Bridge in Seattle suffered extensive damage. Above is one of 22 columns that cracked in the earthquake. Epoxy was injected to shore up the structure. Crews worked round the clock to repair this and other structures throughout the area. Photo: King County**

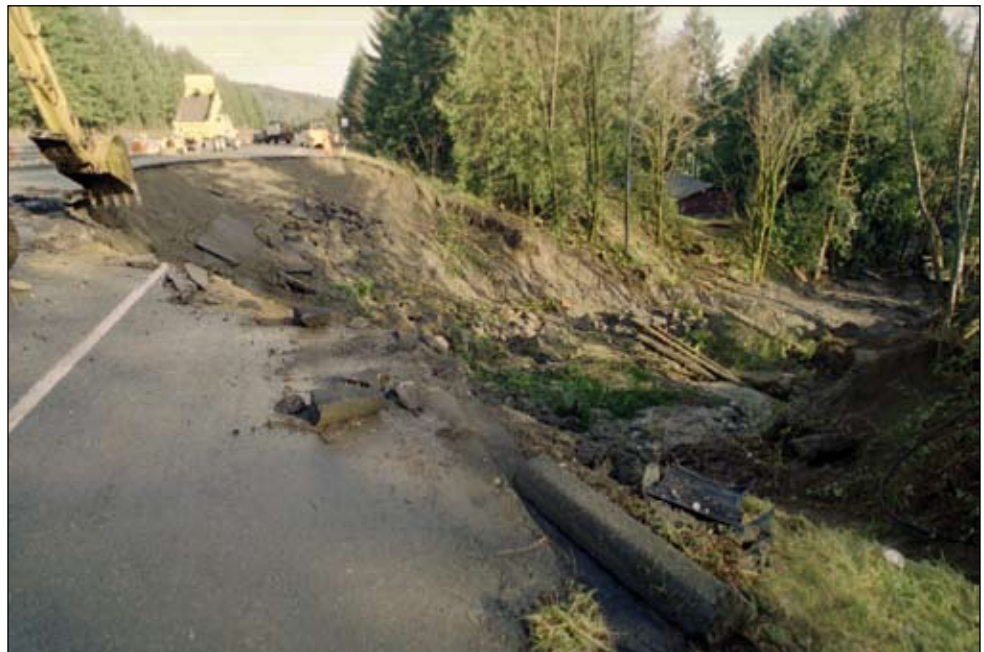
**Liquefaction, lateral spreading, and landslides damaged many roads throughout the area. Photo: William S. Lingley, DGER**

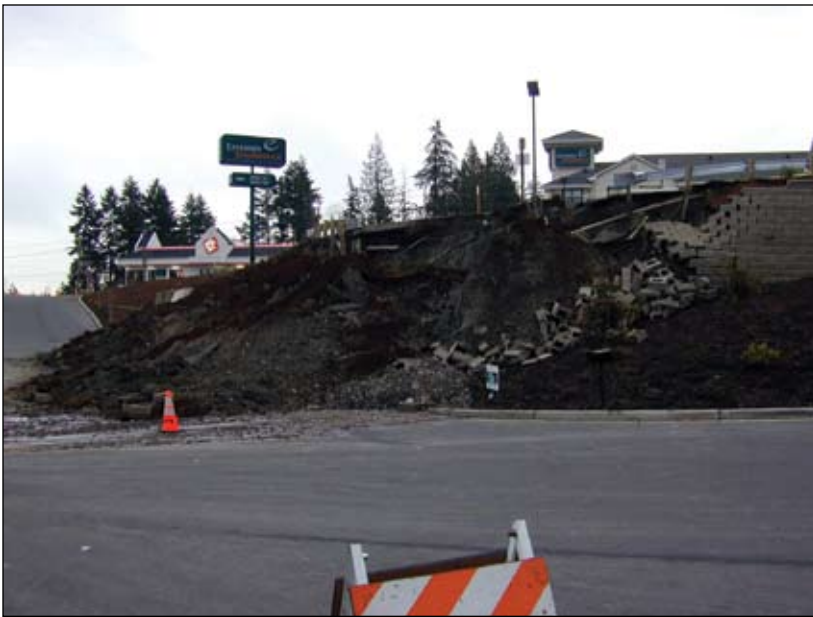
Liquefaction and landslides can break utility lines as well as damage roads and property. With widespread damage, repairs may take longer than expected. Photo: Robert J. Reid

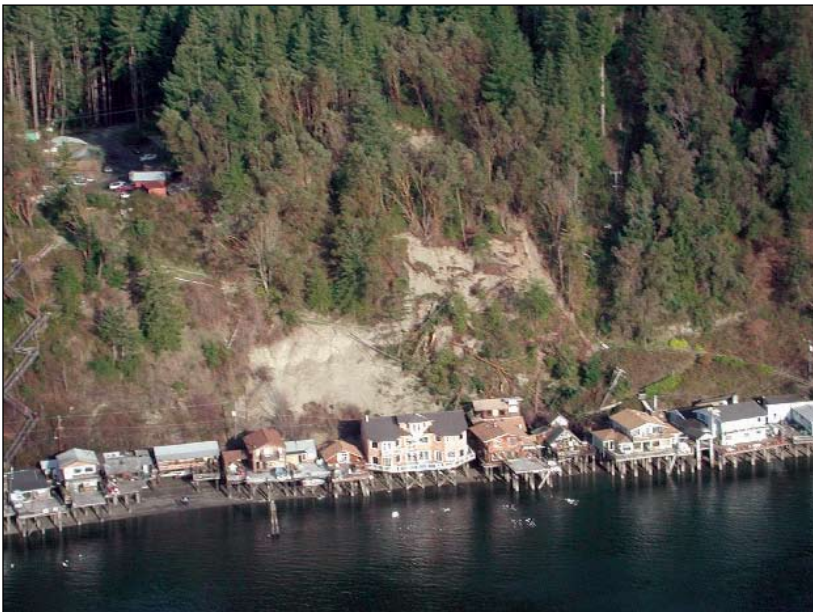
Salmon Beach, near Tacoma, was the site of a landslide three days after the 2001 earthquake. The same hillside slid after the 1949 event. Photo: Dave Sherrod, USGS

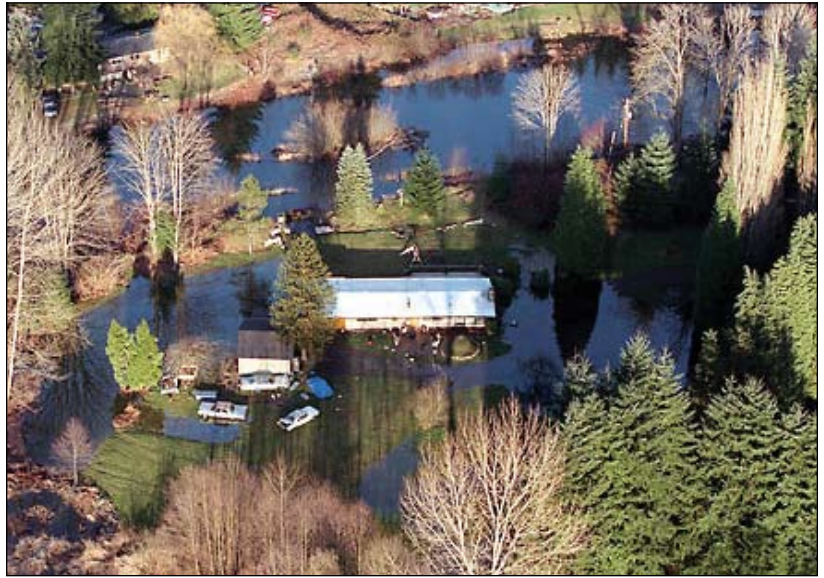
**A landslide dammed the Cedar River, resulting in flooding that damaged two houses. Photo: King County**

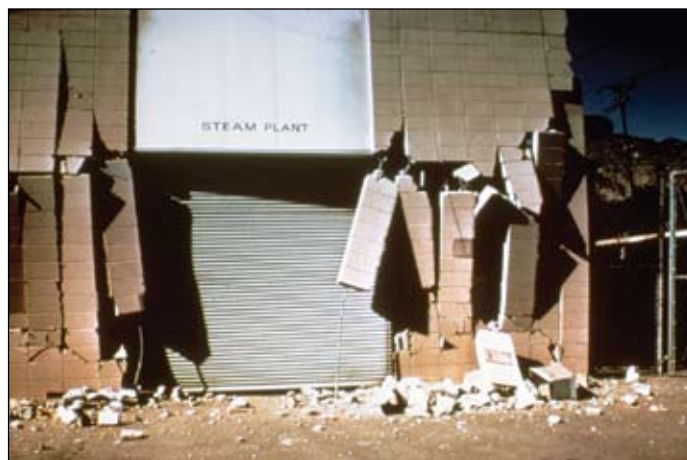
**The 1971 San Fernando earthquake substantially damaged these Juvenile Hall facilities. A portion of the two-story administration building collapsed completely into the first story. Photo: E.V. Leyendecker, USGS**
