GROUND FAILURE ASSOCIATED WITH THE PUGET SOUND REGION EARTHQUAKES OF APRIL 13, 1949, AND APRIL 29, 1965

By Alan F. Chleborad¹ and Robert L. Schuster¹

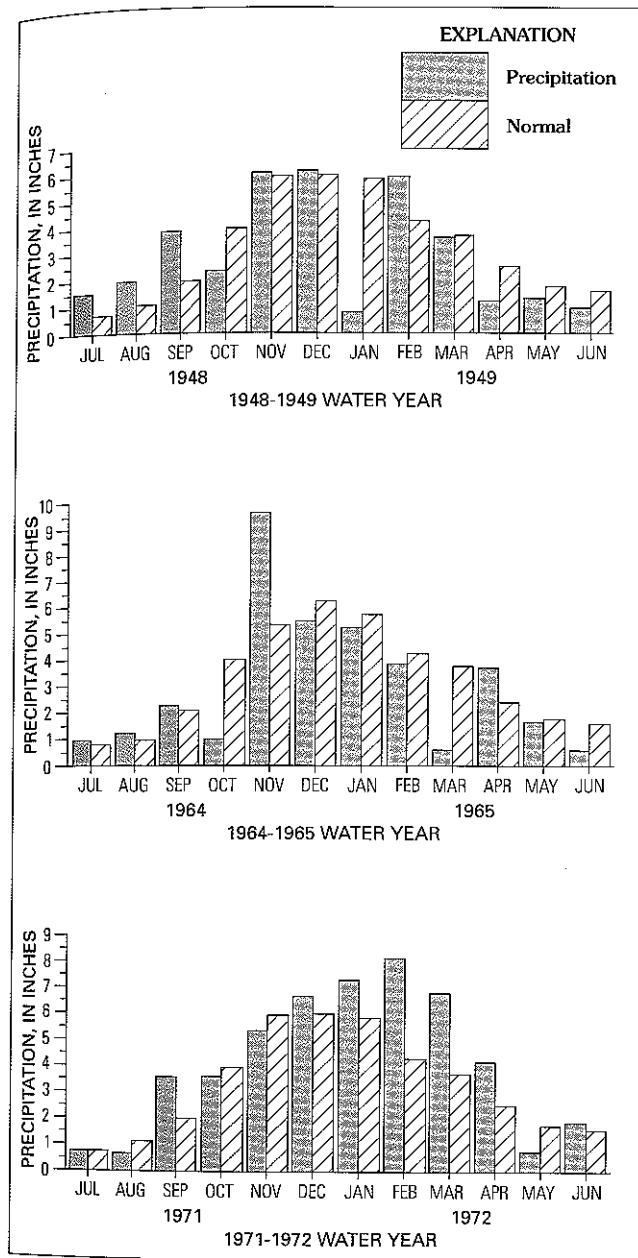
Figure 189. Graphs showing precipitation (1 inch equals 2.54 cm) in the Seattle-Tacoma area for the water years 1948-1949, 1964-1965, and 1971-1972 (U.S. Department of Commerce, 1948, 1949, 1964, 1965, 1971, and 1972).

Tacoma area for the water years 1948–1949 and 1964–1965 (those associated with the 1949 and 1965 earthquakes) are shown in figure 189. These water years were slightly below normal; 8.66 cm below normal in 1948–1949 and 6.60 cm below normal in 1964–1965. For the purpose of comparison, precipitation records from the Seattle-Tacoma area for the water year 1971–1972 (an unusually wet year) are also shown in figure 189. Precipitation during that year was 40.6 cm above normal. High precipitation was a major cause of

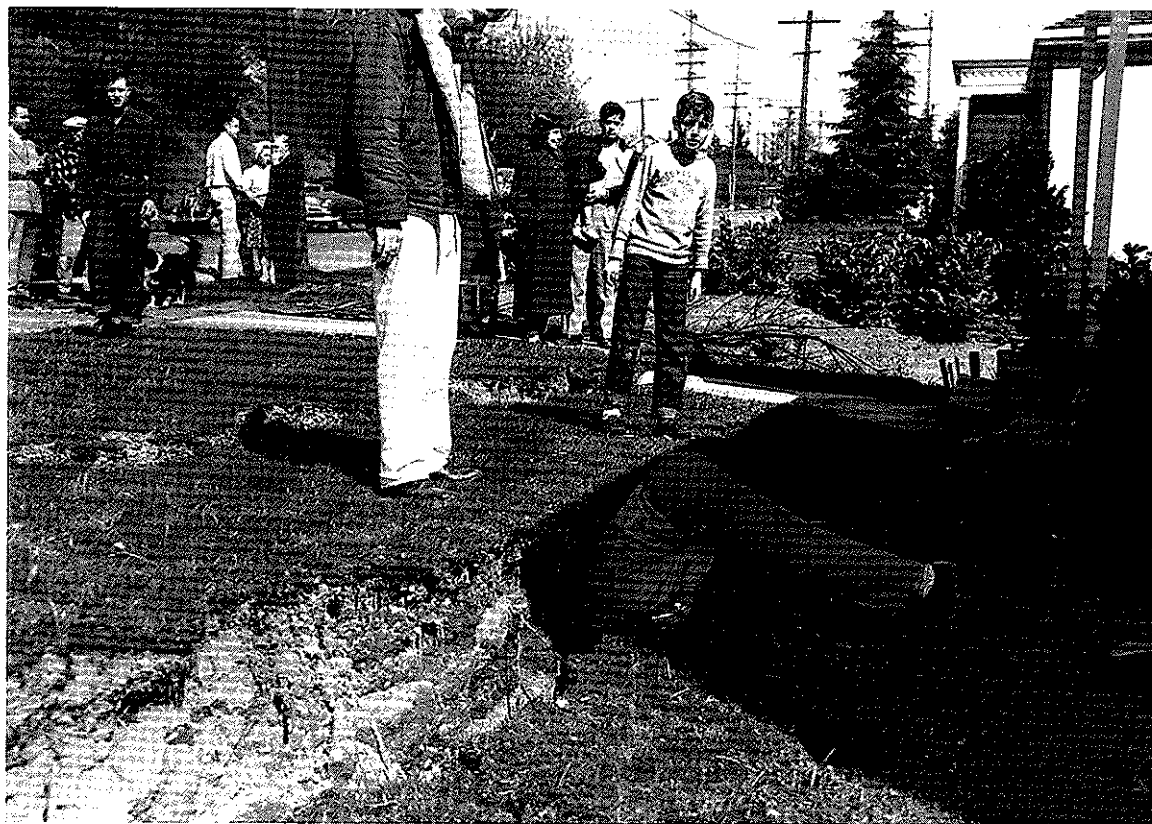
In West Seattle, the number of reported ground failures for the 1965 earthquake far exceeded those of the 1949 event. One of the most destructive 1949 ground failures was a slump that occurred on moderately sloping ground in artificial fill overlying the Esperance Sand Member of the Vashon

Drift (loc. 10; fig. 190). The failure reportedly damaged six homes, including four that were under construction (see damage description, table 29). Hillside residential property (loc. 13) in West Seattle was the site of minor ground cracking in 1949 and ground cracking and settlement in 1965. The proximity of that site to a steep bluff located near the head of a large mapped landslide (Waldron and others, 1962) suggests an incipient slope failure, apparently initiated by the 1949 quake and reactivated in 1965. Minor sliding also occurred in 1965 at a few other locations on steep to moderately sloping bluff areas on the east and west sides of West Seattle (locs. 8, 9, 11, and 12). Two of the 1965 slope failures were wholly or partly in artificial fill (locs. 8 and 11); the other three (locs. 9, 12, and 13) apparently involved the Esperance Sand Member and (or) overlying surficial debris. Most of the bluff areas that border West Seattle have been categorized as unstable with regard to slope stability (Washington Department of Ecology, 1979a). A common slope-failure process that occurs on the bluffs in West Seattle and in other parts of the city, especially during wet periods, involves the Esperance Sand Member and the underlying Lawton Clay Member of the Vashon Drift (Tubbs, 1974; Tubbs and Dunne, 1977). Ground water percolates downward through the Esperance Sand Member until it reaches relatively

Figure 190. Slumping and settlement in West Seattle (pl. 4, loc. 10) induced by the April 13, 1949, earthquake. The slumping exposed artificial fill (lower left) that underlies the site. Photograph from the Seattle Post-Intelligencer Collection, courtesy of the Museum of History and Industry, Seattle, Wash.

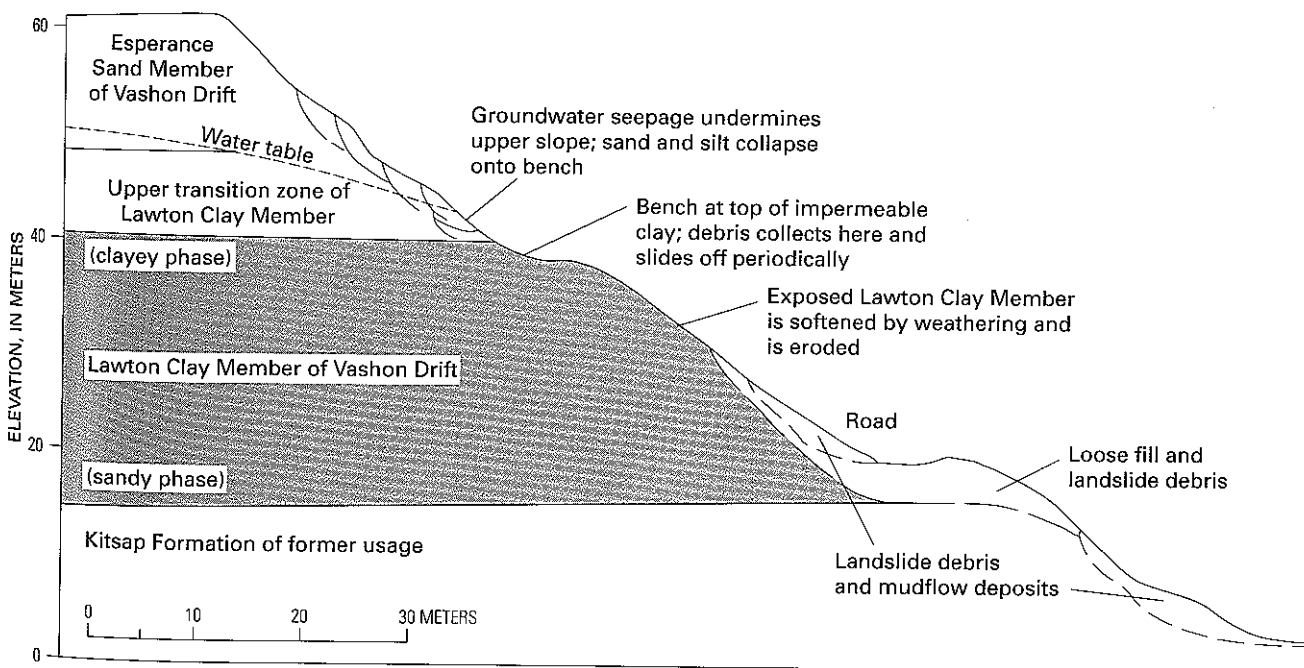
Figure 191. Cross section of a West Seattle bluff showing conditions associated with slope failure (from Tubbs and Dunne, 1977).

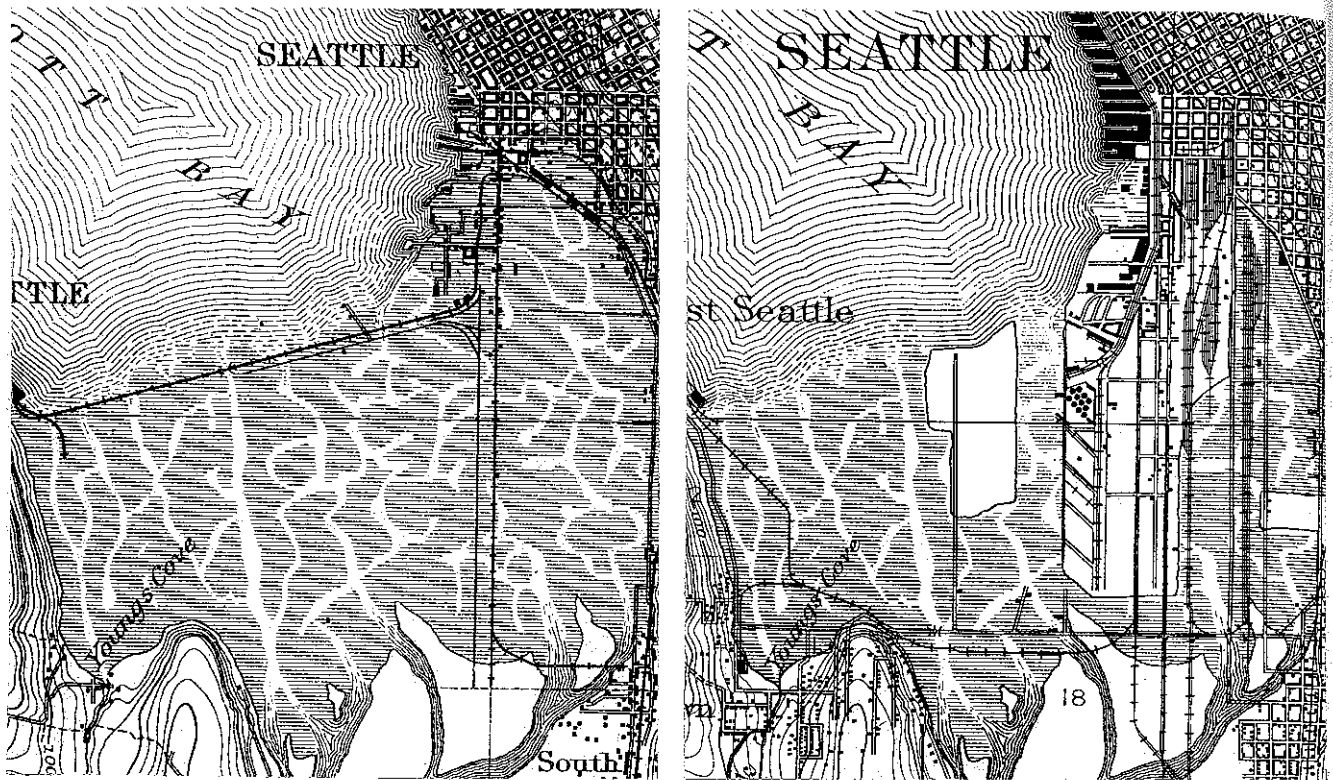
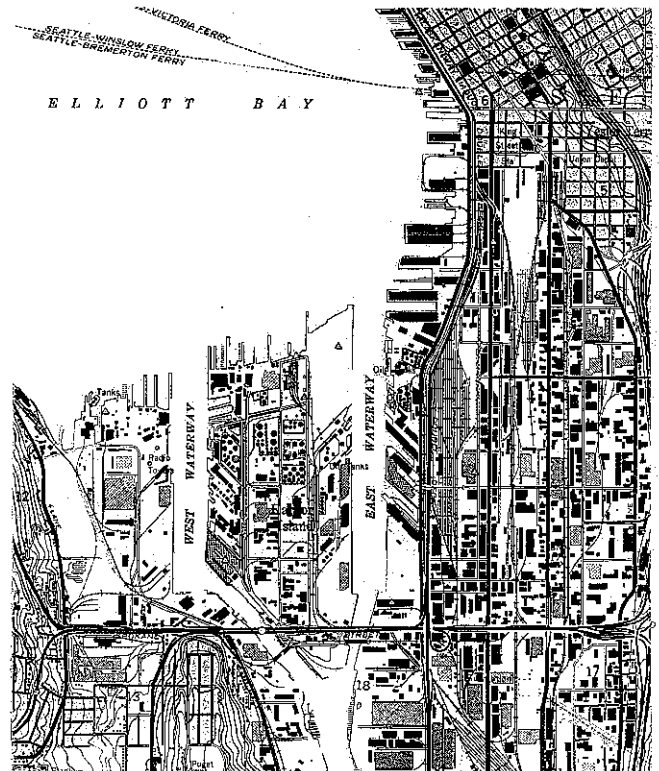
Figure 192. Maps showing the sequence of development of the former tidal flats area at the mouth of the Duwamish River, Seattle, between the years 1893 and 1973. Since 1893, the tidal flats have been extensively covered by artificial fill to allow waterfront development. The area was the site of many earthquake-induced ground failures and considerable property damage in both 1949 and 1965. From U.S. Geological Survey (1894, 1909, and 1949 (photorevised 1968, 1973)).

The Duwamish River–Harbor Island–Elliott Bay waterfront area lies just to the east of West Seattle (pl. 4). The area, much of which is a former tidal flat (fig. 192), was extensively artificially filled (Waldron and others, 1962) to provide real estate for industrial and commercial interests along the waterfront. Structural damage was substantial in this area in both the 1949 and 1965 earthquakes (Edwards, 1951; Mullineaux and others, 1967). The heaviest building damage in Seattle related to the 1965 earthquake occurred in this area, from the lower downtown business district south to about Spokane Street (Mullineaux and others, 1967). A considerable amount of the 1949 and 1965 damage was related to ground failure (table 29, locs. 14–25 and 28). Ground-failure displacements ranged from a few centimeters to about a meter, but most were less than 30 cm. Direct evidence of liquefaction of sediments is provided by reports of sand boils produced by the 1949 earthquake on the west side of the West Waterway (loc. 19), on Harbor Island (loc. 21), and adjacent to the Elliott Bay waterfront (loc. 25), and by the 1965 earthquake at locations 24 and 25 adjacent to Elliott Bay. Incipient lateral spreading or slumping, indicated by lateral as well as vertical displacements, occurred at locations 15–17 north and south of Spokane Street (fig. 193) in

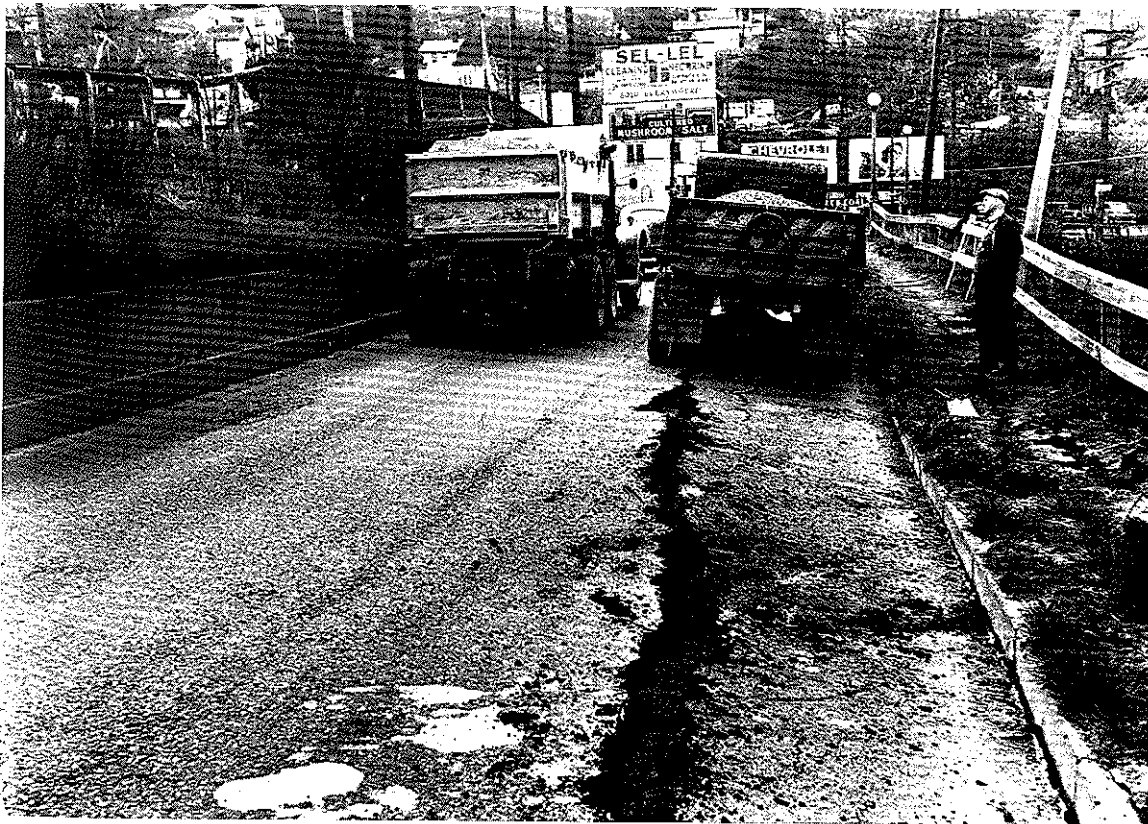
1949 and north of Spokane Street (locs. 18 and 22) in 1965. There were many reports of settlement in the waterfront area in both 1949 and 1965 (pl. 4; table 29) that may have resulted from consolidation of sediments, incipient landsliding, or both. All this evidence indicates that many locations within the Duwamish River–Harbor Island–Elliott Bay waterfront area are highly susceptible to damaging ground failure during intense seismic shaking and that there is a high susceptibility to liquefaction of artificial fill and (or) underlying postglacial sediments in the former tidal flats area. Similar types of ground failure causing equal or greater damage can be expected in the event of future large earthquakes that cause intense ground shaking in the area.

Figure 193. Ground failure along Spokane Street approach to West Seattle (pl. 4, loc. 16) triggered by the April 13, 1949, earthquake. Pavement cracks and slight slump are in a road embankment composed of artificial fill. Note arcuate scarp and tilted light pole at right. Photograph from the Seattle-Post Intelligencer Collection, courtesy of the Museum of History and Industry, Seattle, Wash.

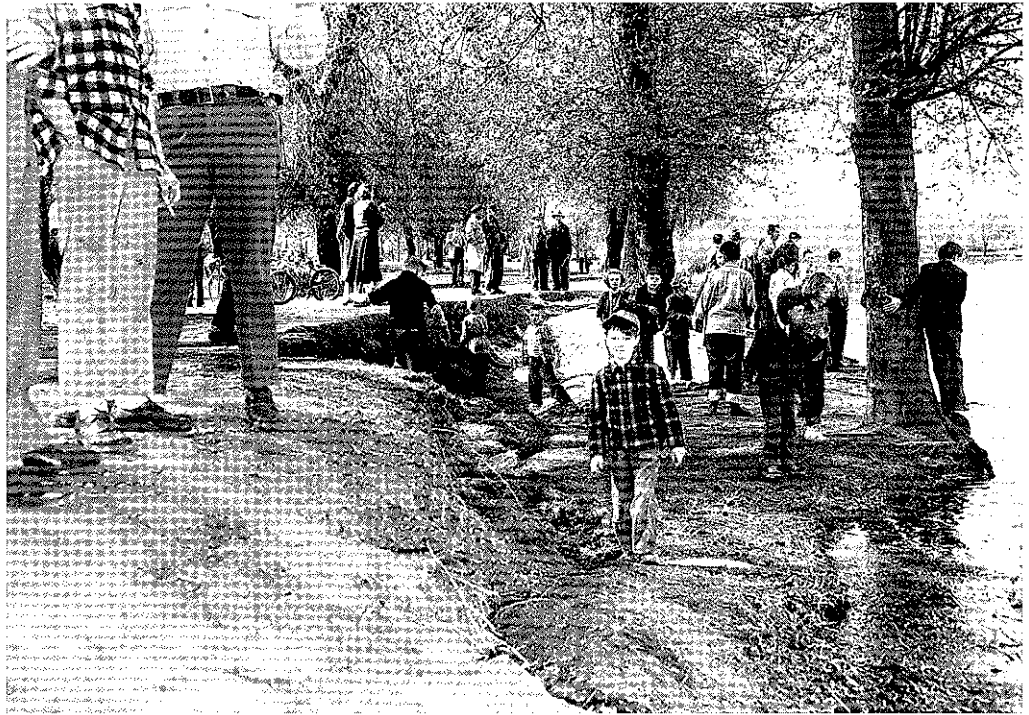
Figure 194. Slump along the shore of Green Lake, north of downtown Seattle. This 1949 earthquake-induced ground failure occurred near the south end of the lake (pl. 4, loc. 33) in an area that subsequently experienced ground failure during the April 29, 1965, earthquake. Photograph from the Seattle Post-Intelligencer Collection, courtesy of the Museum of History and Industry, Seattle, Wash.

Slumping and possible lateral spreading along the south shore of Green Lake (loc. 33; figs. 194 and 195) in 1949 apparently did little damage. Ground failure in the same area in 1965 damaged a small building, fractured walks and paving, and broke utility lines (Mullineaux and others, 1967). Possible liquefaction of sediments at the south end of Green Lake is suggested by the presence of loose granular sediments, the probability of a high water table in sediments at or below lake level, and the characteristics of some of the 1949 and 1965 ground failures that suggest incipient lateral spreading.

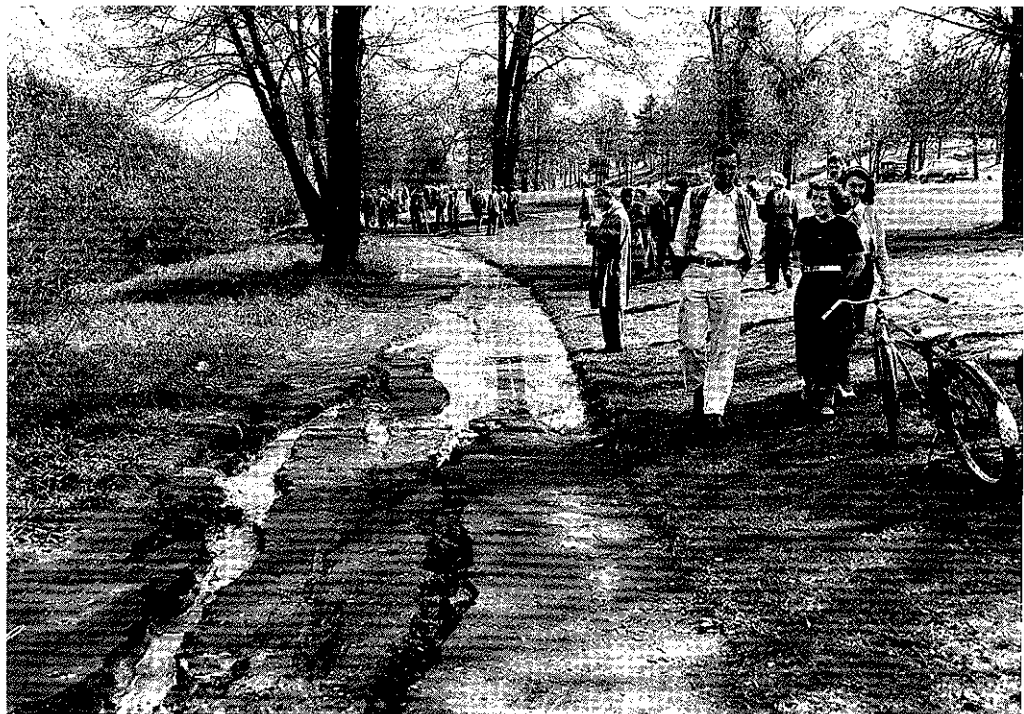
Figure 195. Ground cracks on the southeast side of Green Lake in north Seattle (pl. 4, loc. 33). The cracks opened during or shortly after the April 13, 1949, earthquake and probably resulted from subsidence and lateral movement of ground downslope toward the lake (out of sight to the left of view). Photograph from the Seattle Post-Intelligencer Collection, courtesy of the Museum of History and Industry, Seattle, Wash.

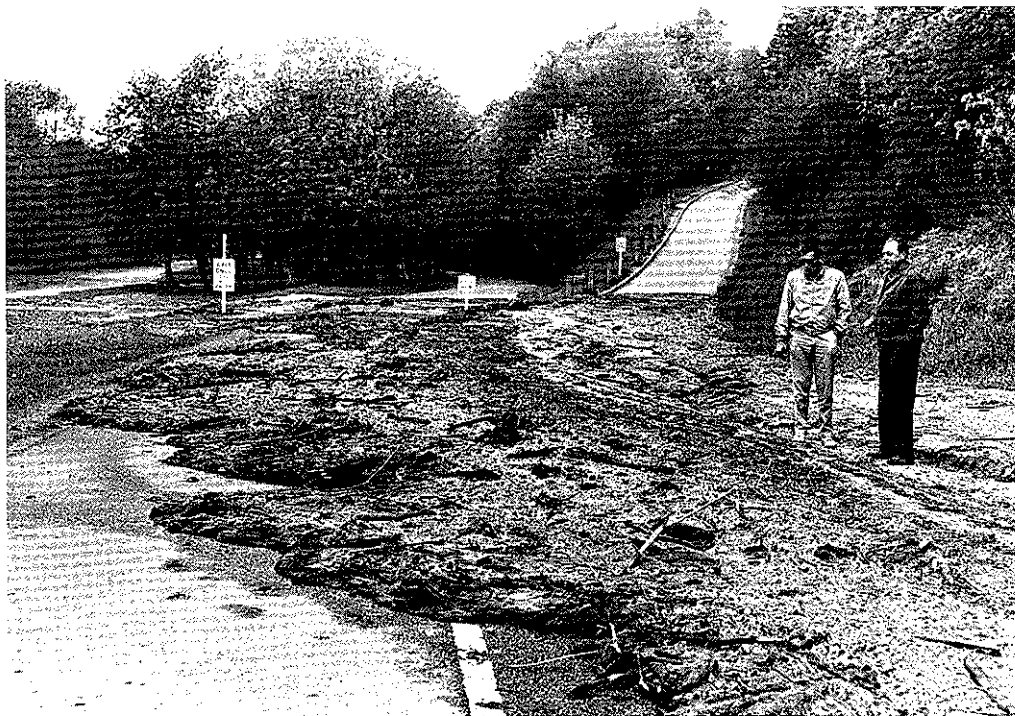
A hillside failure in north Seattle, triggered by the 1965 earthquake, evolved into a debris flow that covered a road in Carkeek Park (loc. 36, fig. 196). The flow originated in a

large ravine north of Piper Creek. The sides of the ravine are underlain by the Esperance Sand Member and undifferentiated nonglacial sediments (Washington Department of Ecology, 1979a). The *Seattle Times* (1965c) stated that the slide "opened a pool of ground water that roared down the creek," flooding the road with debris. Water from a small creek that flows down the ravine may also have mixed with the slide debris, adding to its mobility. The slide resulted in only minor damage to the park road.

Figure 196. Mudflow covering Carkeek Park Road in northwest Seattle (pl. 4, loc. 36). This mudflow developed as material from an earth slide triggered by the April 29, 1965, earthquake mixed with water and flowed down a Piper Creek tributary ravine. Photograph used by permission of the *Seattle Times* Co.

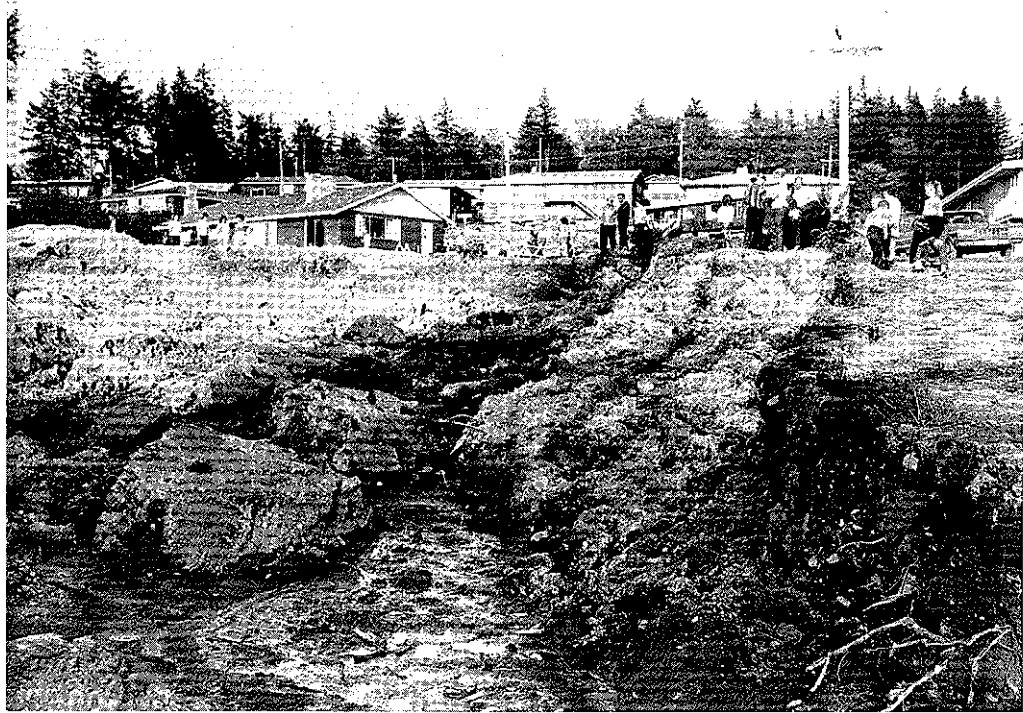
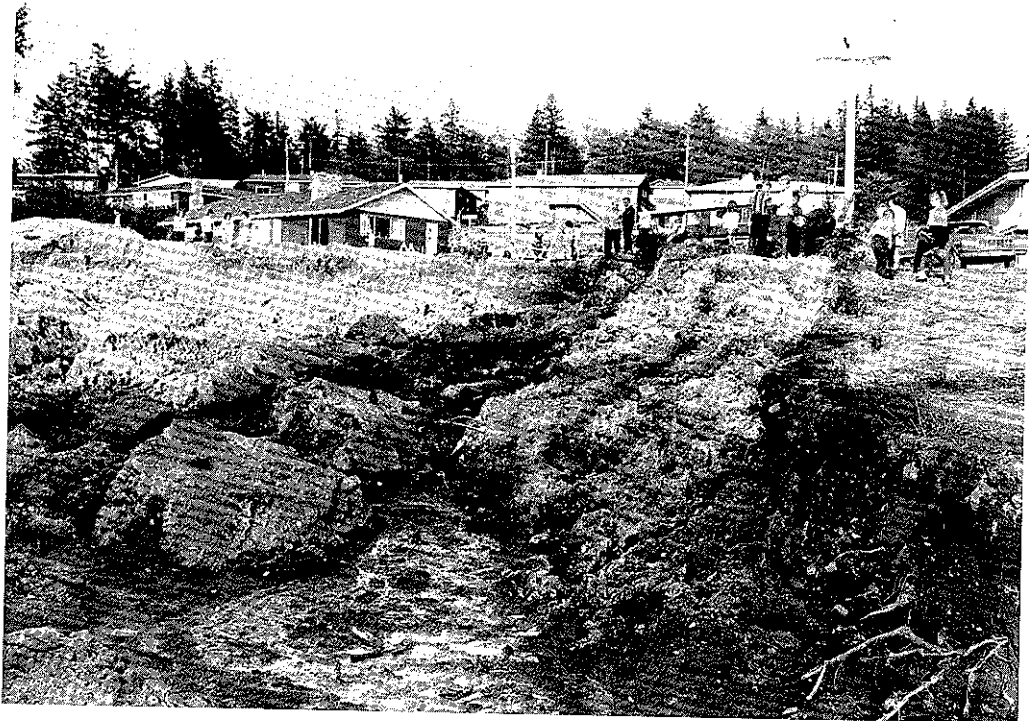
Another 1965 flow failure occurred in the city of Edmonds, north of Seattle (loc. 40; fig. 197). The failure, which took place at the head of a small ravine on moderately sloping ground, left a cavity tens of meters across and 3–5 m deep. Slide debris flowed downslope for several hundred meters. The site of the failure is within an area underlain by advance outwash deposits of the Vashon Drift, mostly clean sand and gravel (Minard, 1983). According to local residents, the site is also directly underlain by artificial fill. An eyewitness to the event reported that the slide uncovered a stream that mixed with the slide material, transforming the slide "into a muck the consistency of wet cement." The earth flow destroyed an abandoned artesian well and watershed located on the property.

Figure 197. Earth flow in Edmonds, Wash. (pl. 4, loc. 40), induced by the April 29, 1965, earthquake. The landslide began at the head of a small ravine and flowed downslope about 180 m, destroying an abandoned city water-well shed in its path. Photograph from the Seattle Post-Intelligencer Collection, courtesy of the Museum of History and Industry, Seattle, Wash.

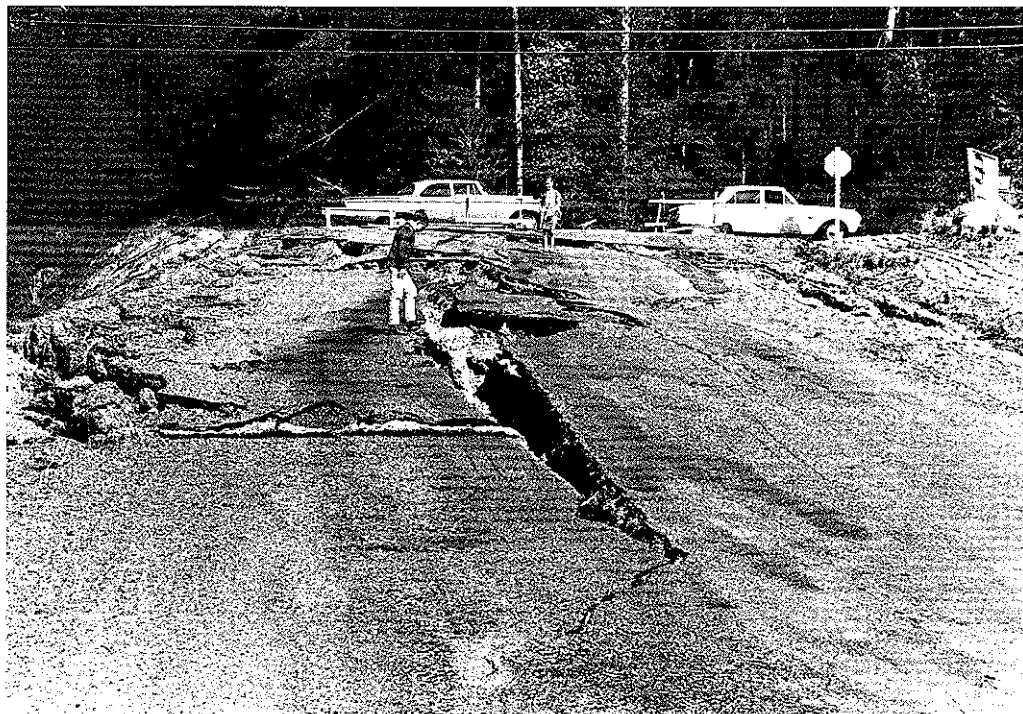
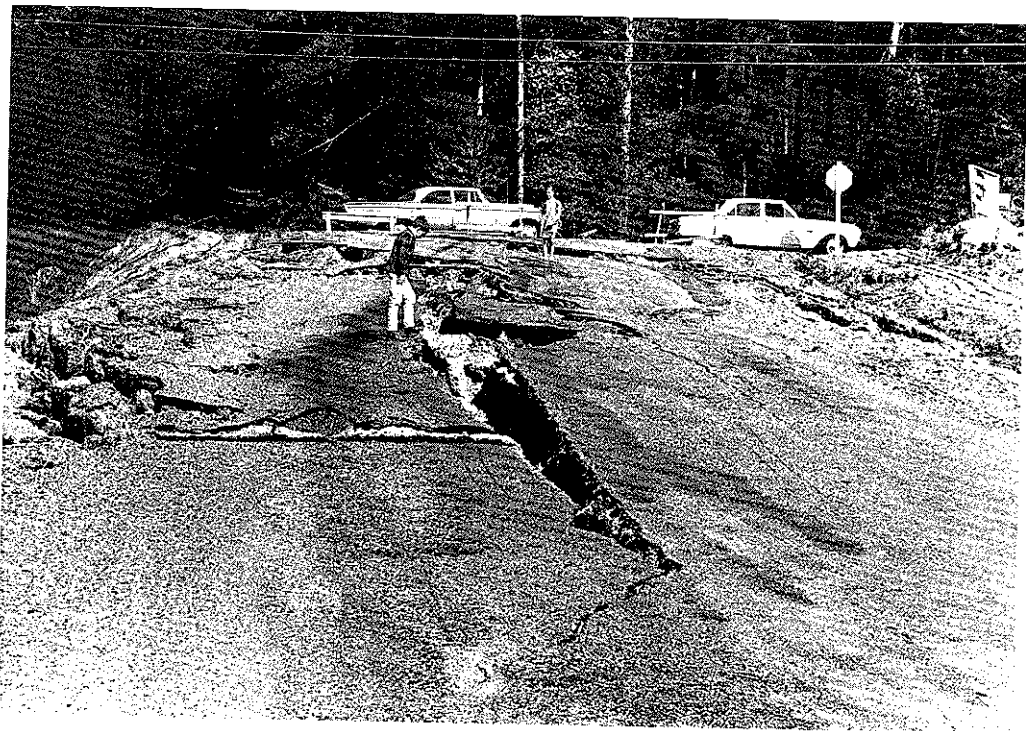
Figure 198. Damage to Country Club Road, southwest of Port Orchard, Wash. (pl. 4, loc. 2), due to slumping induced by the April 29, 1965, earthquake. This slump occurred in granular fill underlain by glacial deposits of the Vashon Drift. Photograph used by permission of the Bremerton Sun.

Another small slide in artificial fill during the 1965 earthquake extensively damaged a paved road south of Port Orchard (loc. 2; fig. 198). Movement was downslope in the direction of a small ravine adjacent to the road embankment. Glacial deposits of the Vashon Drift underlie the artificial fill at this location.

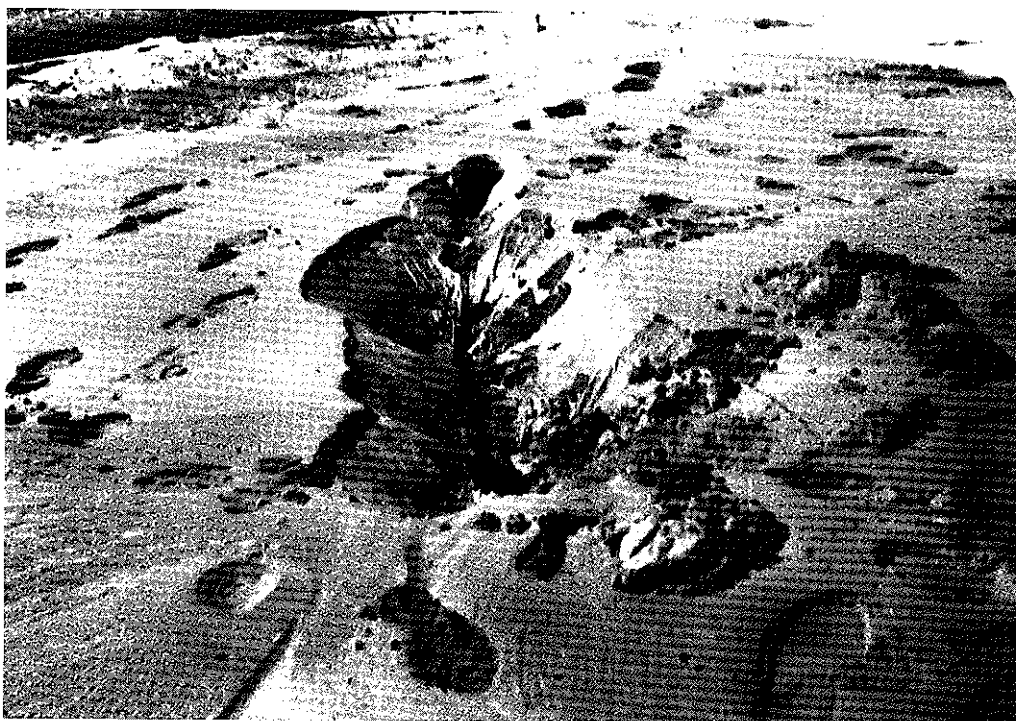
Figure 199. Sand boil in Puyallup, Wash. (pl. 5, loc. 68), produced by the April 13, 1949, earthquake. The earthquake generated many sand boils in northwest Puyallup. Some, such as this one, deposited considerable volumes of sediment on the surface; others were associated with damage to homes in the area. The sand boil vent (collapsed area in the center) is 2–3 m long. Photograph by Richard Six, Puyallup, Wash.

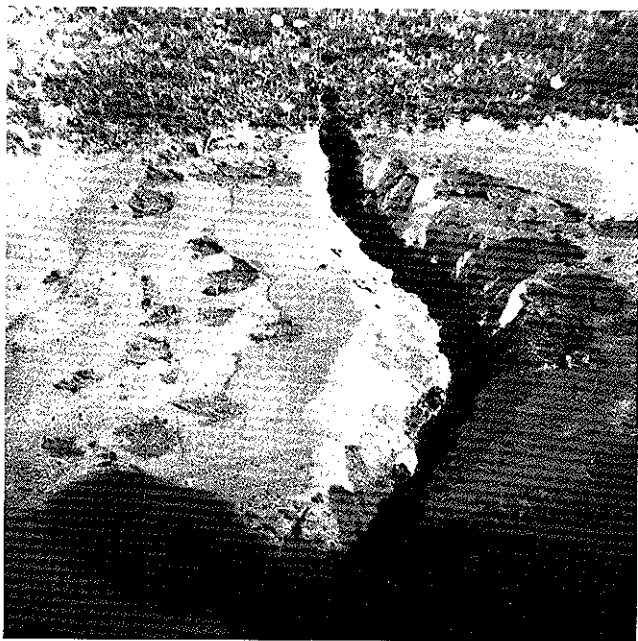
Figure 200. Ground crack and ejected sediment (sand boil) produced by the April 13, 1949, earthquake. This ground failure in northwest Puyallup, Wash. (pl. 5, loc. 68), may indicate incipient lateral spreading due to liquefaction of sediments. Shadow of individual (lower left) shows scale. Photograph by Richard Six, Puyallup, Wash.

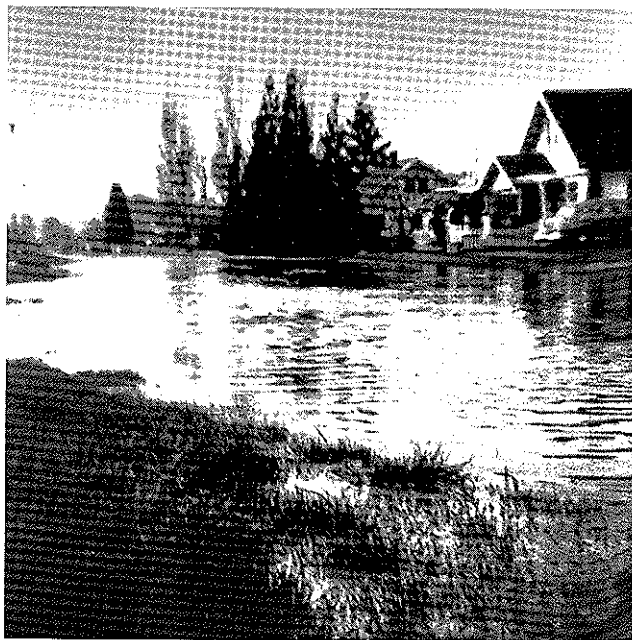
Figure 201. Flooding in northwest Puyallup, Wash. (pl. 5, loc. 68), at the time of the April 13, 1949, earthquake. According to local residents, the flooding could not be attributed to broken water mains and may have resulted from the ejection of ground water from the many sand boils that occurred in the area. Photograph by Richard Six, Puyallup, Wash.

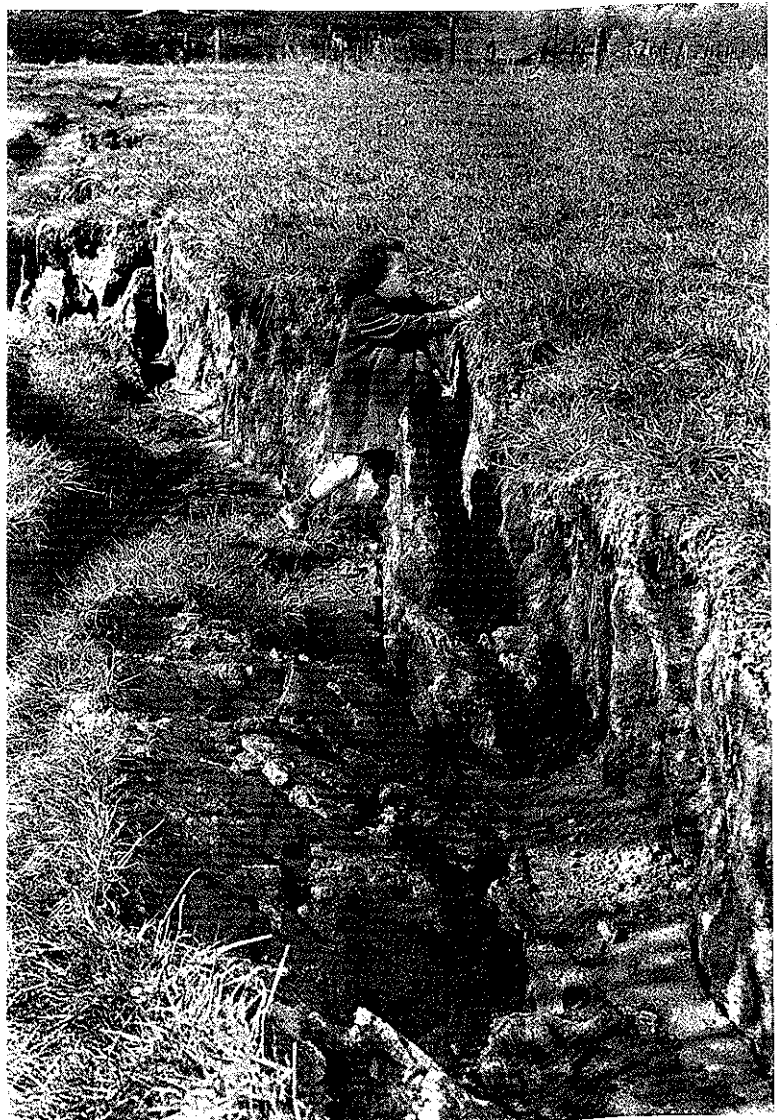
Figure 202. Ground crack along Clarks Creek, northwest of Puyallup, Wash., associated with slumping or lateral spreading of alluvial sediments (pl. 5, loc. 71). This 1949 earthquake-induced ground failure extended along 60–90 m of the west bank of Clarks Creek; lateral movement was in the direction of the creek (out of sight to the left of view). Photograph from the Richards Photographic Studio Photo Collection, courtesy of the Tacoma Public Library, Tacoma, Wash.

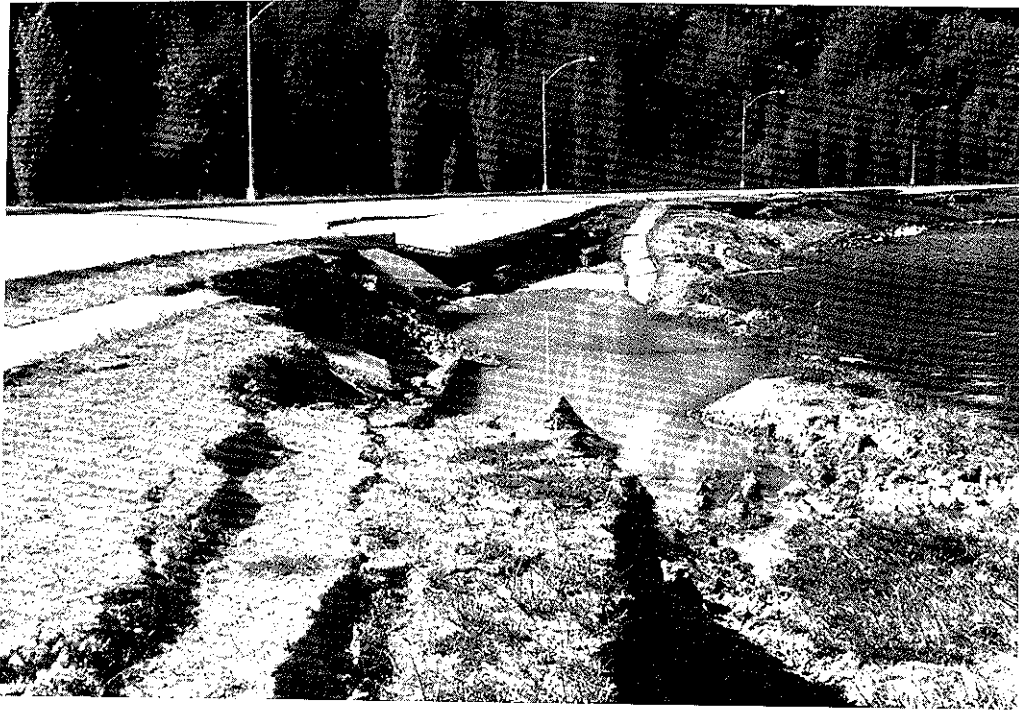
Figure 204. Damage to Deschutes Parkway, Olympia, Wash., resulting from a 1965 earthquake-induced ground failure (pl. 5, loc. 48). The parkway was constructed on granular fill placed on tidal flat muds that are now within the limits of Capitol Lake; failure was probably due to liquefaction. Photograph by Gerald W. Thorsen, Division of Geology and Earth Resources, Washington Department of Natural Resources, Olympia, Wash.

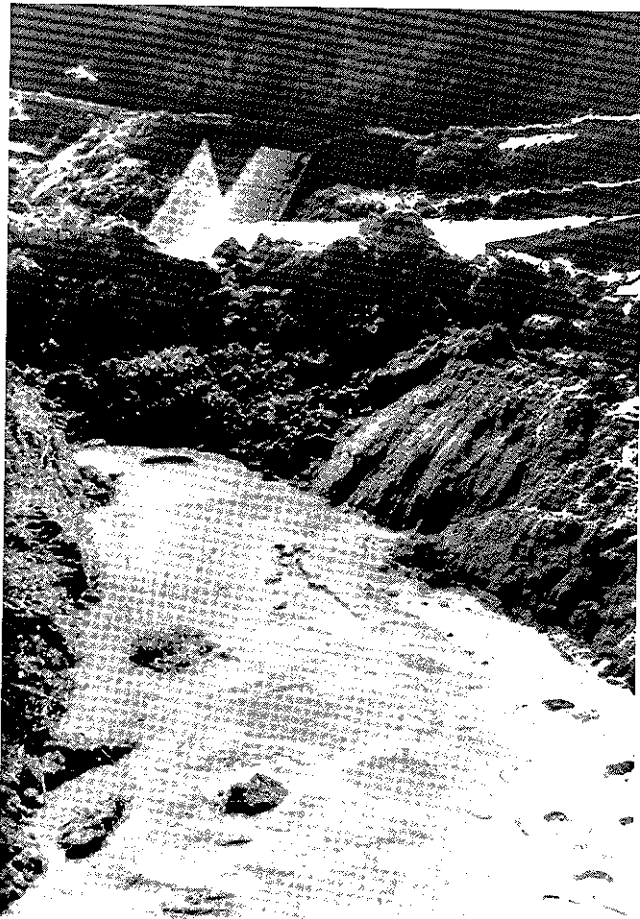
Figure 205. Sand boils near Capitol Lake in Olympia, Wash., related to the earthquake of April 29, 1965 (pl. 5, loc. 48). The sand boils are evidence of soil liquefaction at this ground failure location. Sidewalk slab in background shows scale. Photograph by Gerald W. Thorsen, Division of Geology and Earth Resources, Washington Department of Natural Resources, Olympia, Wash.

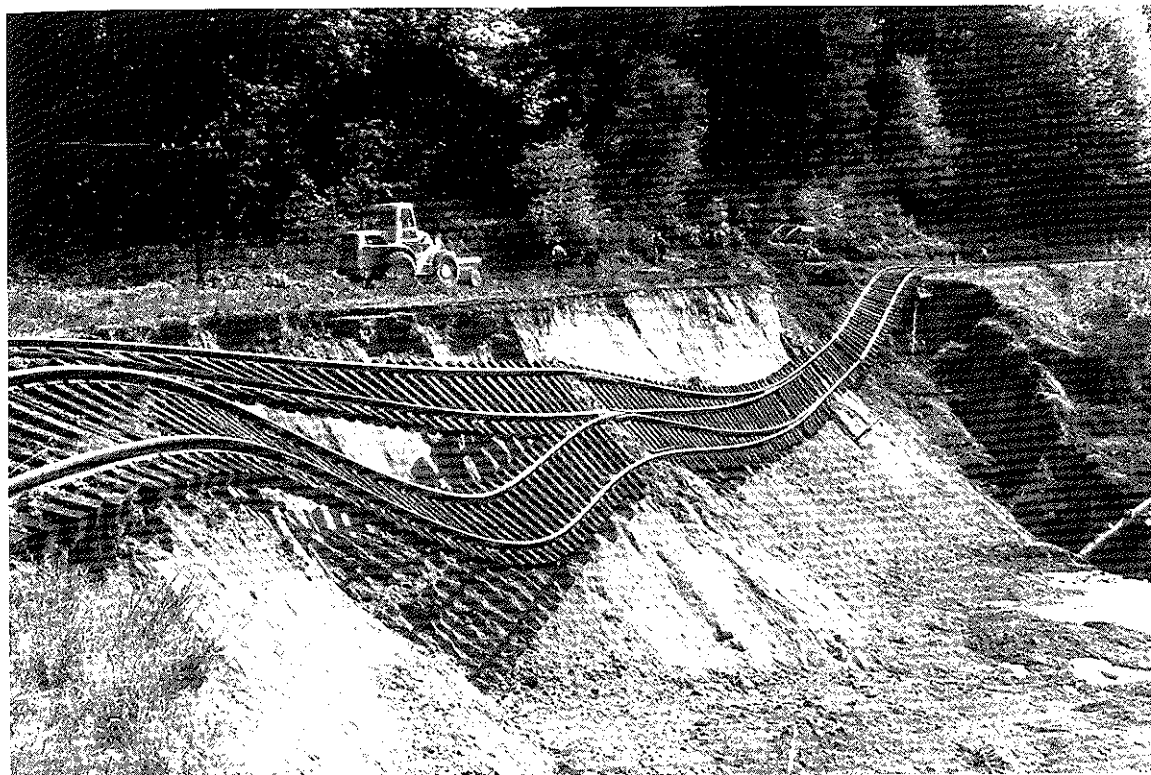
Figure 206. Damage to Union Pacific Railroad tracks near Tumwater, Wash. (pl. 5, loc. 45), due to a 1965 earthquake-induced slope failure in artificial fill. Photograph by Gerald W. Thorsen, Division of Geology and Earth Resources, Washington Department of Natural Resources, Olympia, Wash.

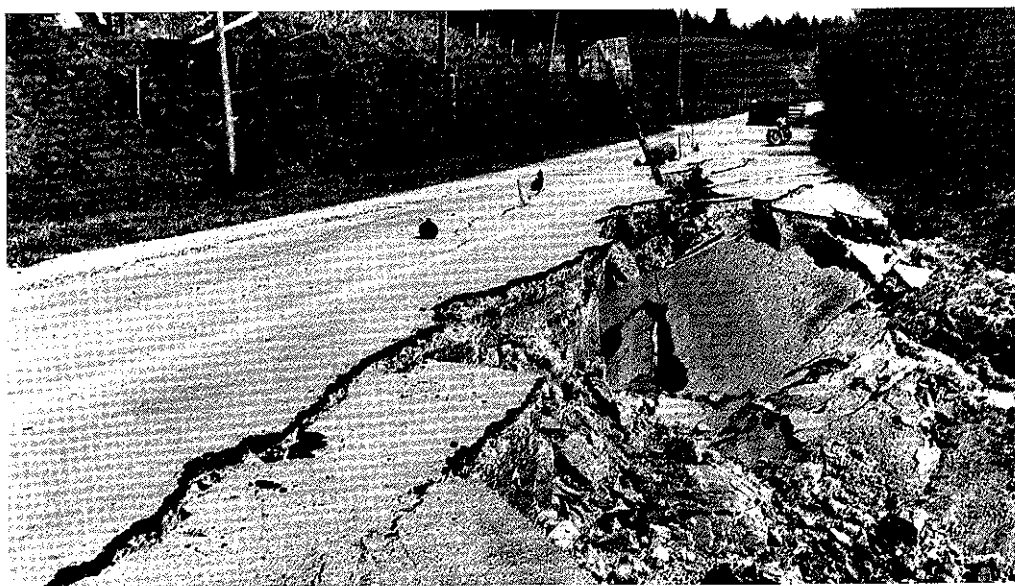
Figure 207. Damage to Black Lake Road south of Olympia, Wash. (pl. 5, loc. 44), caused by failure of a steep lake bank during the earthquake of April 13, 1949. Photograph used by permission of Jack Goldsby, Tumwater, Wash.

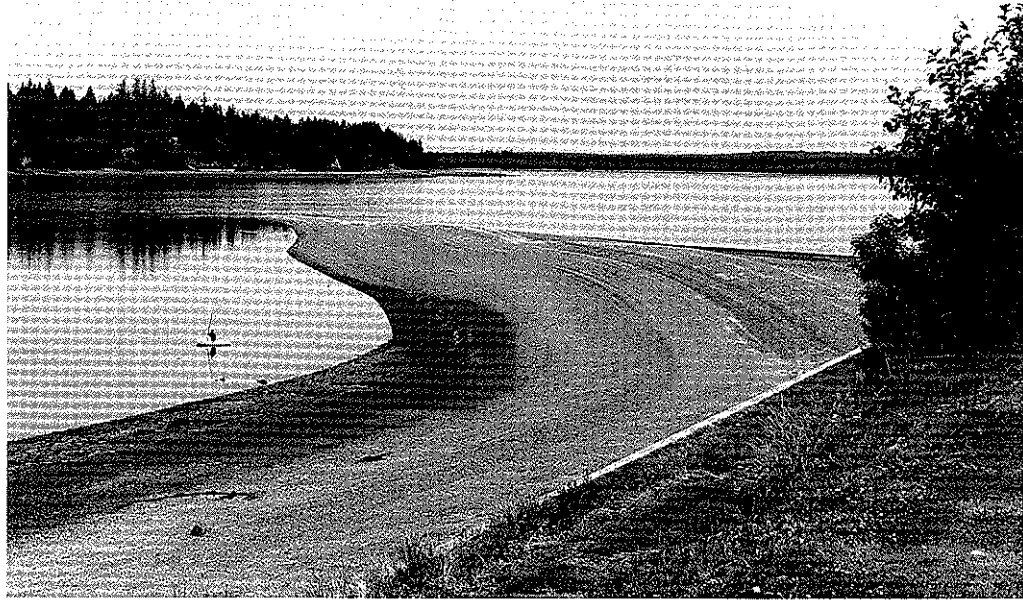
Figure 208. View of Cooper's Point, located 11 km north of Olympia, Wash. (pl. 5, loc. 51). About 45 m of the end of the sand spit failed and disappeared into Puget Sound during the April 13, 1949, earthquake. Photograph was taken in 1988.

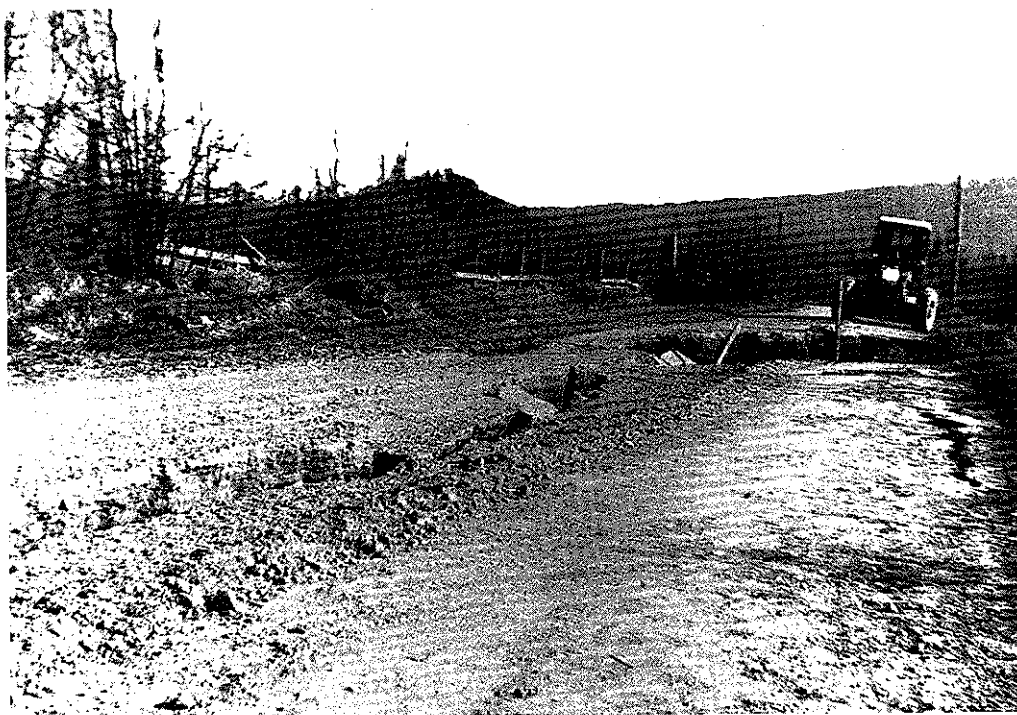
A cluster of ground-failure activity was generated by the 1949 earthquake along the Cowlitz River Valley near Randle (locs. 117–122). Blocks of volcanic rocks fell from steep cliffs east of Randle onto Cline Road (locs. 120 and 121) and onto the old Randle-Packwood Highway (loc. 122). The blocks were reported to be as large as 6 m on a side. On the valley floor, southwest of Randle (loc. 117), a road embankment composed of artificial fill underlain by loose, liquefiable sand slumped into a nearby field. Road damage caused by the slump is shown in figure 209. Simultaneously on the same property (loc. 118), numerous sand boils erupted. To the east and closer to the Cowlitz River (loc. 119), small slumps were triggered along the bank of an abandoned river channel.

Figure 209. Slump in a 1- to 1.2-m-high road embankment in the Cowlitz River Valley, about 1.6 km southwest of Randle, Wash. (pl. 6, loc. 118). This April 13, 1949, earthquake-induced ground failure occurred in artificial fill underlain by loose liquefiable sand. The earthquake also produced sand boils in an adjacent field. Photograph by Alice Peters, Randle, Wash.

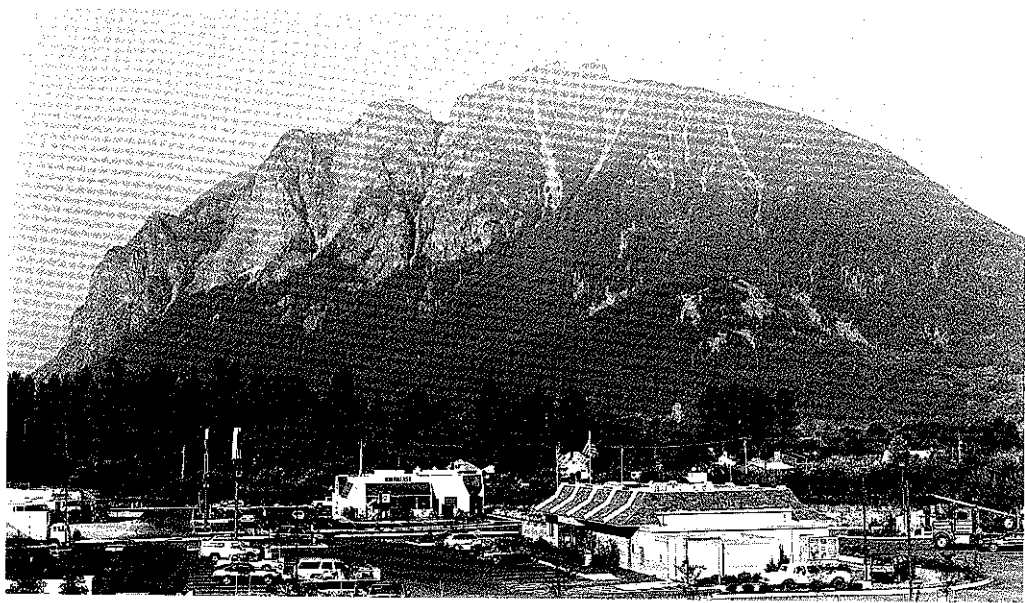
Figure 210. Mount Si near North Bend, Wash. (pl. 6, loc. 130). "Rockslides" on Mount Si were reported for the Puget Sound area earthquakes of April 29, 1945, April 13, 1949, and April 29, 1965. Photograph was taken in 1988.

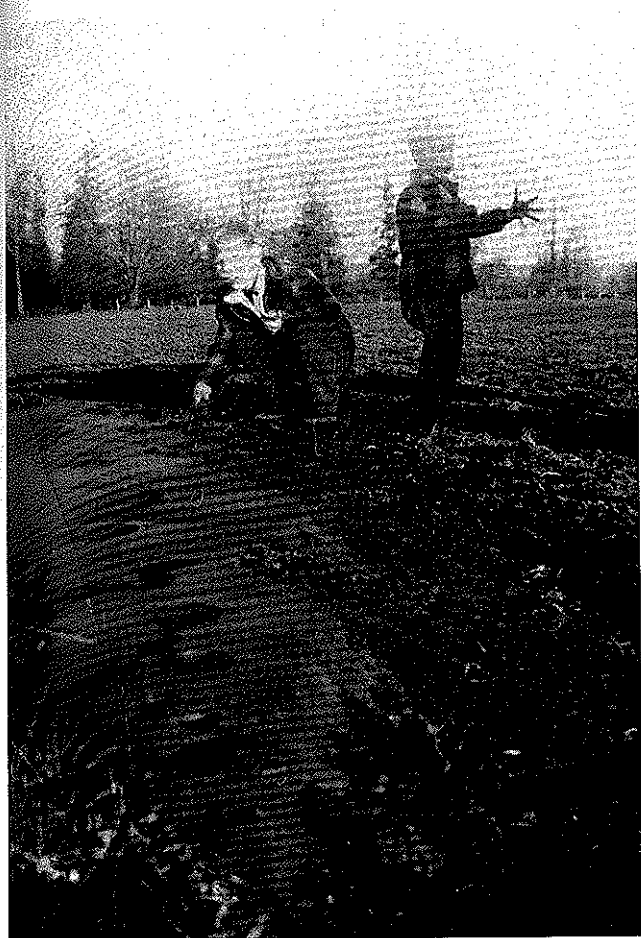
Figure 211. Alignment of sand boils in a field 1.6 km southwest of Centralia, Wash. (pl. 7, loc. 146), is related to linear ground crack from which the water and sand were emitted during a 1949 liquefaction incident. Photograph by Ted Dorn, Centralia, Wash.
