GROUND FAILURE ASSOCIATED WITH THE PUGET SOUND REGION EARTHQUAKES OF APRIL 13, 1949, AND APRIL 29, 1965

By Alan F. Chleborad¹ and Robert L. Schuster¹

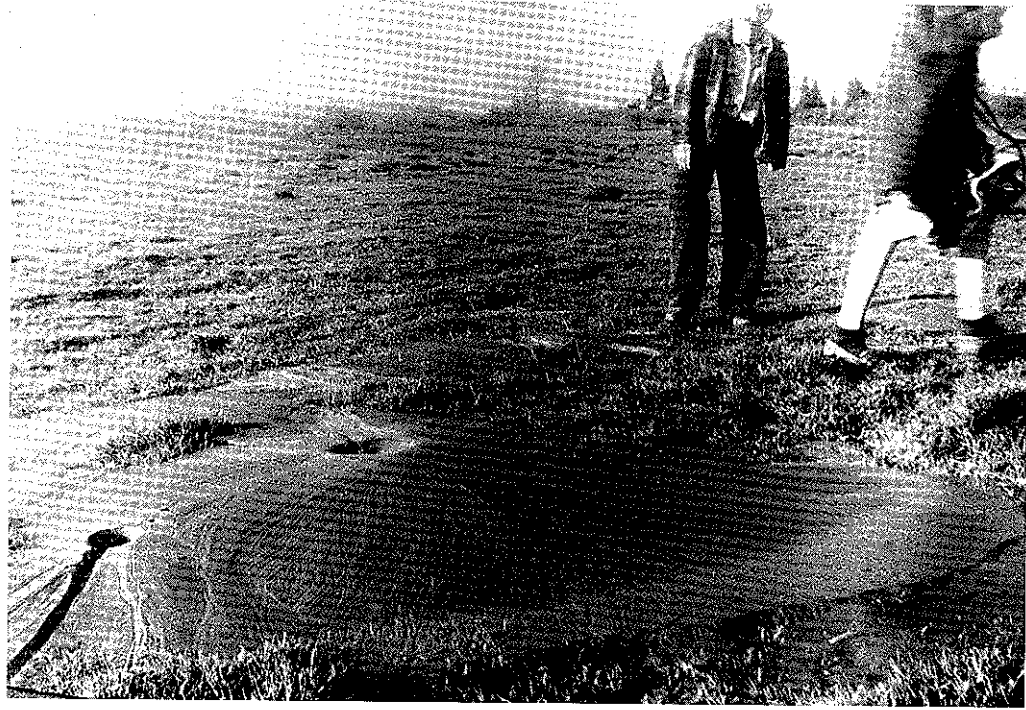
Figure 212. Sand boils on the floodplain of the Chehalis River, about 1.6 km southwest of Centralia, Wash. (pl. 7, loc 146). Water and sand spouted from several ground cracks at this location at the time of the April 13, 1949, earthquake. Photograph by Ted Dorn, Centralia, Wash.

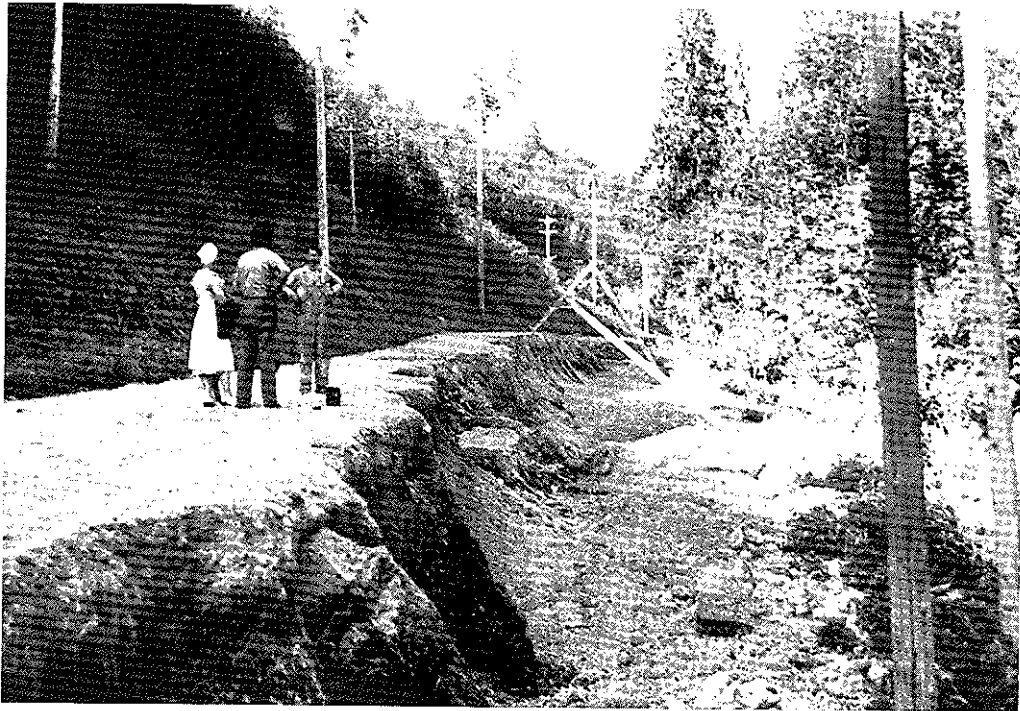
Figure 213. Scarp created by a landslide on the west side of Ohop Lake, Pierce County, Wash. (pl. 7, loc. 138). Incipient failure induced by the April 13, 1949, earthquake resulted in the development of a large ground crack. On May 13, complete failure occurred as the unstable mass suddenly slumped into the lake, damaging the roadway, utility lines, and cottages near the shore. Photograph used by permission of the Tacoma News Tribune.

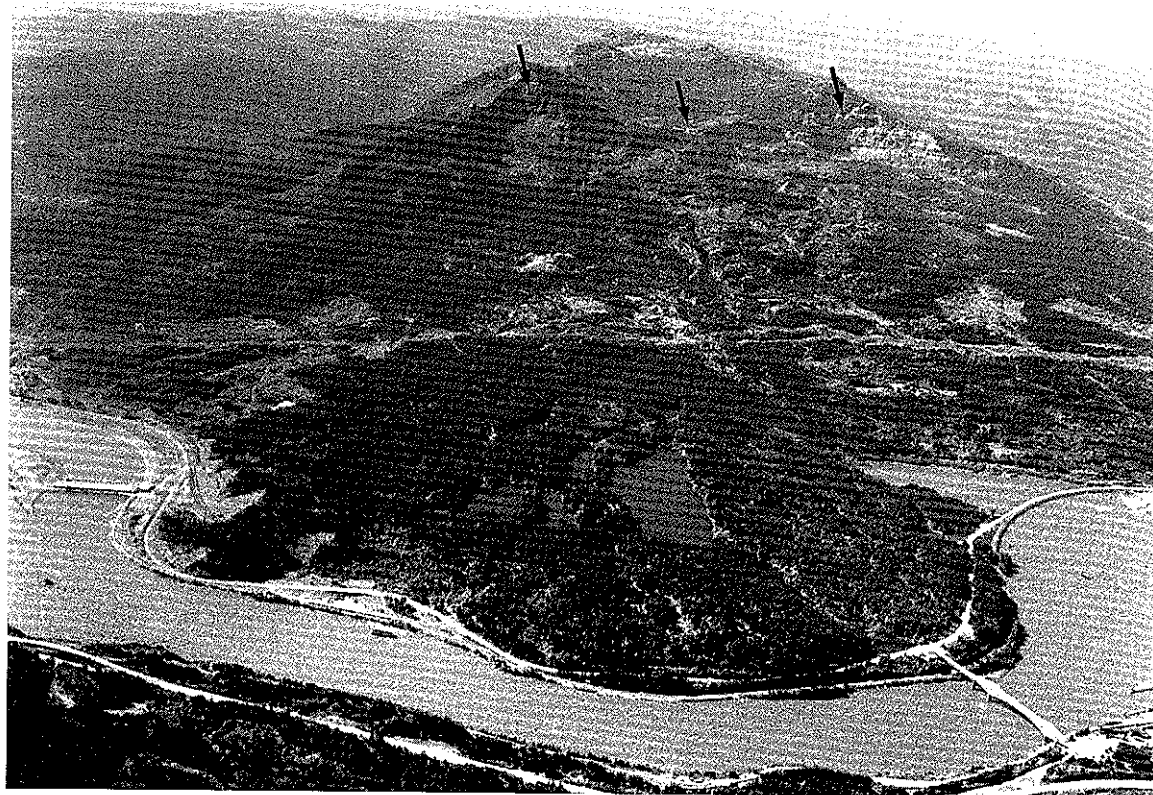
Figure 214. Bonneville landslide area along the Columbia River west of Stevenson, Wash. (pl. 8, loc. 160). Rock fall/rock avalanche activity triggered by the April 13, 1949, earthquake occurred along the steep head scarp (arrows), creating a dust cloud visible for many kilometers along the Columbia River Gorge. Photograph by Derek Cornforth, Landslide Technology, Portland, Oreg.
