CHAPTER 17

Hazard Management on Fans, with Examples from British Columbia

Rolf Kellerhals

Michael Church

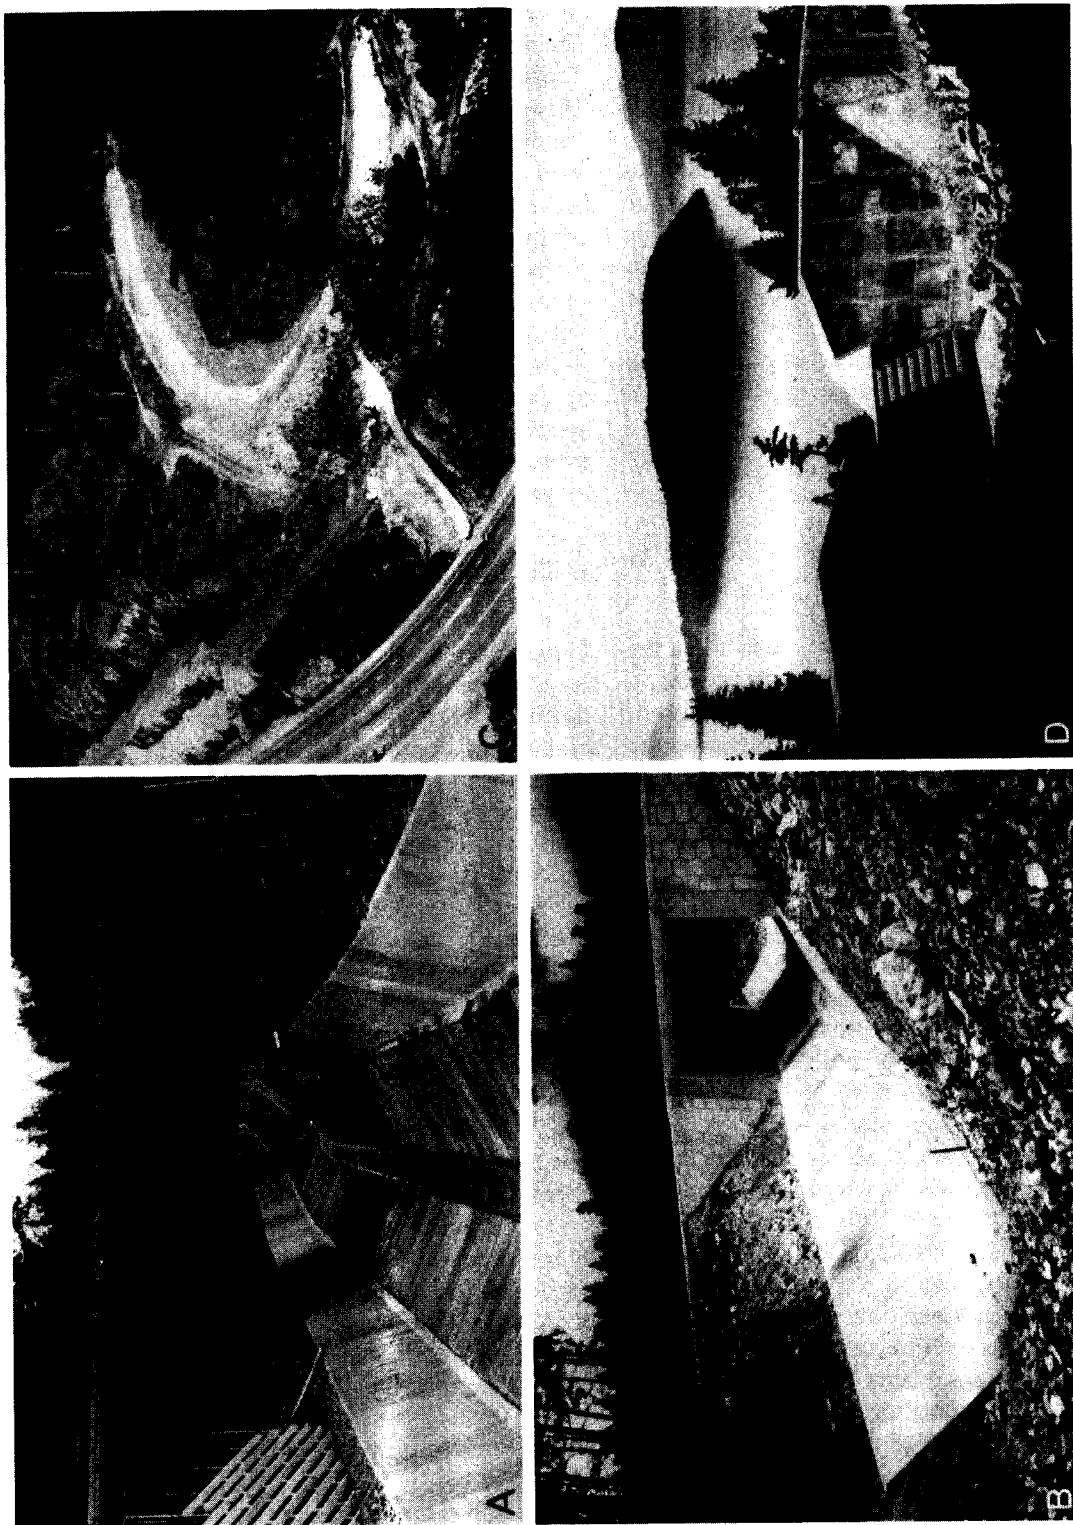
Figure 17.9. (A) Alberta Creek debris chute constructed after the February, 1983, debris-flow (Figure 17.4); (B) Bridge opening with debris chute; (C) Debris flow diversion dyke. A debris storage area of 12 500 m³ capacity is created by a 5 m high dyke. The dark material within the dyke is the deposit of a debris-flow. Photograph courtesy of Thurber Consultants, Ltd. and Dr. Oldrich Hungr; (D) Debris interception barrier on Charles Creek. See Hungr *et al.* (1987) for a detailed description of the design. Photograph courtesy of Mr. Michael Younie

Debris chutes are effective in situations where debris deposition on the lower parts of the fan is acceptable. Figure 17.9A shows the debris chute of Alberta Creek (see Figures 17.3 and 17.4). Chutes are often a good solution in the case of bridge crossings on undeveloped fans since they confine the debris-flow to a fixed channel and help prevent bridge openings from becoming clogged (Figure 17.9B).

Large diversion dykes, as illustrated in Figure

17.9C, are often the preferred solution in British Columbia if space permits. They do, however, require careful maintenance. Any significant debris deposits behind the dykes must be removed if eventual overtopping is to be avoided. Nasmith and Mercer (1979) describe the design of a system of diversion dykes to protect the town of Port Alice. This industrial 'instant town' is located on a large debris-flow fan along one of Vancouver Island's west coast fjords. The debris-flow problem became apparent only some eight years after the town was built. Another case, on a much smaller scale, is described by Martin *et al.* (1984): in this instance, dykes and an interception basin were used to protect a prison built partly on a debris-flow fan.
