Time-Lapse Imagery of the Breaching of Marmot Dam, Oregon, and Subsequent Erosion of Sediment by the Sandy River— October 2007 to May 2008

Data Series 521

By Jon J. Major, Kurt R. Spicer, and Rebecca A. Collins

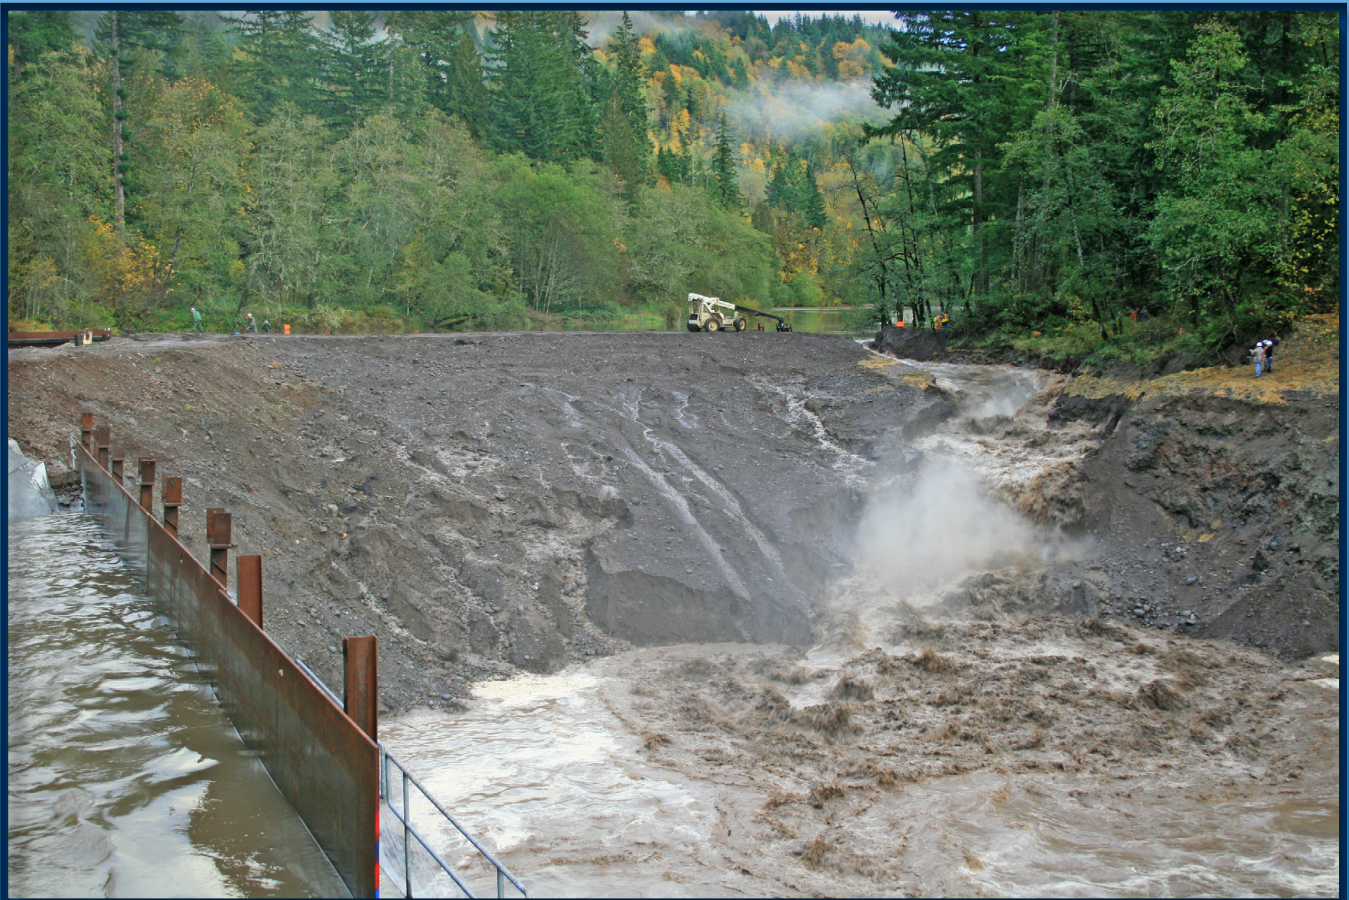
FRONT COVER
Photograph of Marmot Dam, Oregon.

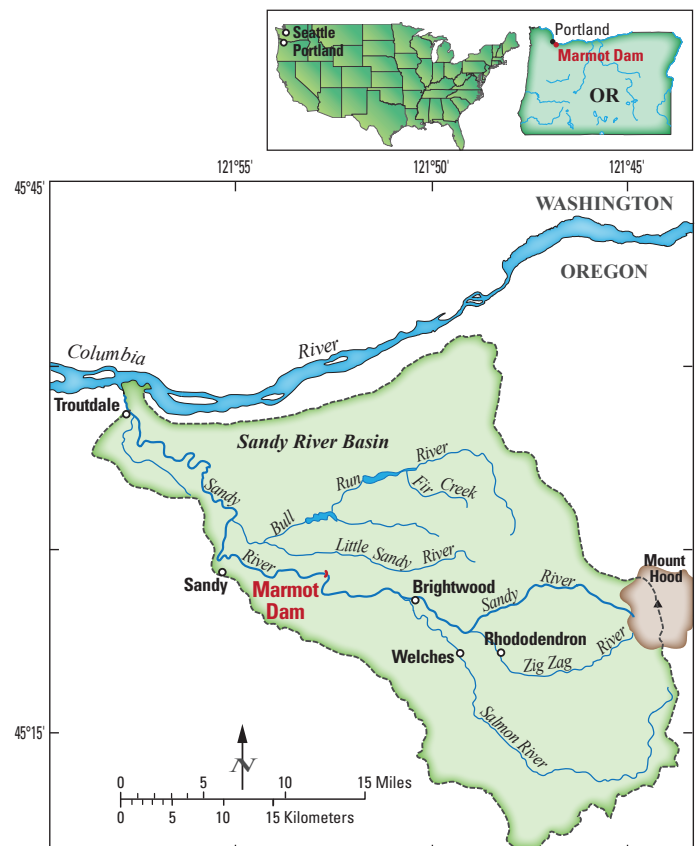
Figure 1. Map of the Sandy River Basin showing the location of Marmot Dam. Portland, Oregon, is located approximately 20 km west of the confluence of the Sandy River and Columbia River.

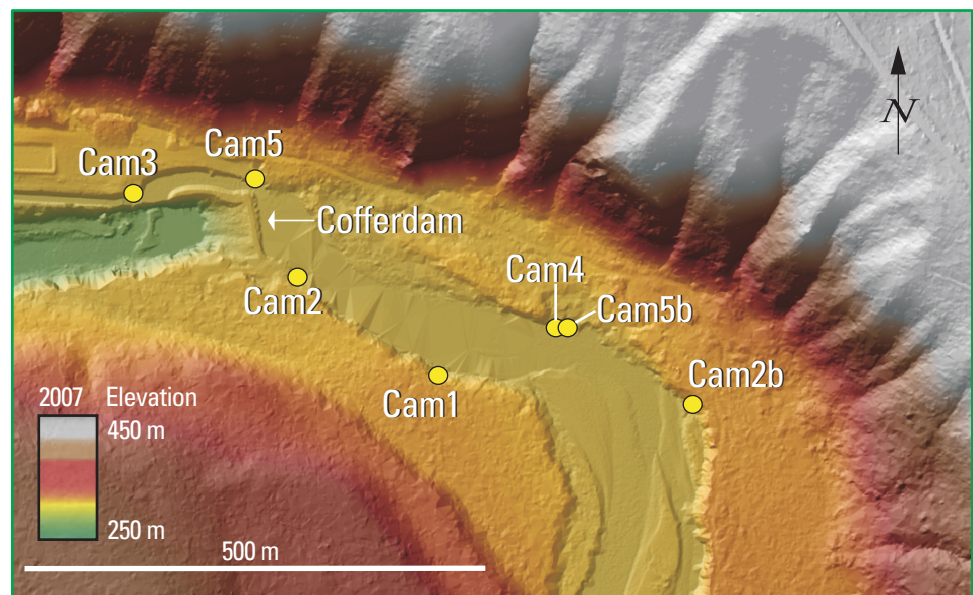
Figure 2. Location of cameras placed around lower Marmot Dam reservoir. The base topography is obtained from a lidar survey conducted from September 29 to October 7, 2007.

Five single-lens reflex (SLR) cameras were placed around the lower 300 m of the Marmot Dam reservoir (fig. 2). Initially, one camera was placed downstream of the cofferdam looking upstream (camera 3); two cameras were placed near the cofferdam crest looking across the reservoir (cameras 2 and 5), and two cameras were placed along the north and south shores of the reservoir about 300 meters upstream of the cofferdam and having views looking downstream (cameras 1 and 4). After the breaching and following erosion of much of the sediment in the lowermost reach of the reservoir, camera 5 was relocated to the position of camera 4, but with a view looking upstream, and renamed camera 5b. Camera 2 was relocated farther up the reservoir reach and placed to have a view looking upstream; it was renamed camera 2b (fig. 2; table 1). Following breaching, the demolition crew for PGE removed the building on which camera 3 was mounted. That camera was consequently moved a few tens of meters and mounted to a pedestrian bridge that crossed the river, but it maintained its upstream view.

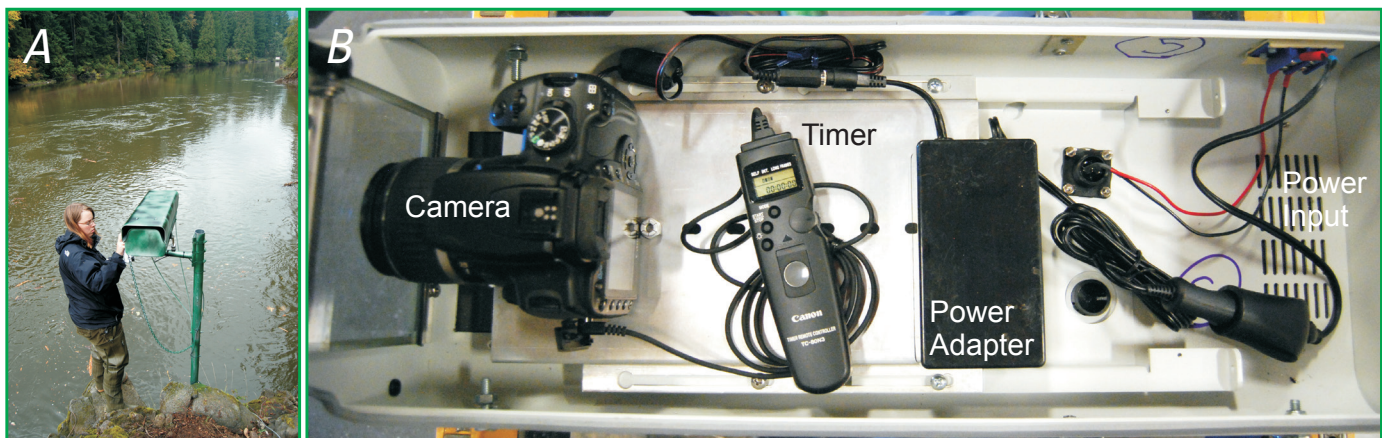
Figure 3. Example of camera system used to obtain imagery. *A*, Camera 4 field station; view looking down reservoir. *B*, Camera, timer, and power adapter inside weatherproof box.

We used Canon Rebel XTi digital SLR cameras having 10-megapixel resolution for this study. Each camera was driven by an external timer (a modified Canon TC-80N3 camera controller) that could be set to take photographs at a desired interval. Each camera was powered by an external 12VDC deep-cycle battery via a 12VDC adapter, and each was enclosed in an environmental housing (fig. 3). Full-resolution images (3,888 x 2,592 pixels) were stored onsite within each camera on 8GB compact flash cards. Depending on the photograph interval chosen, storage cards needed to be changed at intervals ranging from a few weeks to a few months.
