*Final Report*

# **Taylor Lumber and Treating Superfund Site Final Construction Report**

Prepared for  
**U.S. Environmental Protection Agency**

March 2009

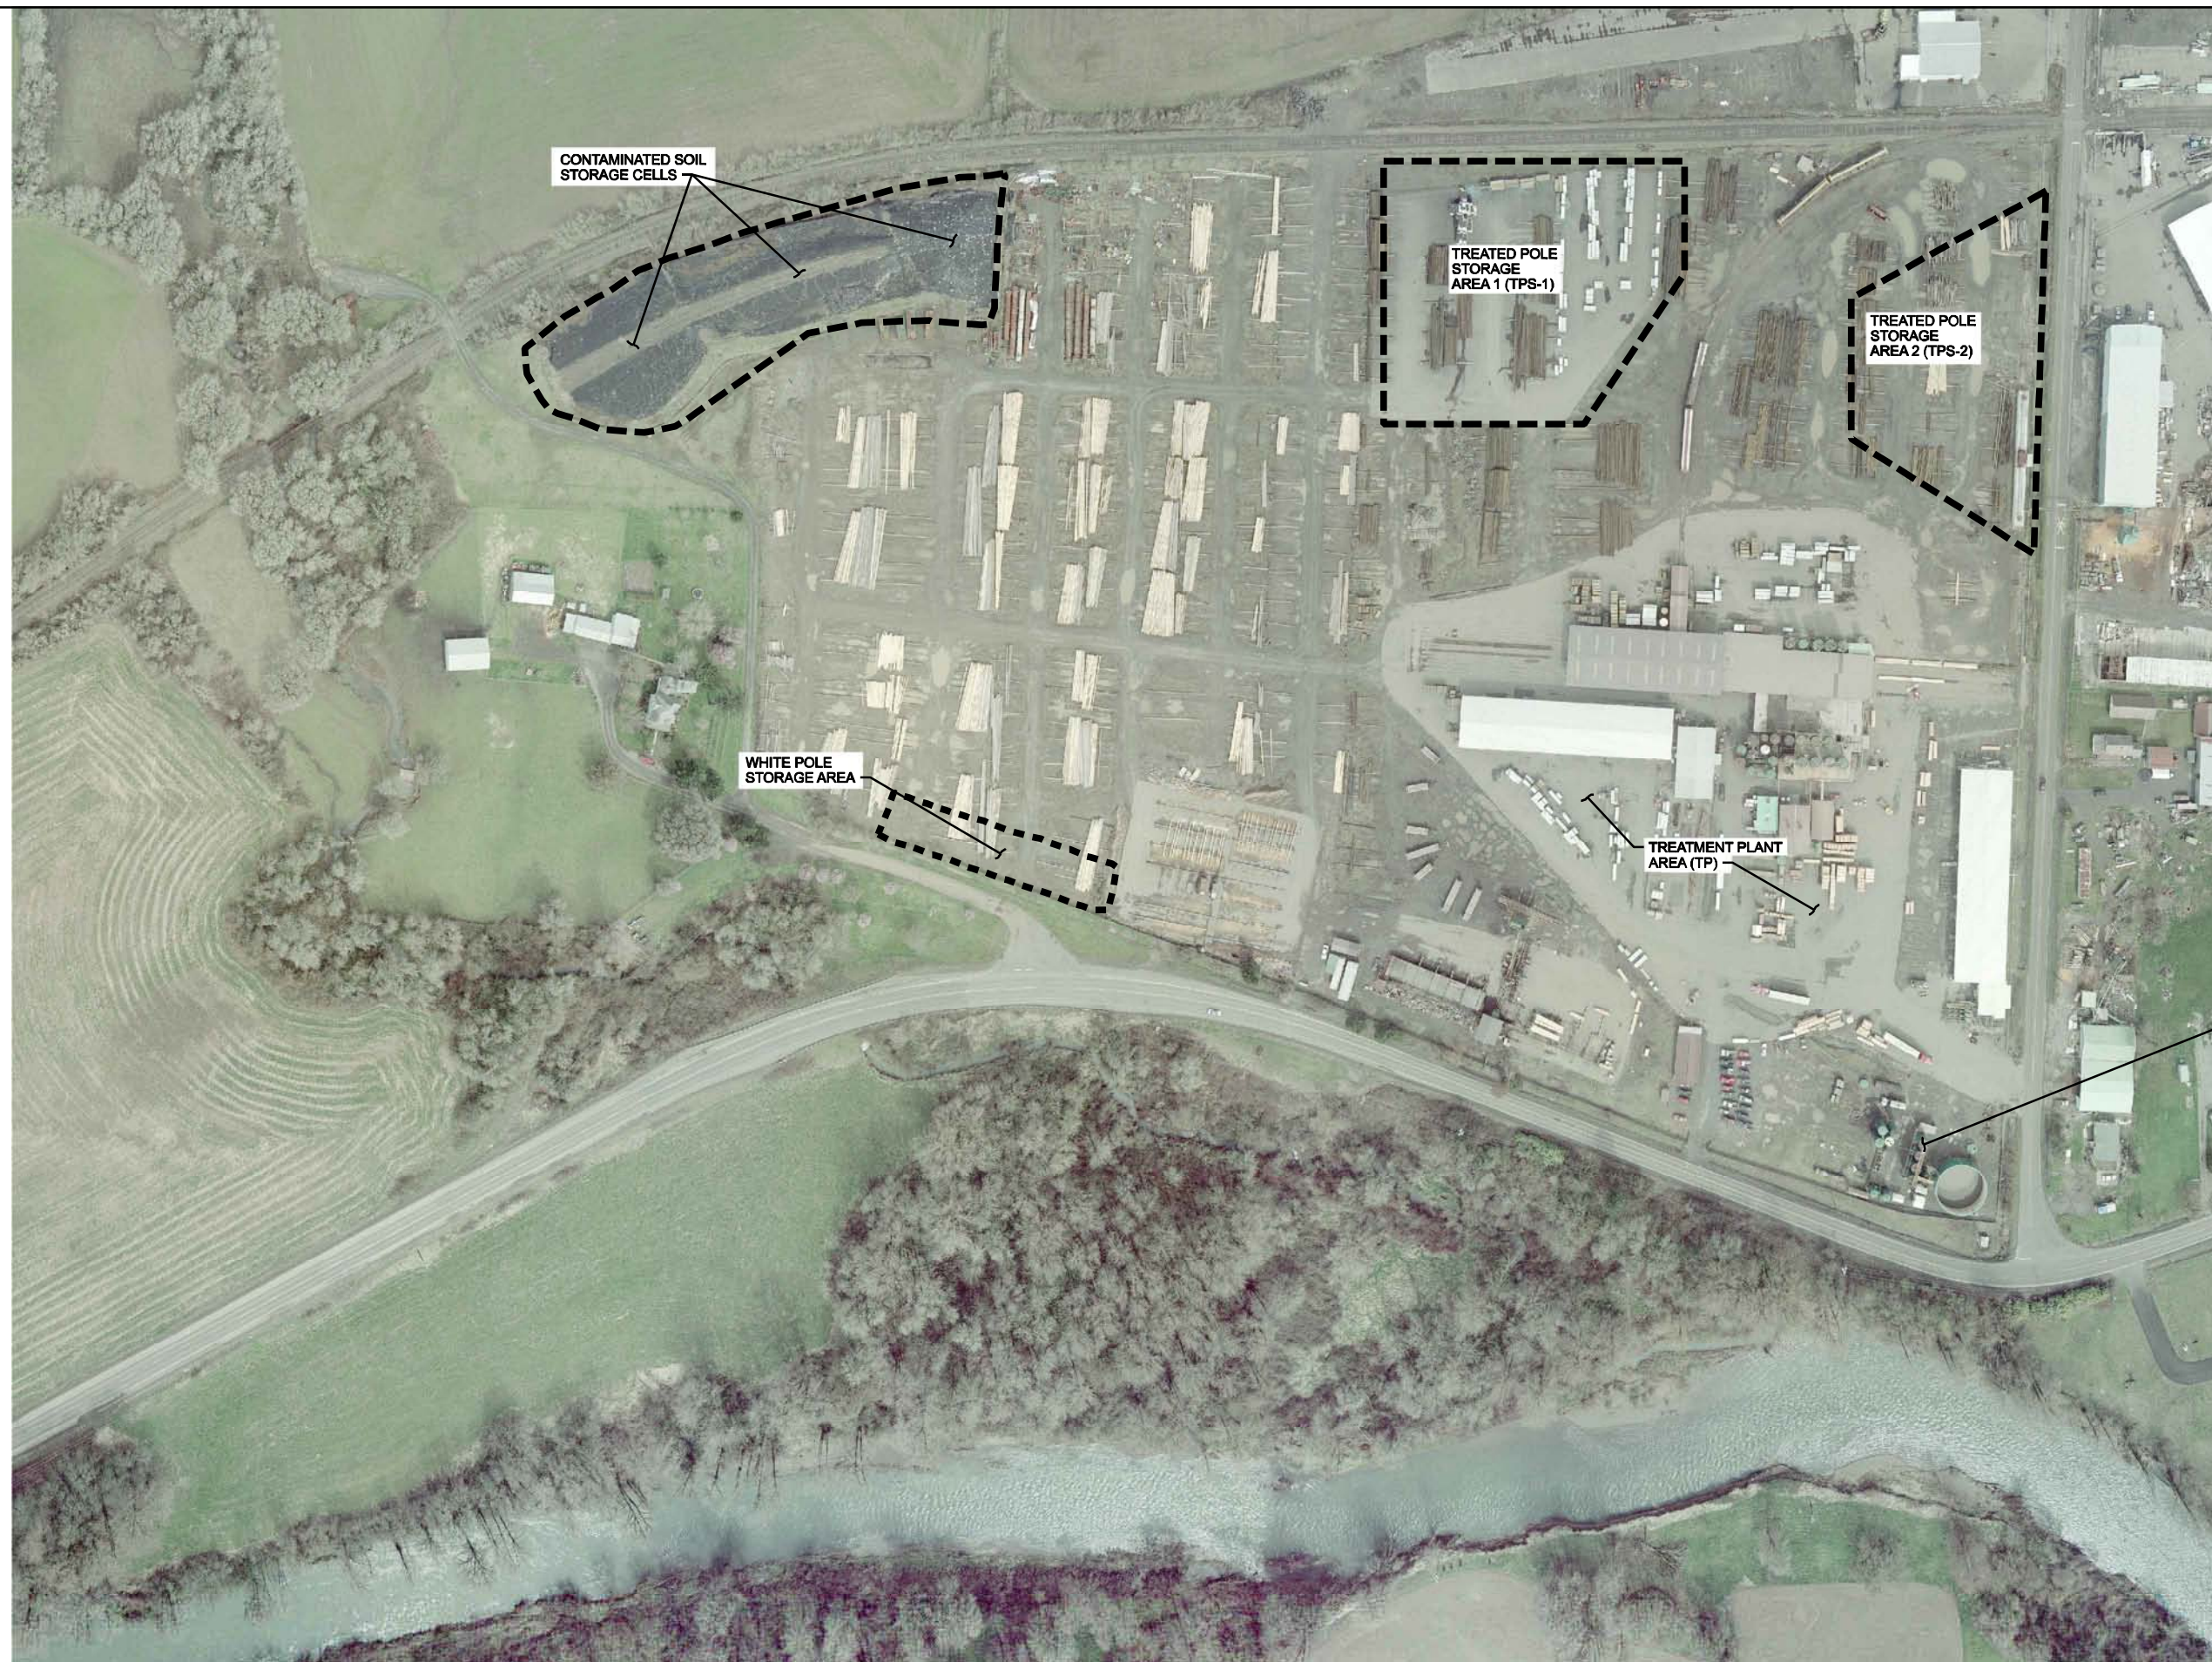
**FIGURE 1-2**  
**SITE PHOTO - PRIOR**  
**TO REMEDIAL ACTION**  
TAYLOR LUMBER AND TREATING SUPERFUND SITE

**NOTE:**  
PHOTO TAKEN MARCH 27, 2006

The remedial action at TLT is focused on the wood-treating portion of the facility currently owned by PWPO. The portion of the site being addressed by the remedial action encompasses approximately 37 acres located west of Rock Creek Road, and is divided into the Treatment Plant (TP) Area, White Pole Storage (WPS) Area, and Treated Pole Storage (TPS) Areas. The designations of these areas reflect general property usage by the former TLT (Figure 1-2).
