# Channel Change and Bed-Material Transport in the Umpqua River Basin, Oregon

Scientific Investigations Report 2011–5041

By J. Rose Wallick, Jim E. O'Connor, Scott Anderson, Mackenzie Keith,  
Charles Cannon, and John C. Risley

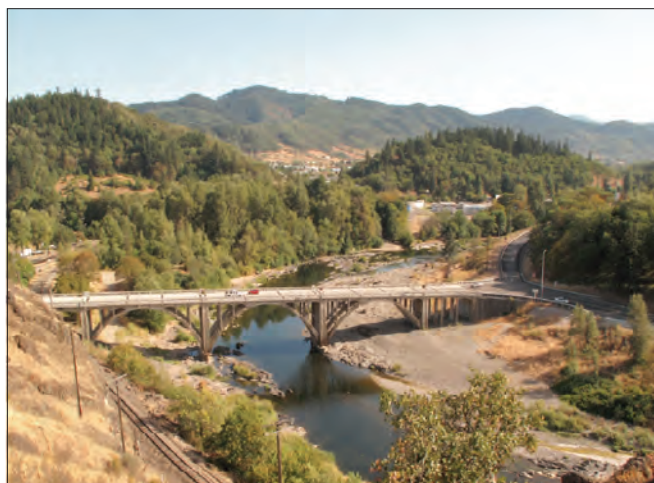
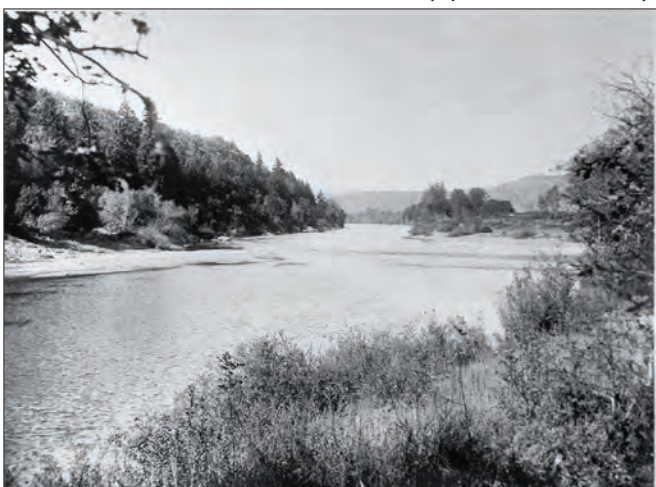
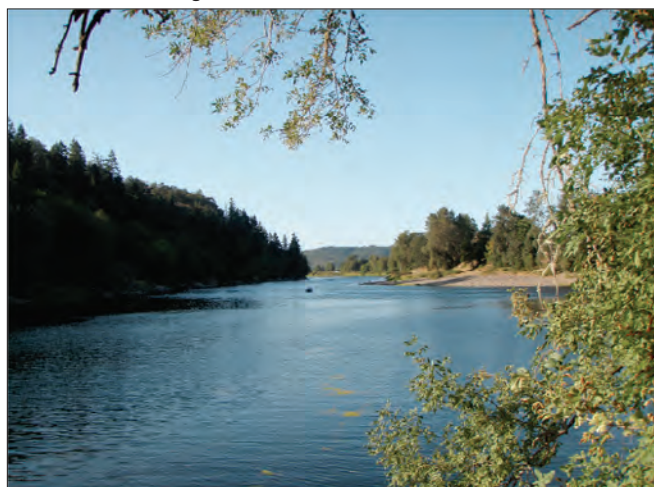
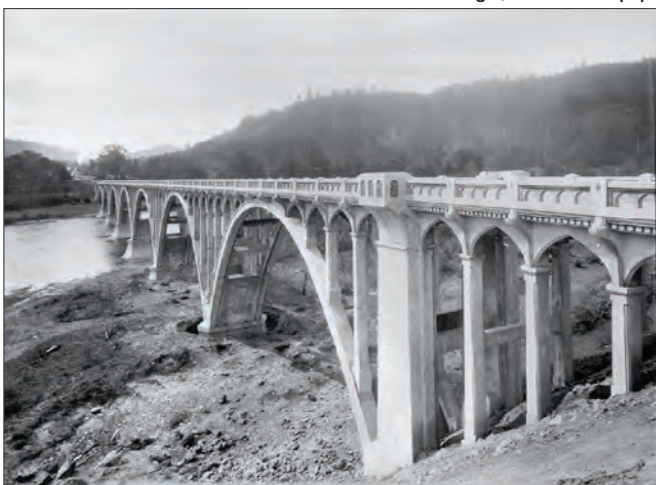
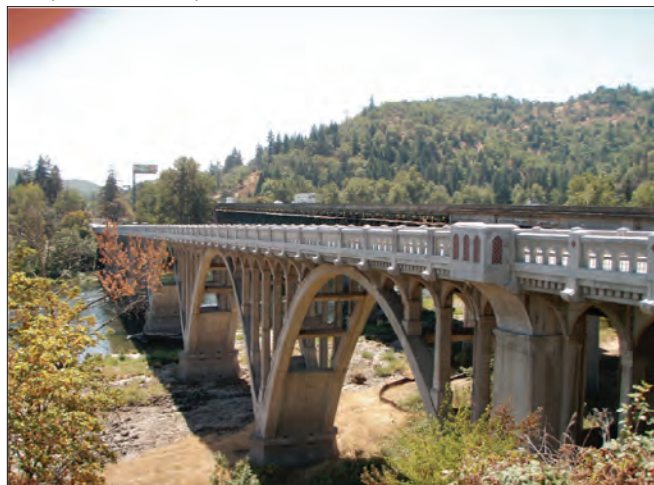
**B.** Confluence of the South Umpqua and North Umpqua Rivers, near Singleton Park, FPKM 168.4, 1925–2009

**C.** Booth Bridge, North Umpqua River, NUFPM 10, 1925–2009

**Figure 26.** Historical channel changes in the Umpqua River basin, Oregon, 1920s–2009. Locations of photographs are provided in [appendix A](#).

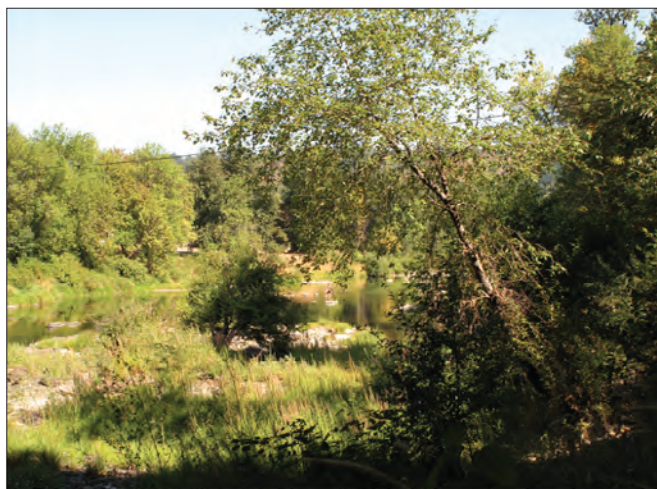
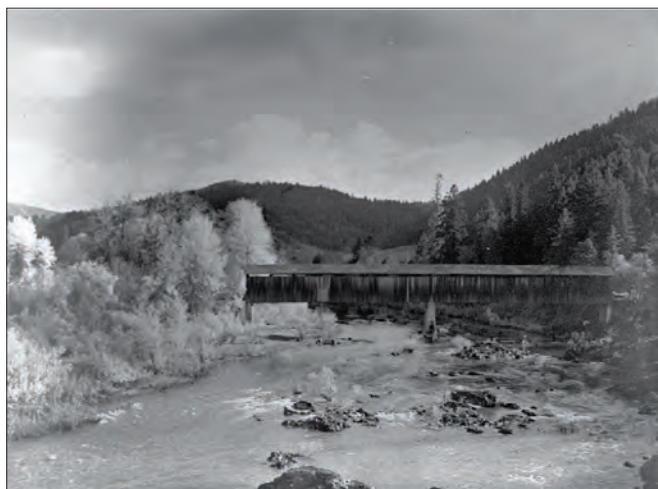
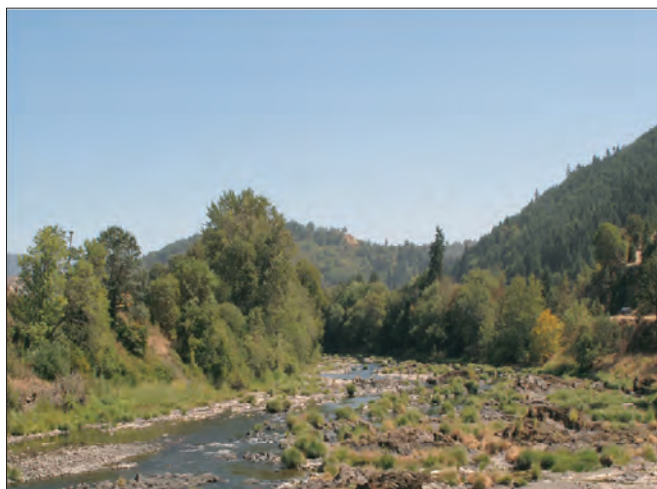
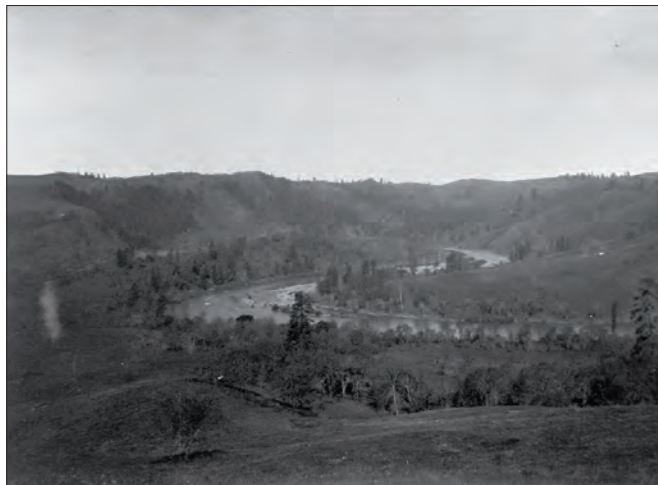
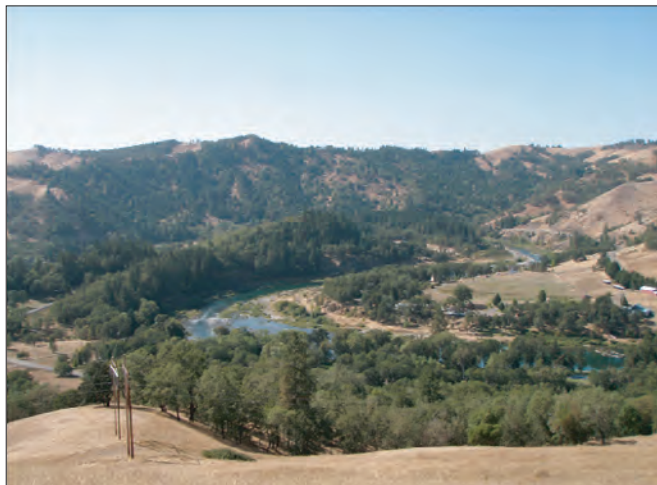
**B.** Rice Creek covered bridge, South Umpqua River, FPKM 204.5, early 1900s–2009

**C.** Whistler's Bend, North Umpqua River, NUFPM 33, early 1900s–2009

**Figure 27.** Historical changes in riparian vegetation in the Umpqua River basin, Oregon, 1920s–2009. Locations of photographs are provided in [appendix A](#).

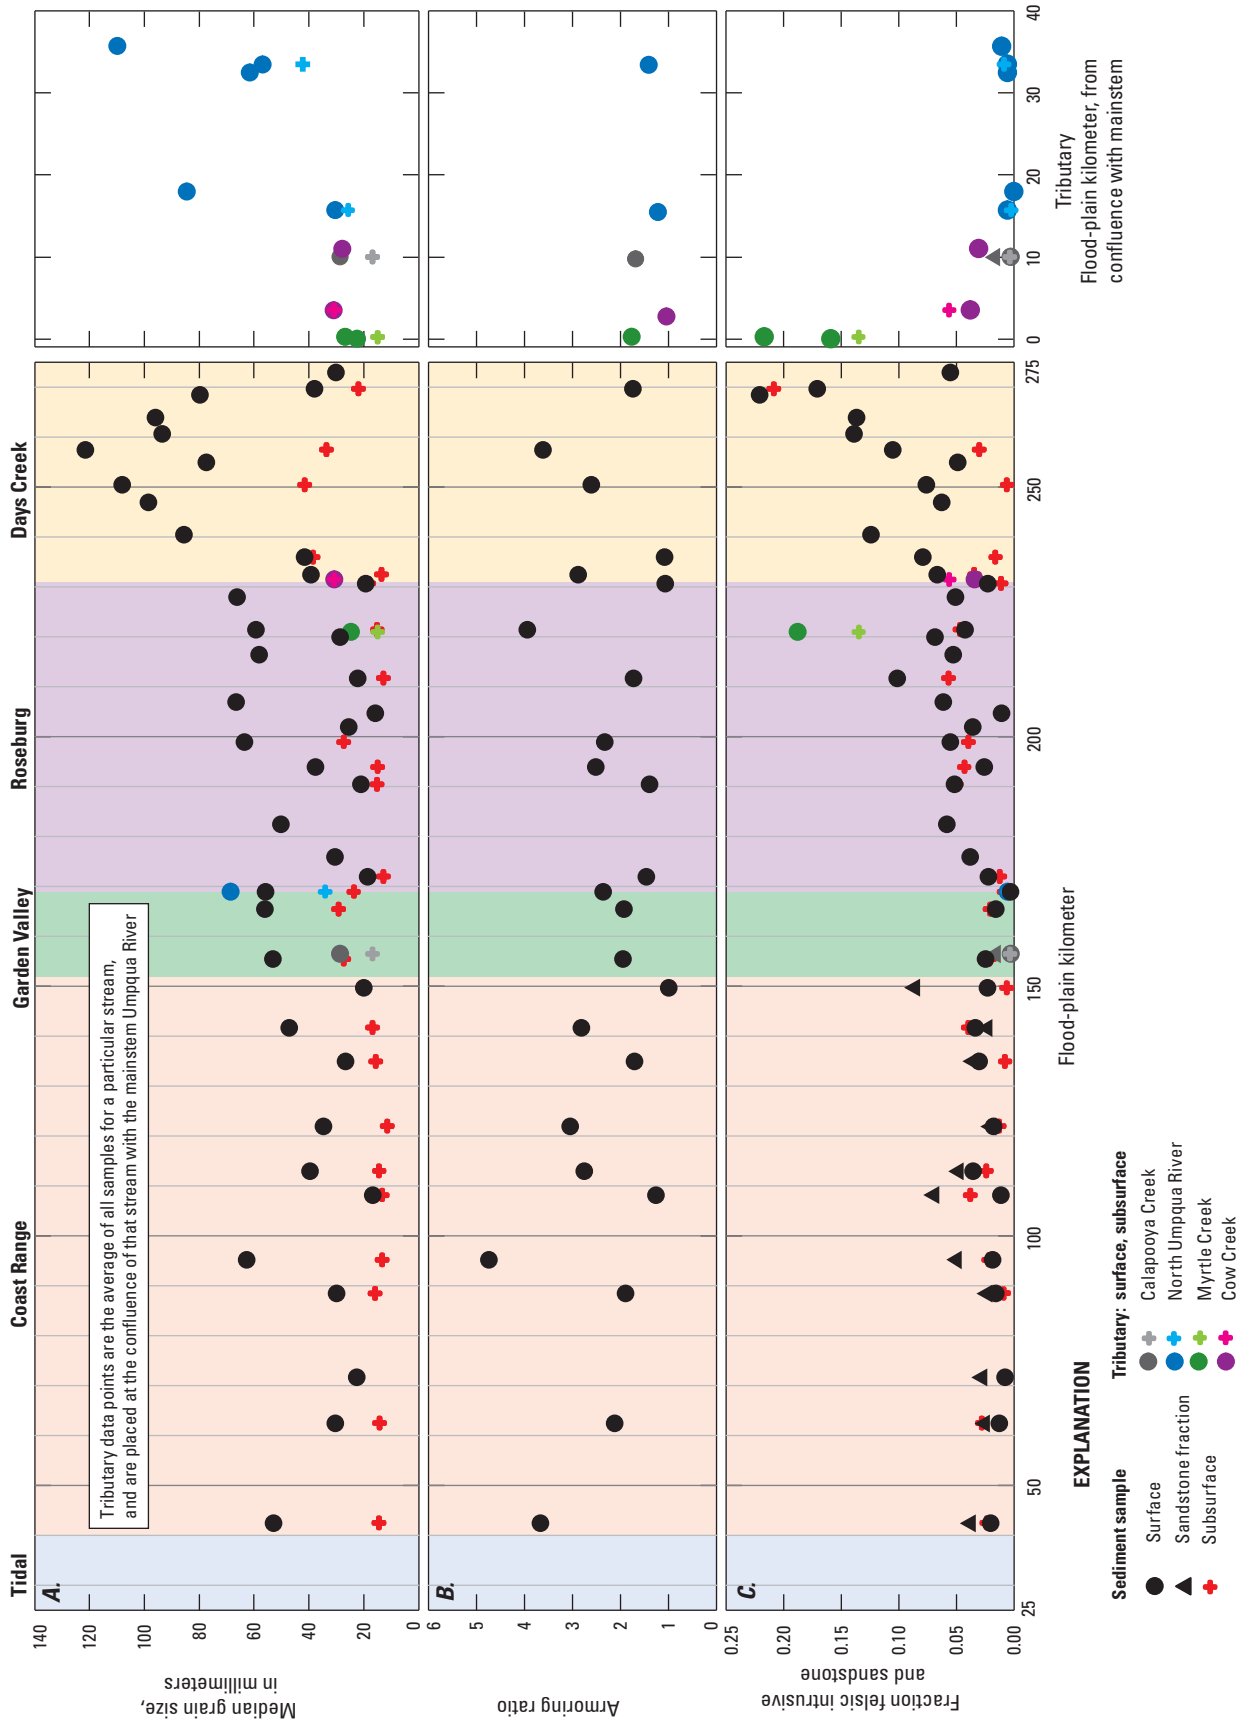
Particle-size distributions show that although the coarsest fractions of the subsurface and surface samples were similar in size, the bed-material subsurface was dominated by a finer matrix of sand to pebble-sized particles (ranging in size from 1 to 10 mm), whereas the bar surfaces were dominated by cobble-sized clasts greater than 30 mm (table 9; appendix C). Disparity between surface and subsurface particle size is commonly attributed to an imbalance between sediment supply and transport capacity, with the surface layer coarsening when the transport capacity of the fine fraction exceeds its supply (Dietrich and others, 1989; Buffington and Montgomery, 1999).

Hence, the ratio of  $D_{50}$  to  $D_{50s}$  (or the “armoring ratio”) can be used to infer the balance between sediment availability and transport capacity. Armoring ratios close to 1, indicating similar surface and subsurface sediment median grain size, indicate high sediment supply, whereas channels with excess transport capacity typically have armoring ratios closer to 2 (Bunte and Abt, 2001). Along the Umpqua and South Umpqua Rivers, armoring ratios ranged from approximately 1 to 4.7, but more than half of the measured bars had armoring ratios greater than 2, indicating excess available shear stress and transport capacity relative to bed-material supply (fig. 37; table 9). The mean armoring ratio for the 25 measurement sites on the South Umpqua and Umpqua Rivers was 2.3, slightly higher than the 2.0 value measured for three sites on the Chetco River (Wallick and others, 2010).

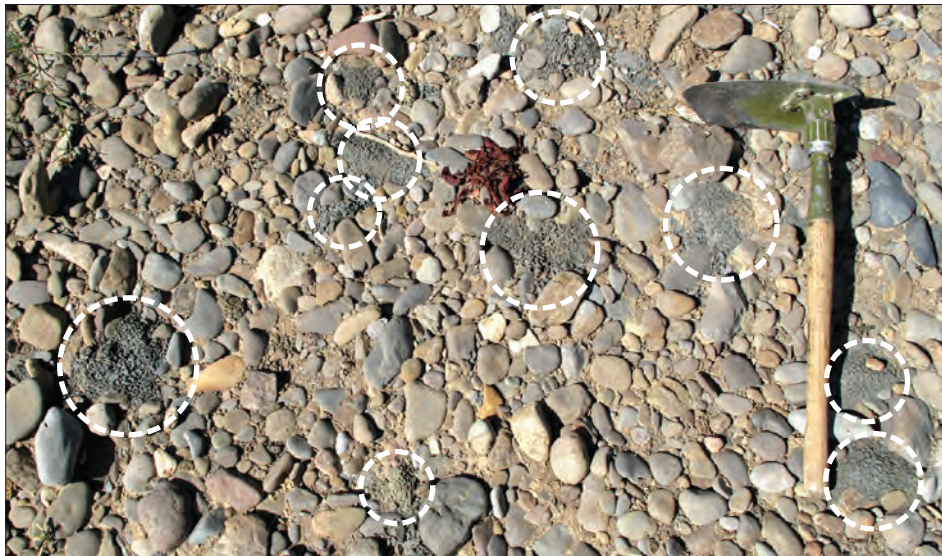
**Figure 45.** Examples of disintegrating sandstone clasts derived from the Tye Formation in the Oregon Coast Range.
