# Patterns and Controls on Historical Channel Change in the Willamette River, Oregon, USA

Jennifer Rose Wallick<sup>1</sup>, Gordon E. Grant<sup>2</sup>, Stephen T. Lancaster<sup>3</sup>, John P. Bolte<sup>4</sup>  
and Roger P. Denlinger<sup>5</sup>

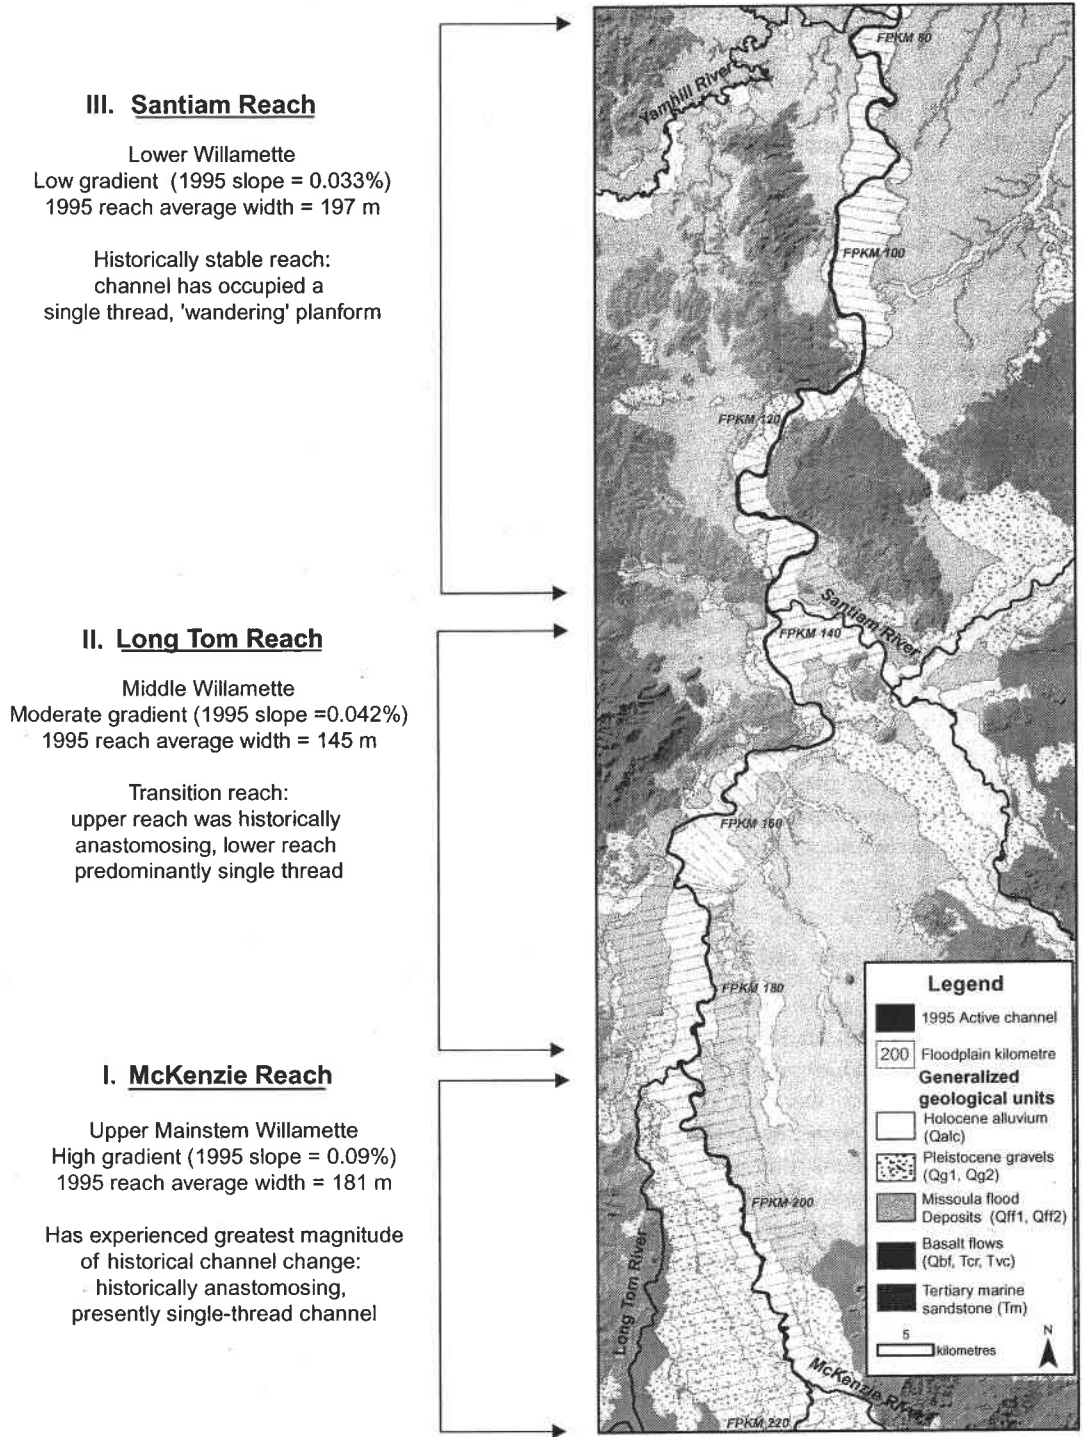
**Figure 23.2** Geologic and physiographic setting of Willamette River study area. The 220 km long study area was divided into three reaches on the basis of planform, discharge and tributary influence. (Geological map from O'Connor *et al.*, 2001. Willamette River active channel and floodplain transect maps from Hulse *et al.*, 2002)

The warmer, drier Holocene climate triggered a wave of regional incision, and Pleistocene braid plains were replaced by the inset anastomosing planform of the modern Willamette. In historical documents, the Holocene floodplain is frequently termed the valley bottom as it is situated 3–35 m below the surfaces of the terraces comprising the main valley floor (Figure 23.3). Holocene floodplain surfaces (unit Qalc, Figure 23.2) range from recent point-bar and active-channel deposits to forested floodplains, and form a 1–2 km wide swath of silts, sands and gravels, deposited less than 12 000 years ago.

The location of the Willamette River with respect to the Holocene floodplain and adjacent older terraces has implications for bank stability and channel change. Along much of its length, the river is flanked on both sides by Holocene alluvium, whereas in other areas, the Willamette flows against older, more indurated bank materials along the floodplain margins (Figure 23.2). The most extensive of these more resistant bank materials include partially cemented Pleistocene gravels (Qg2) that underlay Missoula Flood sediments. Other resistant geological units are locally important and include Tertiary marine sandstones (Tm) that crop out near Albany at floodplain km 110 (FPKM 110) and Tertiary volcanic deposits (Tvc and Tcr) that border the channel near Salem (FPKM 70). Although not strictly speaking a geological control, the Army Corps of Engineers have stabilized large portions of the Willamette River with large, angular boulders (revetments) that form a resistant bank material.

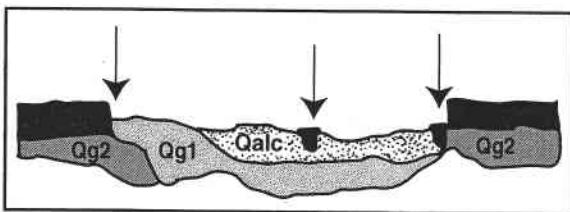
**Figure 23.3** Generalized cross-section of Willamette floodplain. Geological units are same as those shown in Figure 23.2. Arrows indicate typical locations of Willamette River within Holocene floodplain. (Geological units are from O'Connor *et al.*, 2001)

Geological factors also control bank height along the Willamette. Bank height steadily increases downstream as the river becomes increasingly entrenched within both Holocene and Pleistocene surfaces. In the southern valley, elevations of terrace surfaces typically rise 2–5 m above low-water stage, whereas surfaces in the northern valley are up to 15 m higher than low-water stage (O'Connor *et al.*, 2001). Banks are highest where the river flows against Pleistocene terraces composed of indurated Qg2 gravels

and overlying Missoula Flood deposits. Along the upper reaches, Qg2 gravels typically comprise the lower 1–2 m of banks, while along the lower river these same gravels comprise the lower 5–10 m (O'Connor *et al.*, 2001).

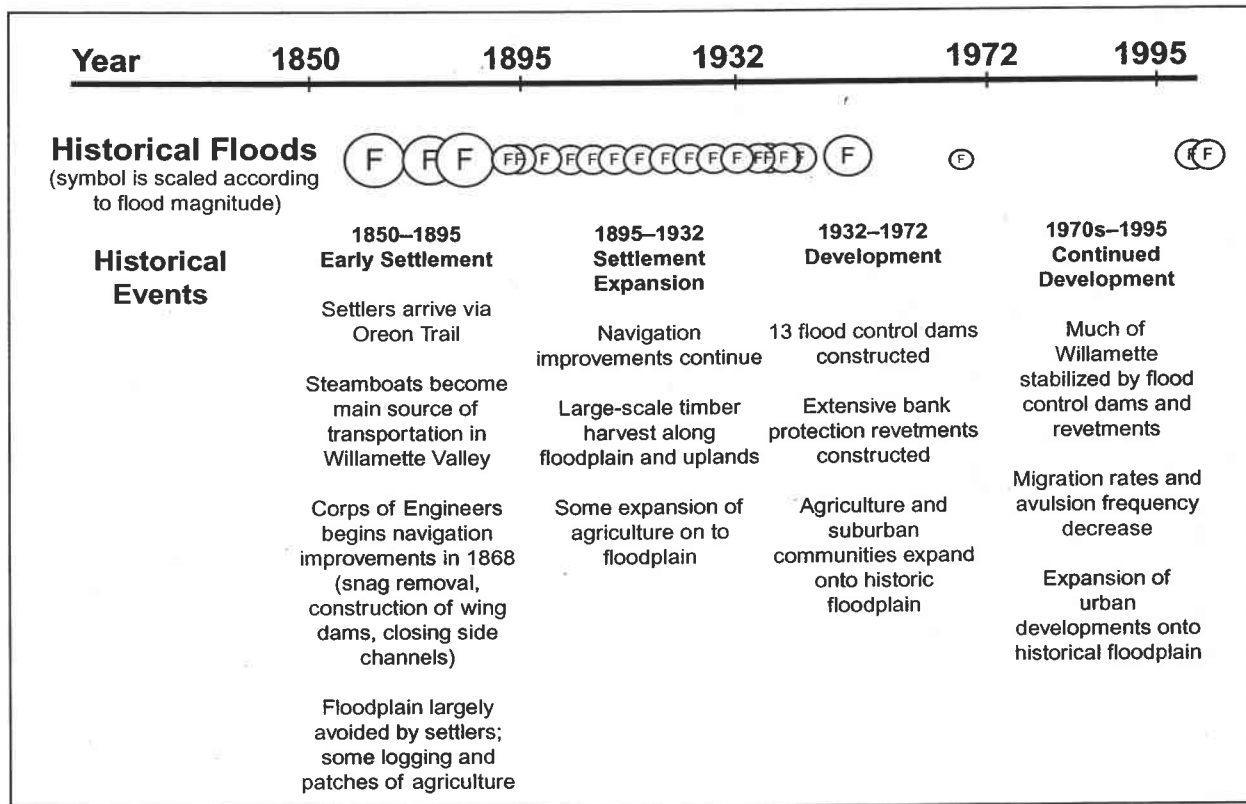
**Figure 23.4** Timeline of geomorphically relevant historical events in Willamette Valley. Prior to Euro-American settlement in the late 1840s, the Willamette River and its floodplain were largely unaffected by human activities. The first Euro-Americans to enter the Willamette Valley were Lewis and Clark in 1805, and the region remained largely unsettled until the late 1840s following the development of the Oregon Trail

ment of the Oregon Trail. We therefore focus our attention on major human modifications since 1850 that may have directly impacted channel planform, style of adjustment, or overall channel behaviour (Figure 23.4).

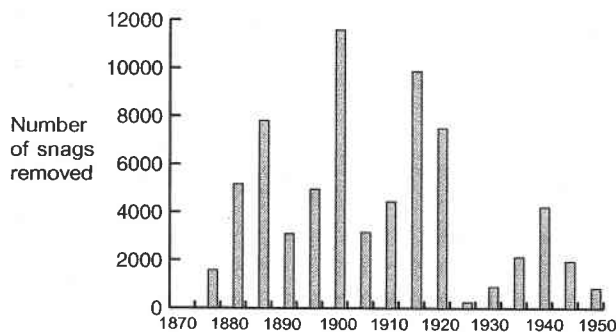
**Figure 23.5** Snag removal 1870–1950 along upper Willamette. Plot shows total number of snags removed per 5-year interval between Albany and Eugene (FPKMs 150–220). Logs removed include harvested streamside trees and downed trees (snags). (Adapted from data provided by Sedell and Froggatt, 1984)

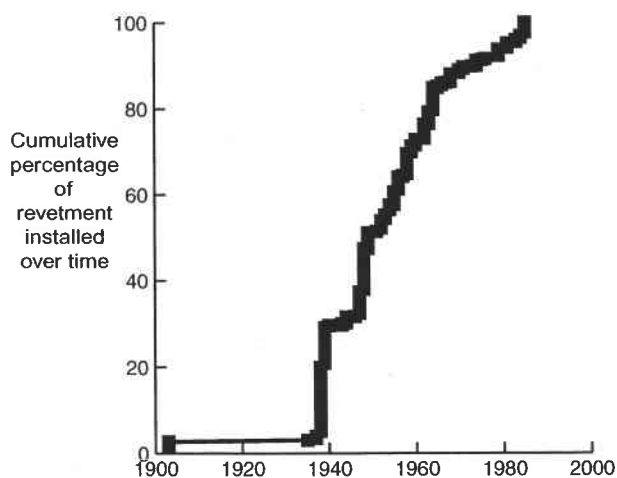
**Figure 23.6** Cumulative percentage of revetment constructed along Willamette River, 1900–1985. Percentage is computed from lengths of revetment that have a known construction date (about 45% of total revetments). (Adapted from data provided by Gregory *et al.*, 2002c)

Although bank protection had begun in the late nineteenth century, the extent and rate of bank stabilization efforts increased dramatically in the mid-1930s (Figure 23.6). Revetment construction by the Corps and private individuals continued through the late twentieth century (Fig. 23.6), and by the 1970s, 90% of all present-day revetments were constructed (Gregory *et al.*, 2002c).

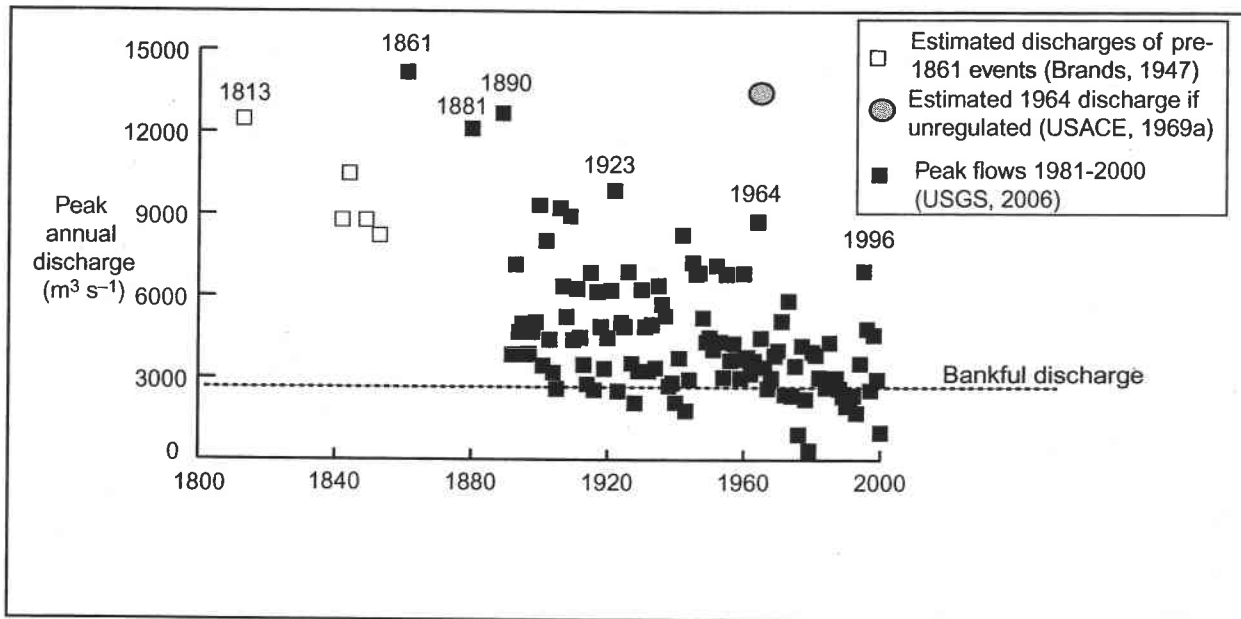
**Figure 23.7** Peak discharge 1813–2000 for Willamette River at Salem. Peak flows have decreased steadily following construction of 11 major flood control reservoirs. Discharge for pre-1861 events was estimated from historic highwater marks (Brands, 1947)

The Willamette River has historically experienced a wide range of floods of different magnitudes (Figures 23.4 and 23.7). Peak flows generally occur in the rainy season between November and March, and are typically associated with rain-on-snow events involving warm, moist subtropical air masses. Infrequent, extreme events (which we refer to as ‘large floods’) arise when these extra-tropical excursions result in intense rainfall accompanied by warm air temperatures over a period of several days, rapidly melting pre-existing deep and extensive snow packs in the Cascade Mountains and foothills. Such conditions led to the largest historic floods, which occurred in 1861, 1881, and 1890, though several other large floods may have also occurred earlier in the nineteenth century before the advent of gauged records (Figure 23.7). Many communities were wholly or partly destroyed in the 1861 flood (approximately  $14\,160\text{ m}^3\text{ s}^{-1}$  at Salem) as floodwaters filled the Holocene floodplain and in some areas, overtopped the Pleistocene terraces (Miller, 1999; Gregory *et al.*, 2002b). The large floods of 1881 ( $12\,120\text{ m}^3\text{ s}^{-1}$  at Salem) and 1890 ( $12\,690\text{ m}^3\text{ s}^{-1}$ ) also heavily damaged several towns and caused extensive erosion (USACE, 1881; Brands, 1947; Anderson, 1974).

gauge records indicating that the three largest historical floods in 1861, 1880 and 1891 occurred during this time period (Figure 23.7); (2) flood model results showing stream power during the largest floods is concentrated in overbank areas and therefore more likely than smaller floods to cause channel widening and avulsions (Fig. 23.12); (3) the observation that the 1850–1895 period was marked by numerous avulsions whereas subsequent time periods with fewer large floods had substantially fewer avulsions (Figure 23.8); (4) historical records during this early period (e.g. Brands, 1947) that describe large, channel-spanning, wood rafts that, once mobilized during exceptional floods, could readily have served as tools for stripping surfaces and eroding banks, thereby facilitating channel widening (Johnson *et al.*, 2000); (5) aerial photographs of the Willamette floodplain that reveal many examples of large-amplitude bends having been abandoned through avulsions, with few examples of meander bends that have evolved entirely through lateral migration (Figure 23.13).

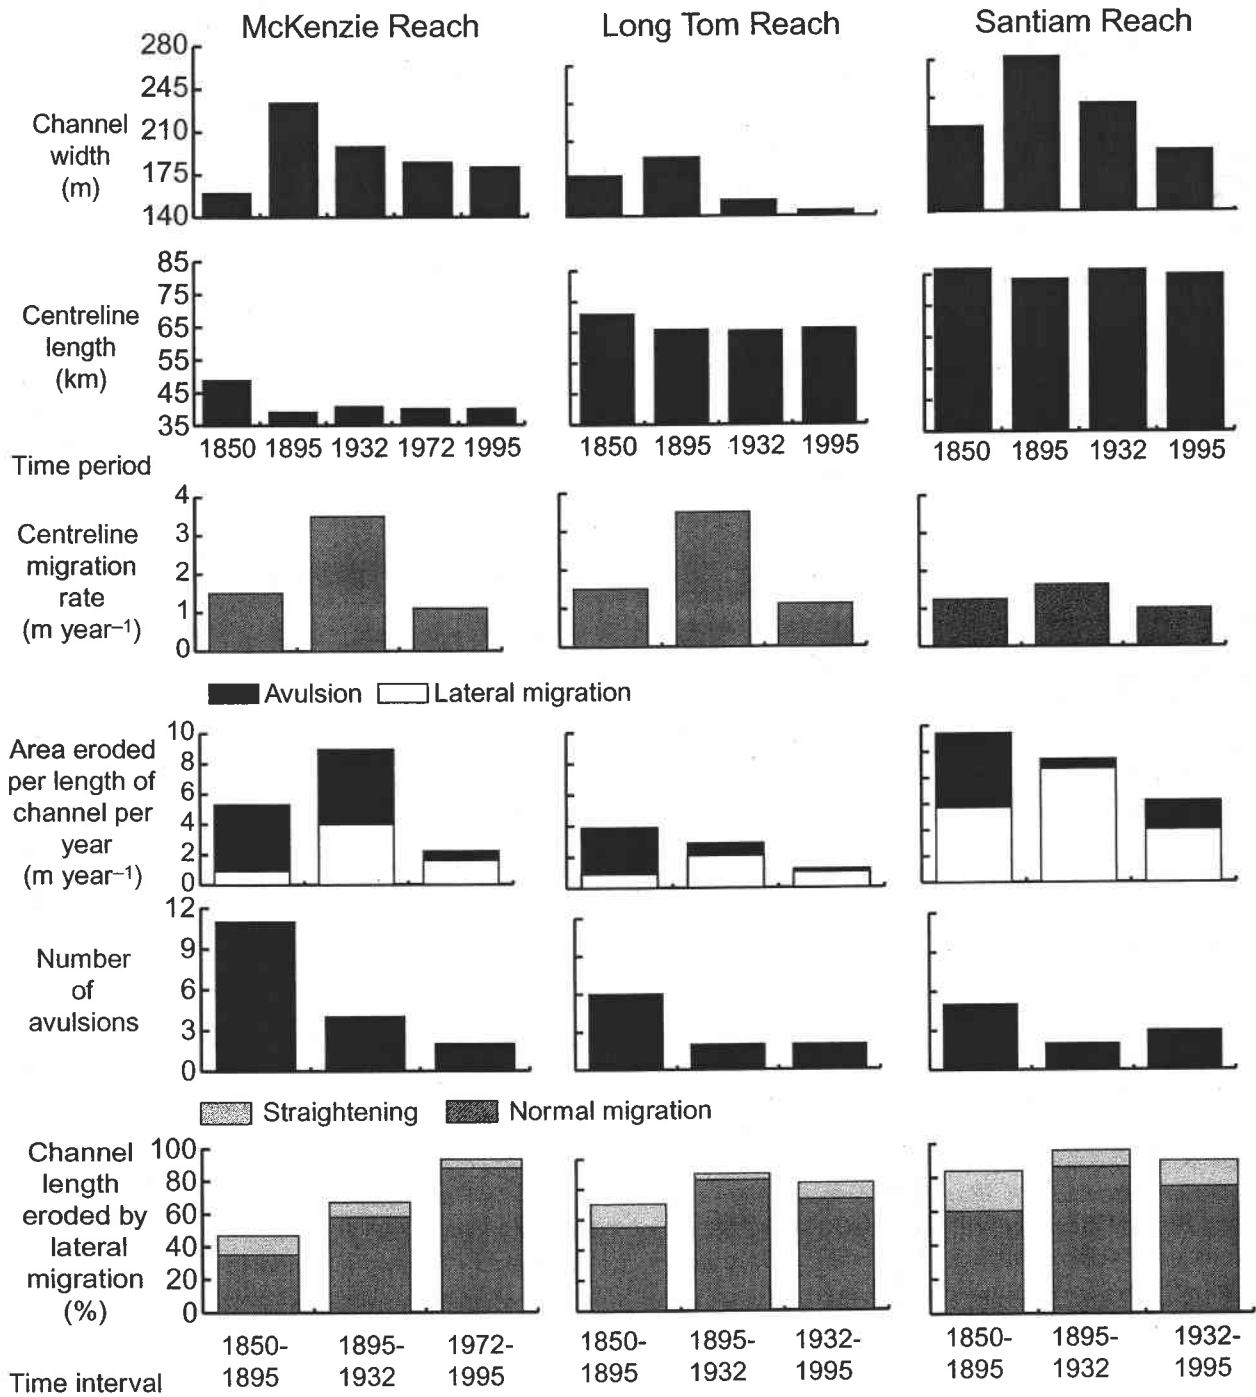
**Figure 23.8** Patterns of channel change for mainstem Willamette River, 1850–1995

After experiencing a general widening and straightening during 1850–1895, the McKenzie reach narrowed by 15% as lateral migration became dominant during 1895–1932 (Figures 23.8 and 23.10). Although migration rates more than doubled and the length of channel subject to migration increased by 20%, centreline length only increased slightly. The overall style of migration was quite dynamic as several low-sinuosity portions of the 1895 channel developed into bends that subsequently migrated downstream (Figure 23.10).

Twentieth century channel change along the Santiam Reach was marked by channel narrowing and an overall decrease in floodplain erosion (Figure 23.8). Although three avulsions occurred, they generally bypassed smaller portions of the floodplain compared with larger, historic avulsions. Migration rates were similar to rates experienced during the mid-late nineteenth century, but the area affected by migration is much less than for historic periods. Decreased migration, fewer avulsions and continued channel narrowing cause much of the 1995 channel to be positioned within the boundaries of the 1932 channel.

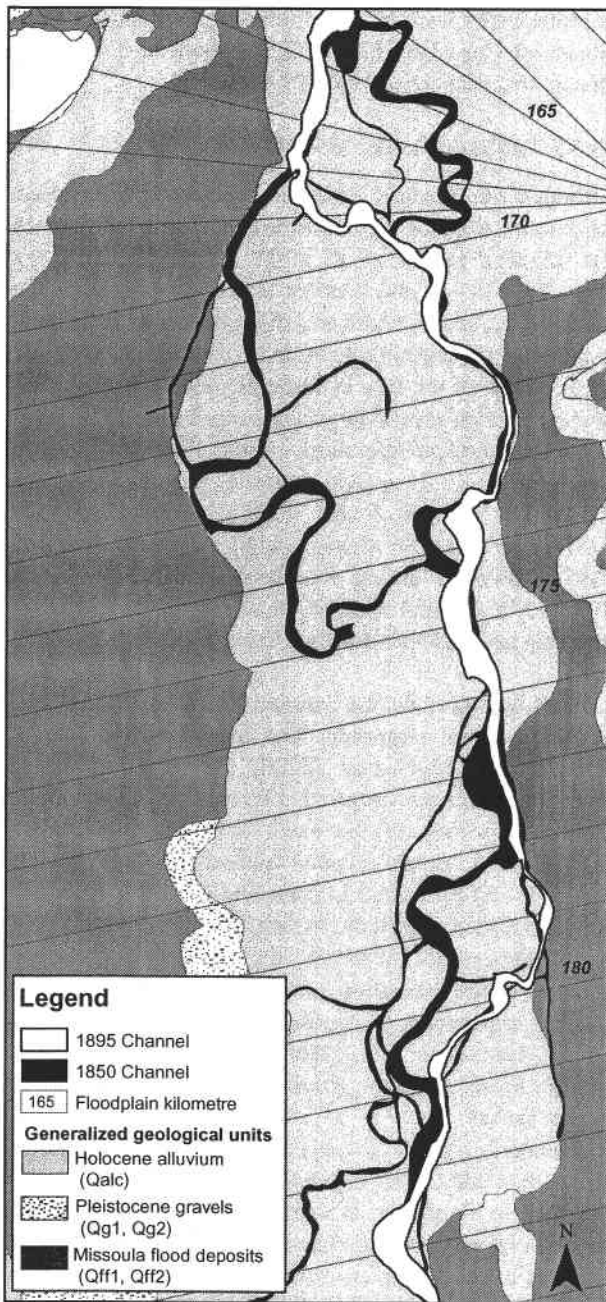
**Figure 23.9** Example of avulsions 1850–1895 along upper Willamette River. Similar large-scale avulsions occurred along the entire Willamette River during this time period. In many cases, the 1895 channel avulsed into former side channels (e.g. FPKM 165–170) or carved cut-off channels (e.g. FPKM 169). (Geological map from O'Connor *et al.*, 2001. Historical Willamette River channel maps and floodplain transect maps from Hulse *et al.*, 2002)

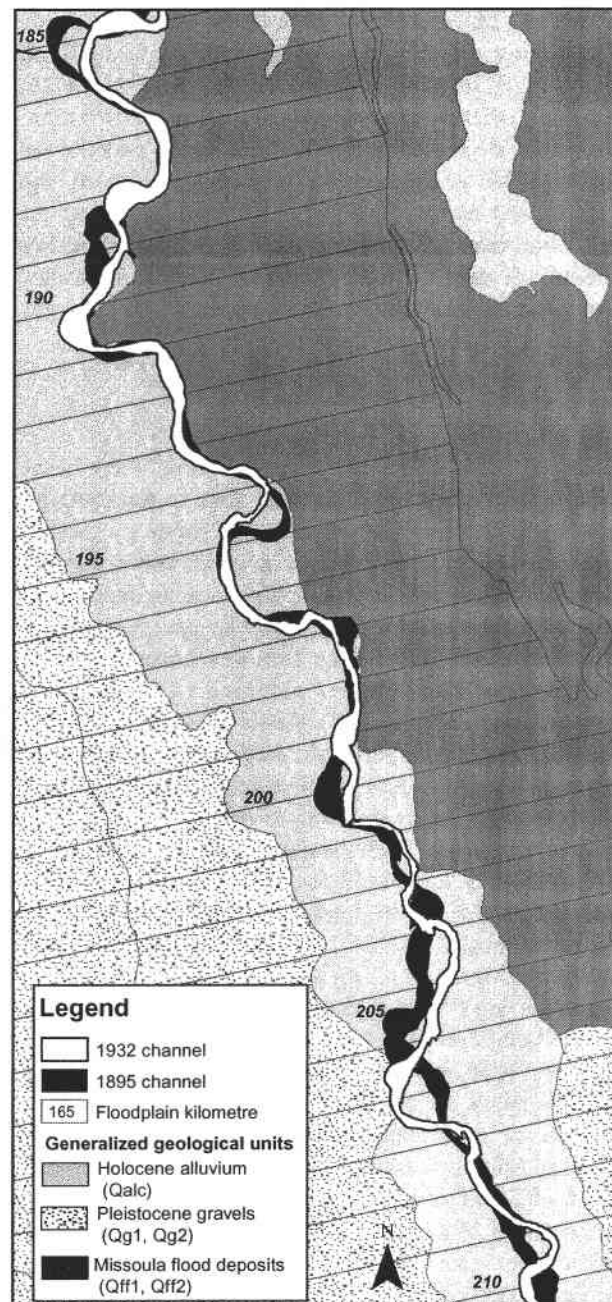
**Figure 23.10** Example of rapid meander migration 1895–1932 along upper Willamette River. Along much of the Willamette River, small initial bends in the 1895 channel developed into larger bends which subsequently migrated downstream by 1932 (e.g. FPKM 200–205). As sinuosity increased, channel width also narrowed during the 1895–1932 time period. (Geological map from O'Connor *et al.*, 2001. Historical Willamette River channel maps and floodplain transect maps from Hulse *et al.*, 2002)

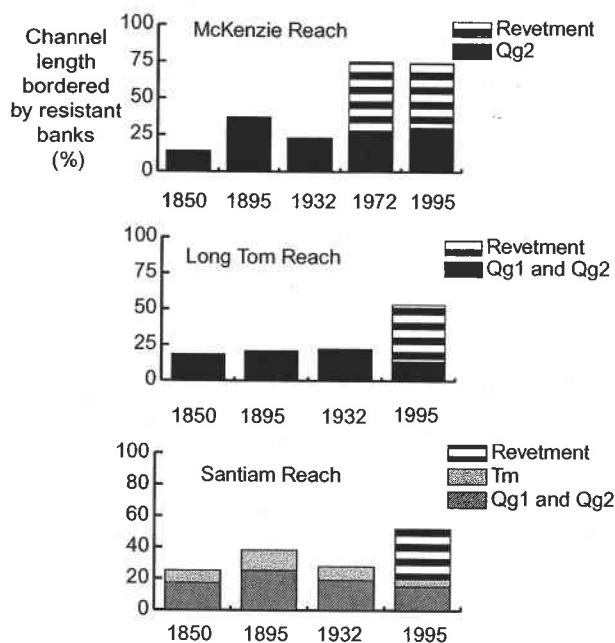
**Figure 23.11** Length of channel bordered by resistant bank materials. Revetment installed in the 1930s–1970 stabilizes large areas of the Willamette River, while naturally resistant banks have historically bordered an additional 13–40% of each reach. (Geological units from O'Connor *et al.*, 2001)

Along all reaches, the percentage of channel bordered by resistant banks has increased substantially over the 150-year study interval (Figure 23.11). Moreover, we see that some bends situated adjacent to naturally resistant bank materials (e.g. the Qg2 located along floodplain margins) were historically able to migrate or avulse away from resistant banks, causing the percentage of channel bordered by resistant banks to fluctuate slightly over time (Figure 23.11). However, bank stabilization in the mid-twentieth century apparently causes many of these bends

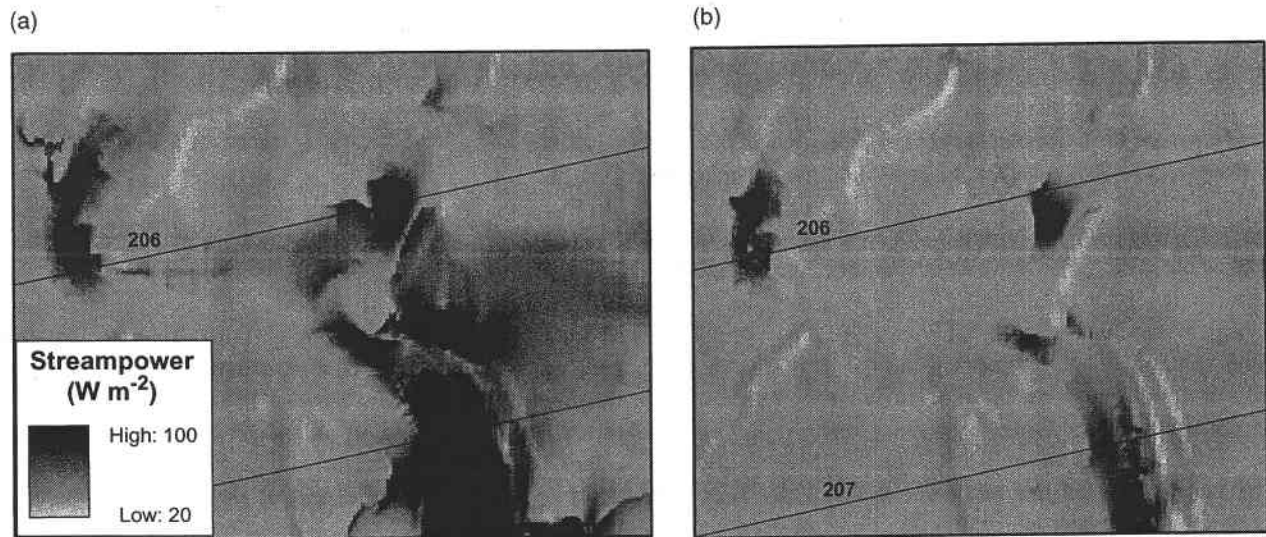
**Figure 23.12** Comparison of streampower for large floods and moderate floods. Streampower was calculated as the product of shear stress and velocity using MIKE 21, a two-dimensional hydrodynamic model. Area shown spans FPKM 205–208 along the upper Willamette upstream of Harrisburg. (a) Streampower at  $7930 \text{ m}^3 \text{ s}^{-1}$ , estimated peak discharge for the 1861 flood of record at Harrisburg. (b) Streampower at  $2100 \text{ m}^3 \text{ s}^{-1}$ , approximate peak discharge for the 1996 flood at Harrisburg. The 1996 flood was similar in magnitude to the ‘moderate’ floods that occurred frequently in the early twentieth century

On the upper Willamette, large-magnitude floods such as the 1861 event ( $\sim 7930 \text{ m}^3 \text{ s}^{-1}$  at Harrisburg) inundate the entire Holocene floodplain and generate erosive overbank flows (Figure 23.12a). In many areas, flow follows the regional (floodplain) topography rather than the river, causing streampower to be concentrated in areas outside the main channel. Power is typically highest along inside, rather than the outside, of meander bends. Such patterns of erosive flows could have led to scouring of point bars, and may have caused widening of the channel or migration towards inside of bend (straightening). Streampower is also high at the downstream end of bends, but on the outside of the channel where chute formation and avulsions are likely to occur. Overbank flows in areas not adjacent to the channel could have carved new side-channels, or triggered migration and avulsions along existing secondary channels.

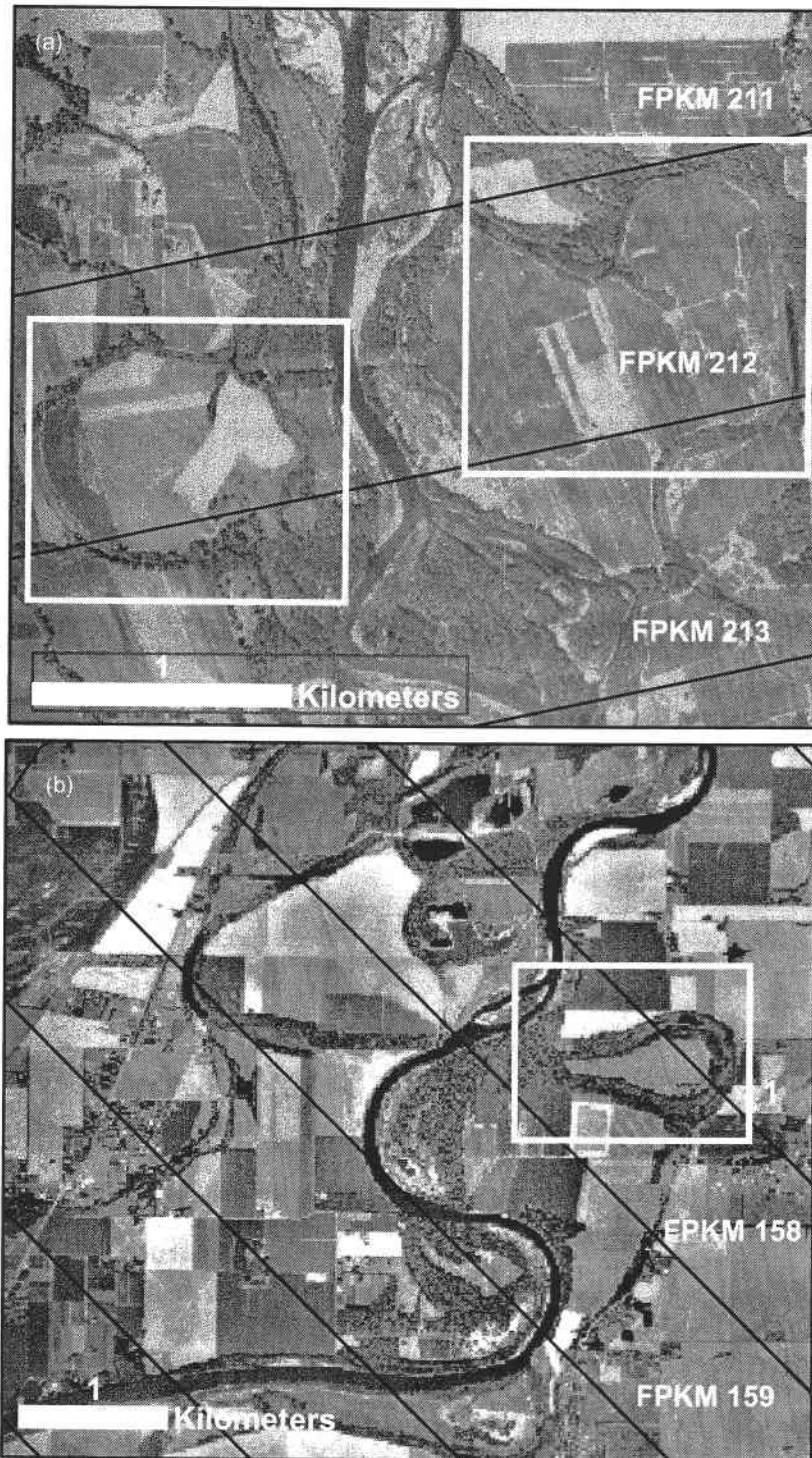
**Figure 23.13** Examples of avulsions and meander migration recorded in remnant floodplain features. (a) Examples of abandoned large-amplitude bends as recorded in aerial photographs of Willamette River floodplain. These bends were probably active in the nineteenth century. Similar features are found in many other areas of the southern Willamette Valley. (b) Example of meander bend that evolved entirely through lateral migration. Such bends are rare in the Willamette Valley floodplain. This bend is located between Corvallis and Albany and probably formed along a side channel in the early twentieth century
