# **Working with Beaver to Restore Salmon Habitat in the Bridge Creek Intensively Monitored Watershed**

## **Design Rationale and Hypotheses**

October 2012

## **NOAA Technical Memorandum NMFS-NWFSC Series**

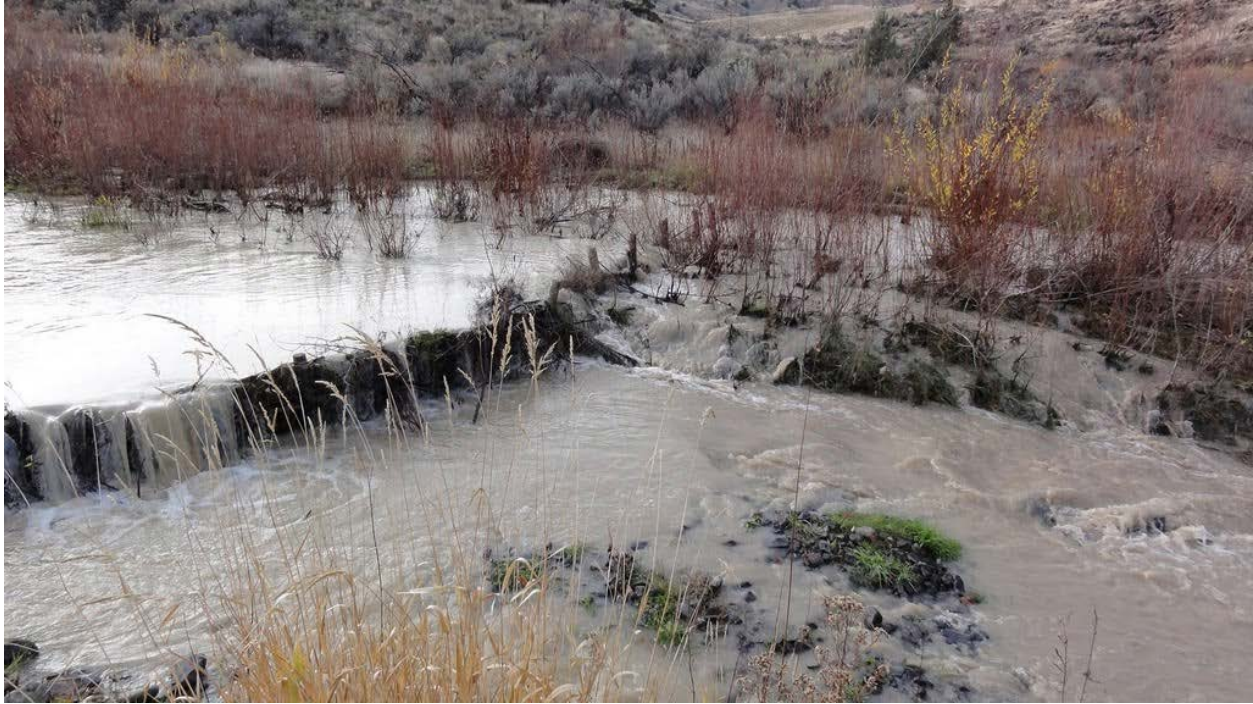
Figure 10. A typical SD (SF-17 at Sunflower) with willow branches woven between vertical posts and the back side sealed with rock and clay. Note that the dam height is sufficient to divert flow onto the river left terrace, mimicking a stable beaver dam.

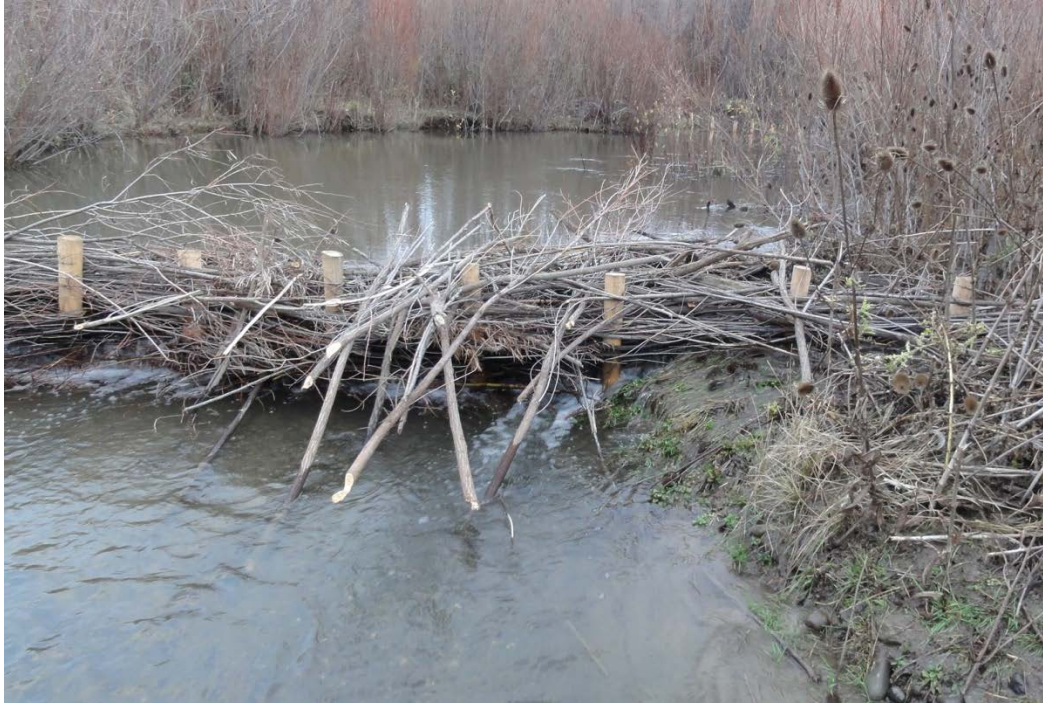
Figure 11. A PLWW is similar to an SD, but acts more like a weir in that water is allowed to flow through the willow branches such that low flows are not overtopping the structure and the woven branches may not extend to the top of the posts. These may naturally seal up by trapping sediment and organic material moving downstream or they may be utilized by beaver. Note that beaver have started to colonize this PLWW, as evidenced by the chewed stems aligned parallel to the flow in the middle of the photograph.

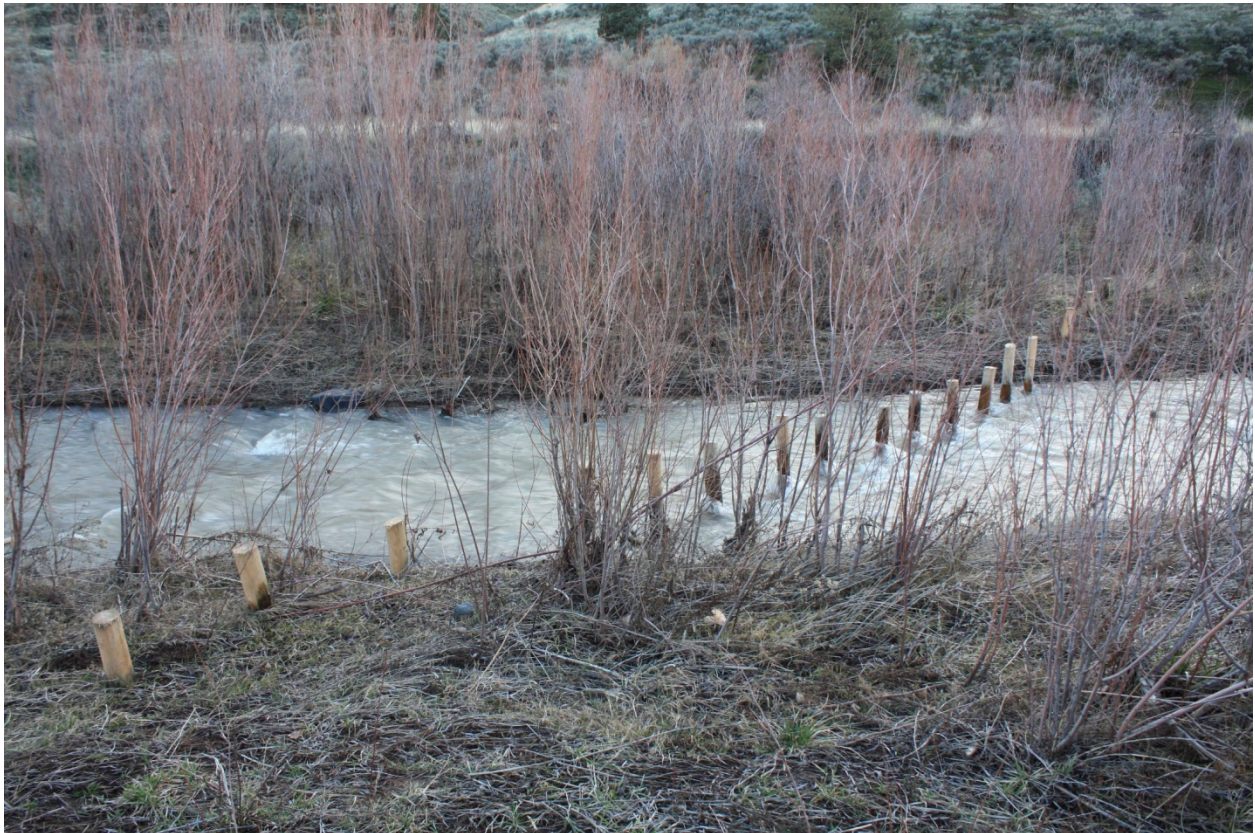
Figure 12. The purpose of a PL is to provide a site where beaver can build a stable dam. They generally create little or no geomorphic changes unless utilized by beaver.

PLs (Figure 12) were placed in sites where a future beaver dam was desired and where geomorphic conditions were suitable for a dam. In contrast to PLWWs, PLs by themselves were limited to sites where there was minimal risk if no aggradation occurred because beaver did not use them to build a dam. These structures were not intended to be functional unless beaver utilized them to build a dam.

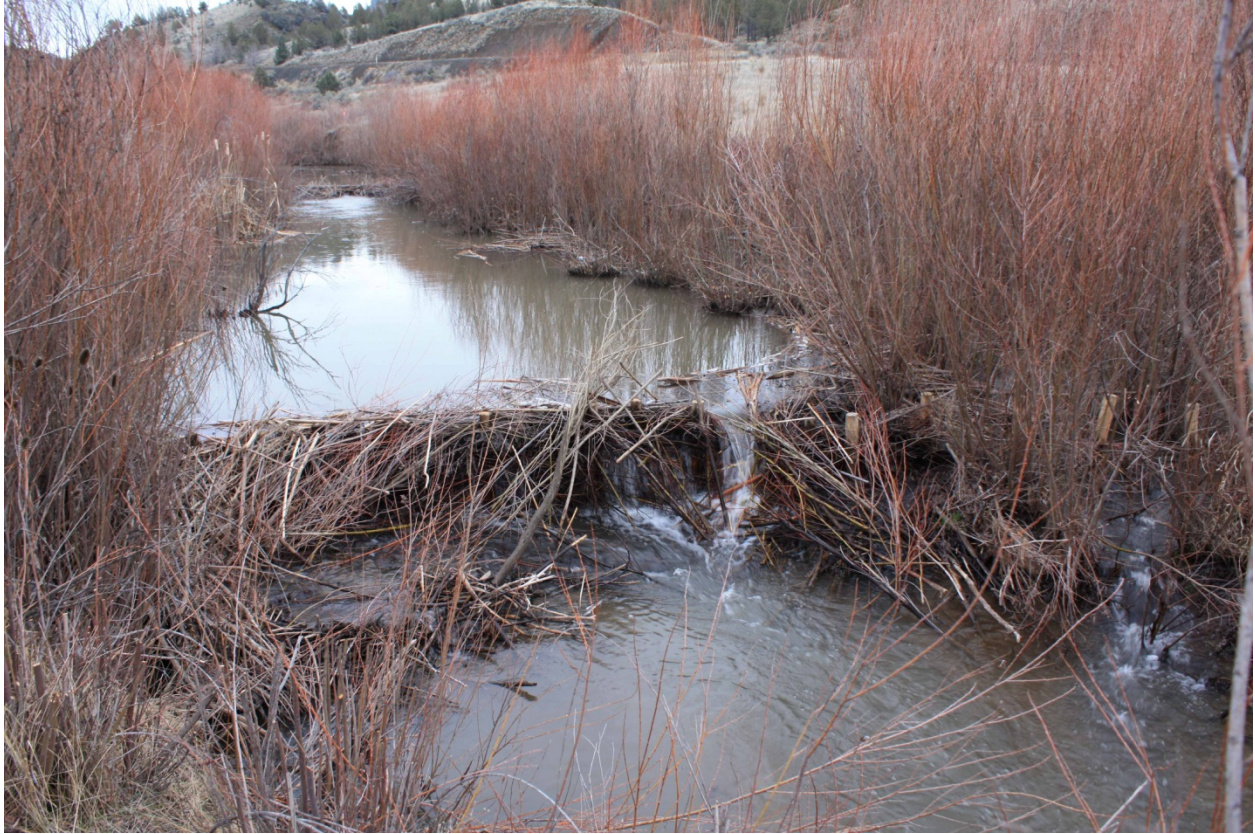
Figure 13. Any active dams within the treatment areas were strengthened with posts to lengthen their functional life, since most dams along the incised Bridge Creek have been shown to last less than a year (Demmer and Beschta 2008). This structure was one of four dams built in sequence in Lower Owens to form a new colony. Within 1 year, all four dams had backfilled with sediment, which improved floodplain connectivity and habitat complexity, but made the site unsuitable for beaver. However, because we had installed additional PLs just downstream, the beaver were able to use them to build new dams, which allowed the colony to persist.

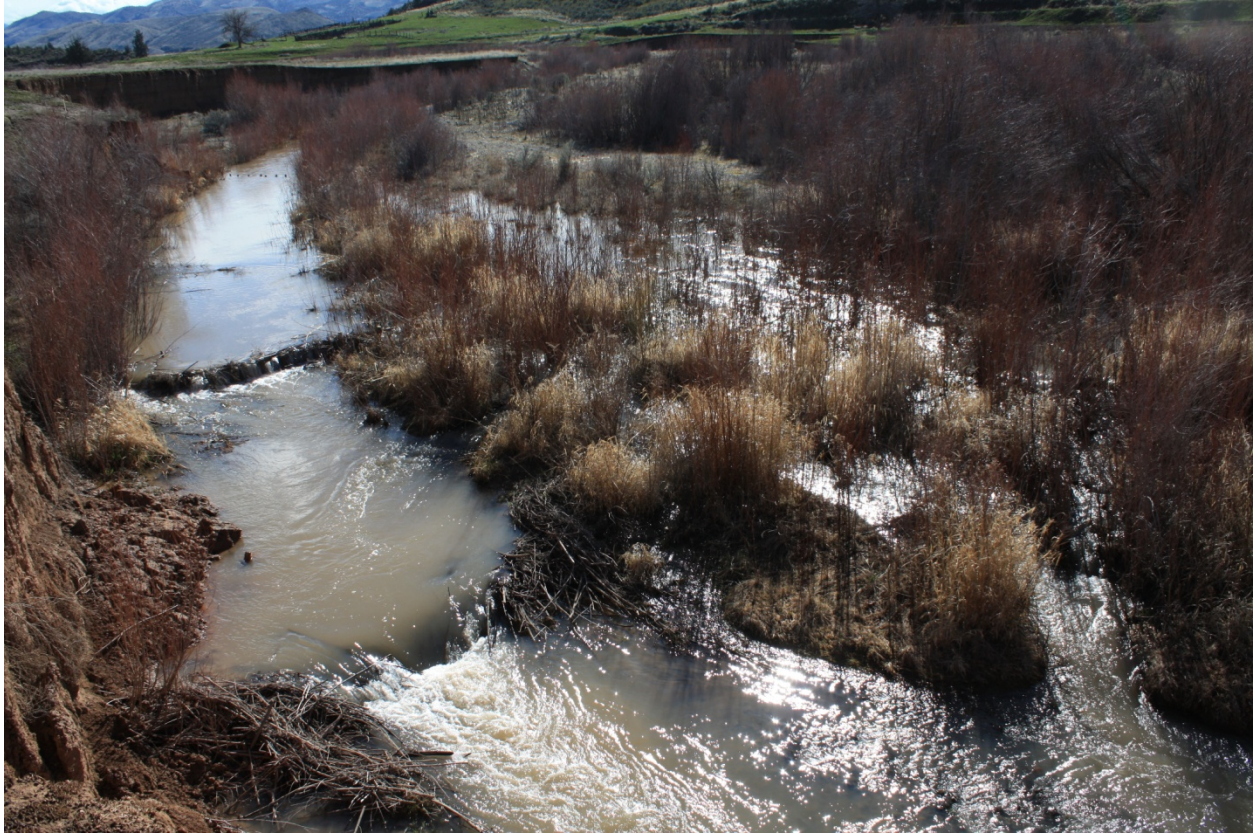
Figure 14. Any abandoned dams with significant structure remaining were reinforced with posts, since these were sites where beaver had previously built dams and with additional structure available might do so again. Beaver abandoned this dam (PC-15 in foreground) and one immediately downstream (not in photograph) after they were breached by high flows. Within a year following reinforcement by posts, beaver rebuilt this dam and built two more dams on PLs (one visible immediately upstream of PC-15, the other farther upstream), resulting in a flooded terrace and complex, multichannel habitat forming on river left and diverting flow away from a high exposed bank on river right.
